SERVICE LETTER

TO: ALL OWNERS, OPERATORS AND PILOTS OF MCDONNELL DOUGLAS HELICOPTER COMPANY (MDHC) 369 SERIES HELICOPTERS THAT HAVE ANTENNAS INSTALLED ON THE UPPER SURFACE AREAS OF THE AFT BOOM FAIRING.

ANTENNA LOCATION AND FLIGHT MANEUVER CAUTION

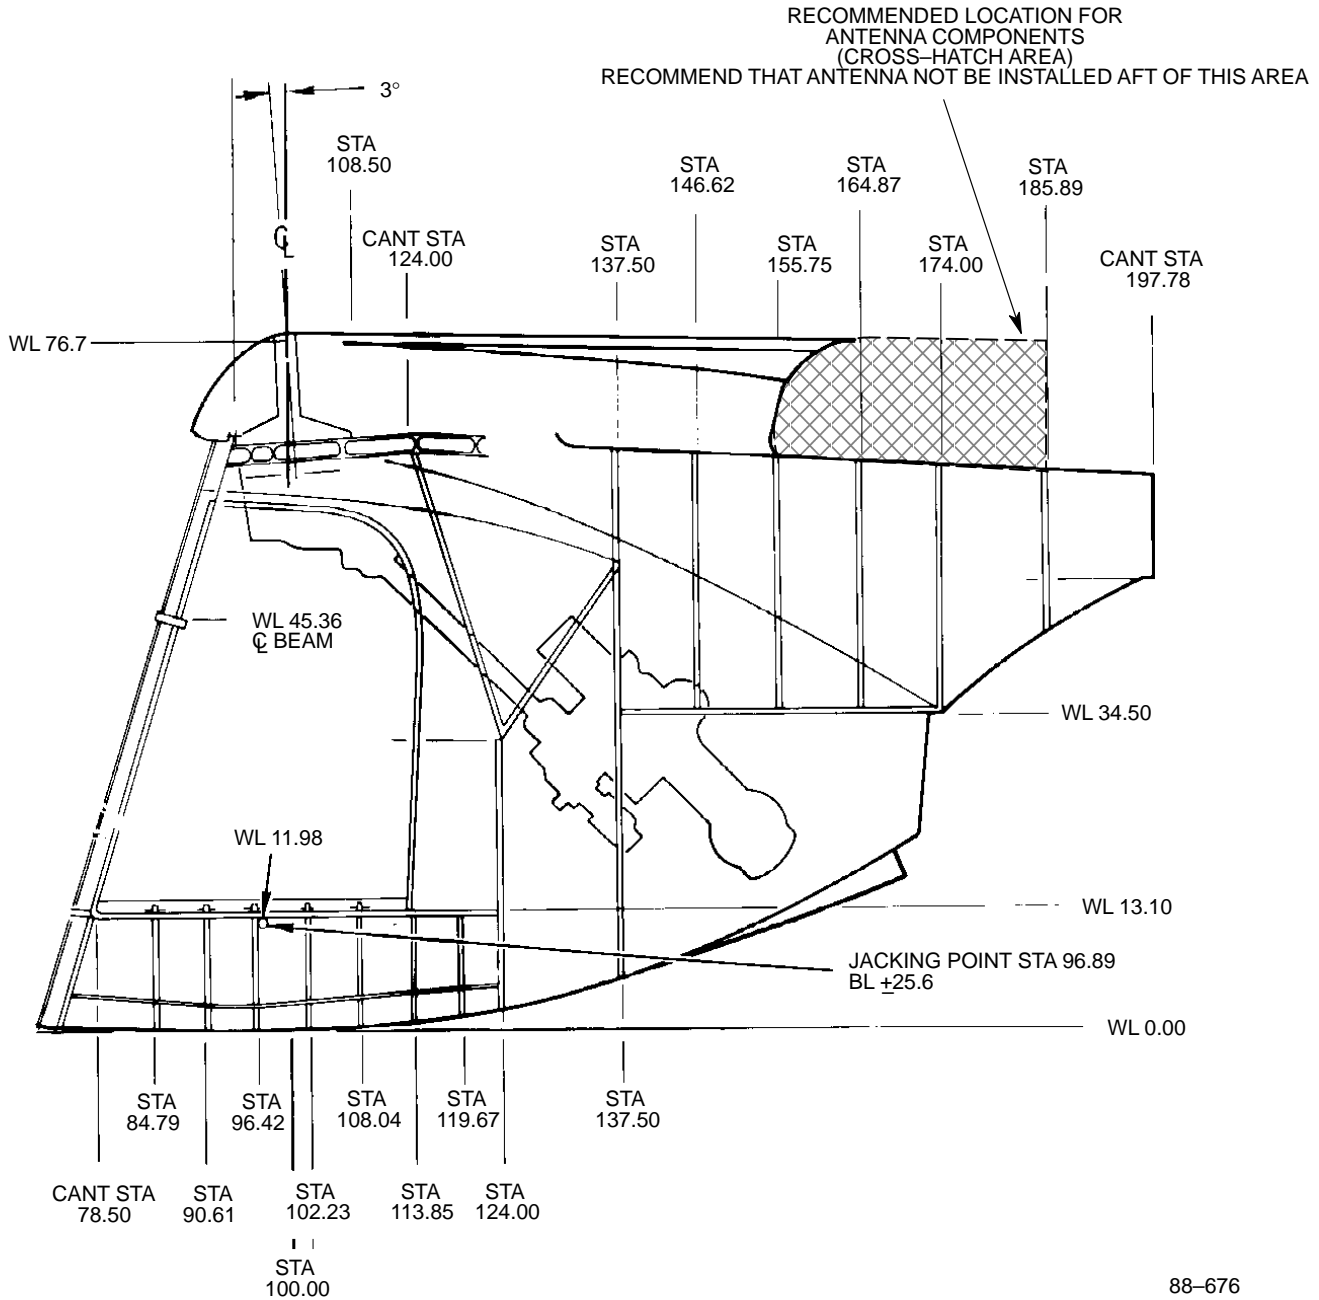
Figure 1. Recommended Antenna Location

MDHC has received information from operators indicating that antennas (e.g., LORAN antennas) installed on the upper surface of the aft boom fairing have been struck by the main rotor blades during practice touchdown autorotations. MDHC strongly recommends that operators who have installed antennas on the upper surfaces of the aft boom fairing relocate those installations to a position where contact between any rotating component and an antenna will not be possible. Figure 1 shows an acceptable location for such installations.
