SERVICE BULLETIN

OVERRUNNING CLUTCH ASSEMBLY, PN 369A5350-603 REWORK AND INSPECTION OF PN 369A5350-11 CLUTCH SUBASSEMBLY AND PN 369A5361 BALL BEARING; PERIODIC INSPECTION OF PN 369A5350-21 CLUTCH SUBASSEMBLY

All Model 369D and 369MD Helicopters

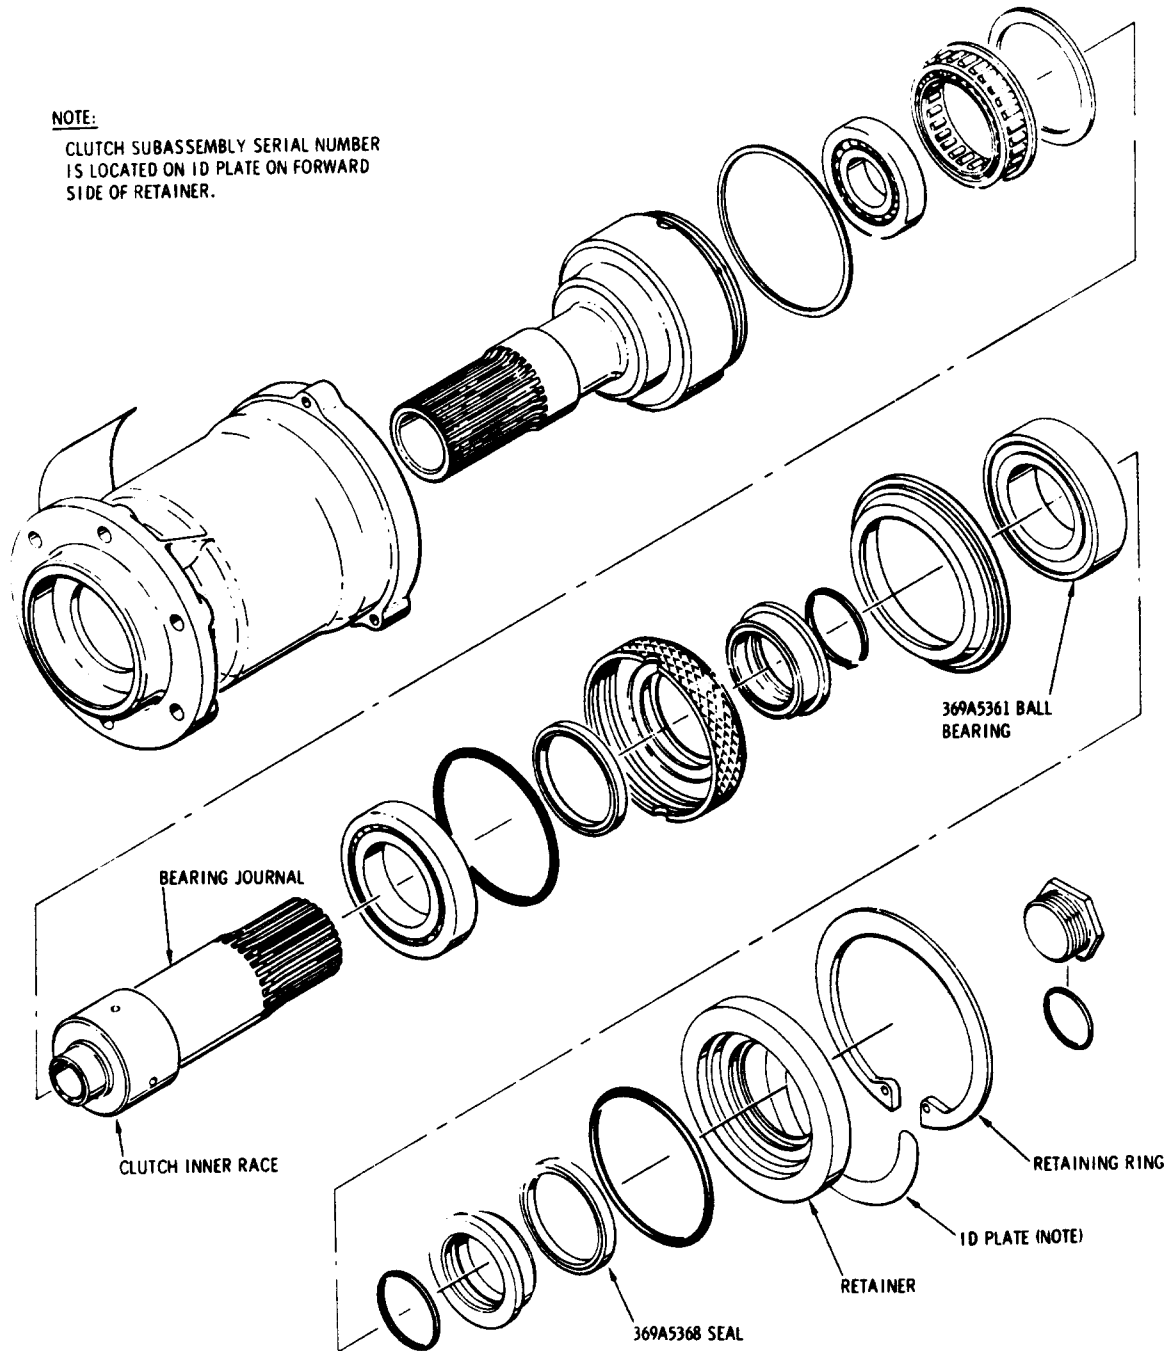
Figure 1. Overrunning clutch assembly

- (3). Temporarily install coupling bolt, to maintain internal fluid.
- (4). Remove clutch retainer to expose 369A5361 ball bearing (see Figure 1).
- (5). Check 369A5361 ball bearing for excessive loss of grease.

- (1). Remove clutch subassembly PN 369A5350-21, per Basic HMI-Vol I.
- (2). Temporarily install coupling bolt, to maintain internal fluid.
- (3). Remove clutch retainer to expose 369A5361 ball bearing (see Figure 1).
- (4). Check 369A5361 ball bearing for excessive loss of grease.

CLUTCH SUBASSEMBLY SERIAL NUMBER IS LOCATED ON ID PLATE ON FORWARD SIDE OF RETAINER.
