SERVICE BULLETIN

DATE: 8 DECEMBER 1978

INSPECTION AND REWORK OF TAIL ROTOR HUB, PN 369A1725-5 AND 369A1725-501; INSPECTION OF TAIL ROTOR BLADE ATTACHMENT BOLTS; PN MS21250-06040

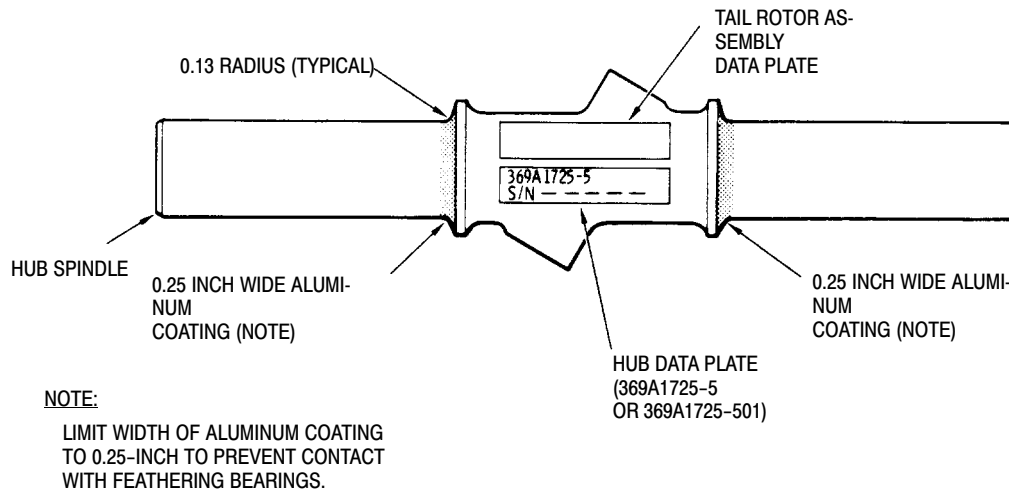
Figure 1. Rework of Tail Rotor Hub Assembly

- (2). Clean hub with MEK.
- (3). Using 10X glass, inspect hub for cracks and corrosion or other damage. Pay particular attention to area of 0.13 radii between the spindles and center portion of the hub. (See Figure 1.)

- (a). Indications of cracking are cause for hub rejection, except as noted below.
 - 1). Minor surface imperfections or discontinuities in the unmachined center of the hub may appear to indicate cracking. This area may be dressed with medium grade emery cloth for minimum material removal to remove the imperfections.

- (b). If corrosion or pitting is noted, clean hub surface with fine emery cloth or crocus cloth.
 - (c). If surface repair was performed in a. or b. above, clean hub with MEK and reinspect hub with 10X glass. Pay particular attention to 0.13 radius areas on both sides of the hub.

- (d). If hub is rejected, contact HH Customer Service Department for disposition.
- (4). Magnetic particle inspect hub for cracks, per MIL-I-6868. Pay particular attention to 0.13 radius areas on both sides of the hub. If hub is rejected, contact HH Customer Service Department for disposition.

- (5). Rework hub as follows using Alumazite Z:
 - (a). Shake contents of container thoroughly.
 - (b). Brush a thin (0. 0002 to 0. 0005 inch) even coat onto cleaned surface of 0.13 radius areas on both sides of the hub. (See Figure 1.) Limit width of aluminum coating to 0.25 inch, to prevent contact with feathering bearings.

- (c). Allow a flash-off (drying) time of 8 to 10 minutes.
 - (d). Bake hub for 1 hour at 375° to 425° F in oven or use heat lamp.
 - (e). Air cool hub.

- (6). Add letter “Z” following serial number on hub data plate, to denote rework of 369A1725-5 or 369A1725-501 hub. (See Figure 1.)
