SERVICE BULLETIN

DATE: 11 JUNE 1979

INSPECTION AND REPAIR – STATION 142 TAIL ROTOR CONTROL BELLCRANK SUPPORTS, PN 369A3035–11 AND 369A3035–15

500D Model 369D Helicopter Serial Nos. 0003D through 0531D; 0533D, 0535D and 0537D

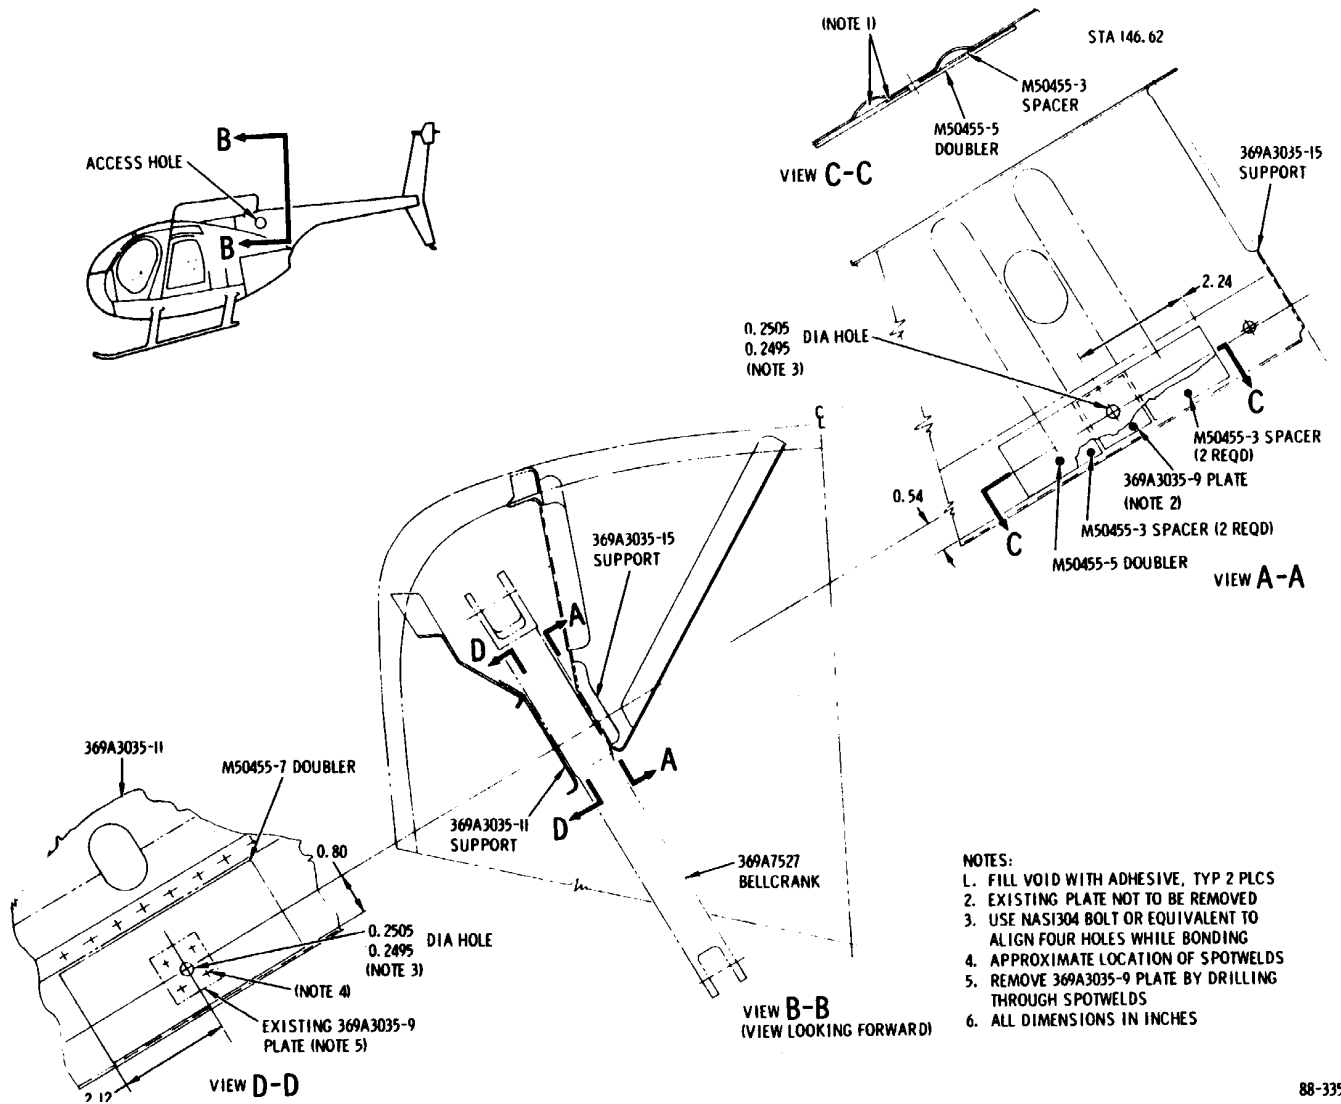
Figure 1. Installation of Doublers - Tail Rotor Control Bellcrank Supports

- (1). Remove Station 142- tail rotor control bellcrank assembly, per Section 8 of HMI-Vol-ume I.
- (2). Using bright light and mirror, visually inspect PN 369A3035-9 doublers on bellcrank supports for cracking or damage. (See Figure 1.) Pay particular attention to the four spot weld spots attaching doublers to supports.

NOTE: Perform Part II of this Notice prior to next flight, if cracking or damage to doublets at ellcrank attach area is noted.

- (1). As required, remove Station 142 Station tail rotor control bellcrank assembly, per Section 8 of HMI-Volume I.
- (2). Remove existing 369A3035-9 doubler from outboard 369A3035-11 bellcrank support, by drilling out doublet spotwelds, 4 places, as shown in Figure 1.

- Removal of 369A3035-9 doubler from inboard side of 369A3035-15 bellcrank support is not required.
 - Stop drill any crack or cracks found in 369A3035-11 and -15 bellcrank supports.
- (3). Lightly abrade laying surfaces of 369A3035-11 and -15 bellcrank supports; it is not necessary to abrade through paint to secure good bonding. If abrading removes paint and primer from supports, doublers and spacers must be bonded immediately after abrading.

- (5). Install spacers and doublers as shown in Figure 1. Use NAS1304 bolt or equivalent as alignment pin to align holes while bonding. Coat bolt or pin with bond releasing agent to prevent possible adhesion to structure.
- (6). Insert wood block, and metal shims as required, between bellcrank supports to press doublers against structure and prevent excessive adhesive build up. Slot wood block to provide relief for alignment pin. Wrap wood block and shims in waxed paper to prevent possible adhesion to structure.
- (7). Cure adhesive for 24 hours; remove wood block and shims from supports.
- (8). Reinstall Station 142 bellcrank per HMI-Volume I.
- (9). Record compliance with Part II of this Notice in Compliance Record of helicopter Log Book.
