SERVICE BULLETIN

SUBJECT: INSPECTION AND REPAIR OF AFT FUSELAGE SKIN CRACKS;
INSTALLATION OF DOUBLERS ON BOOM FAIRING LOWER
LONGERONS

MODELS AFFECTED: 500D Model 369D Helicopter Serial No. 0003D thru 0529D

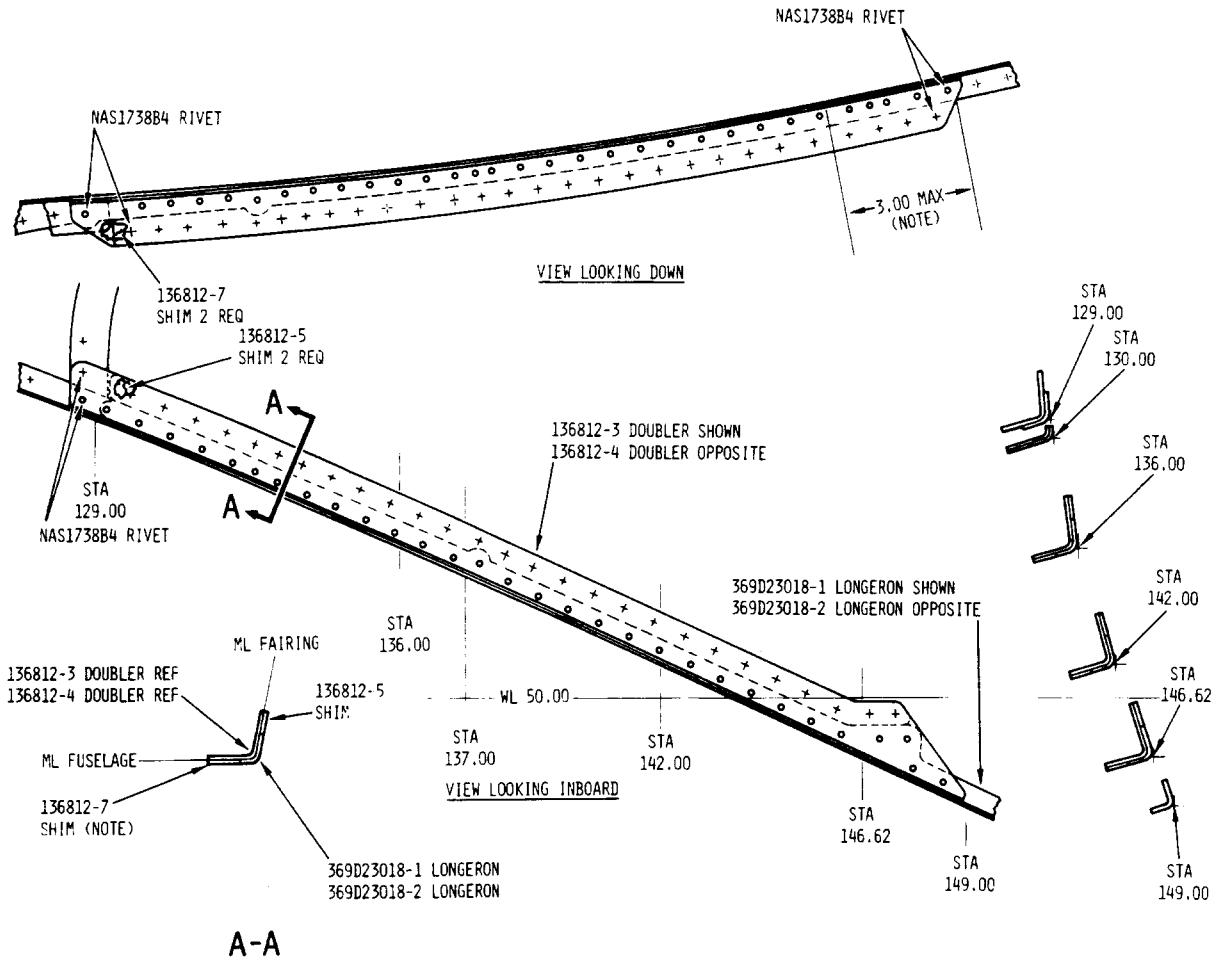
Figure 1. Figure 1. Field Modification - 369D23018-1 and -2 Boom Fairing Longerons

PREFACE: Field reports indicate that incidents of cracking of the aft fuselage skin has occurred in the area–adjacent to the boom fairing lower longerons. This area is noncritical for either static or fatigue loads.

b. Drill out existing rivets securing 369D23018-1 and -2 boom fairing lower longerons to fuselage structure and skin, between Station 129.00 and Station 149.00, as shown in Figure 1.

c. Position and nest -3 and -4 doublers in place in longerons; mark and drill rivet holes in doublets to match rivet pattern in longerons.

If rivets are in radius of -3 or -4 doublers, relocate rivet adjacent to problem hole (approximately 3.5 x rivet diameter spacing) and maintain a minimum of 1.5 x rivet diameter edge distance on 369D23018 longeron.

For Model 369MD (Military) Helicopters equipped with Black Hole Ocarina (BHO) Infrared Suppressor System, trim up to 3.00 inches (maximum) on No. 136812-7 shim on installation (See Figure 1.)

- d. Install doublets temporarily on longerons with Cleco fasteners or equivalent. Position -5 and -7 shims in place on each doublet as shown. Mark and drill rivet holes in doublets and shims. Install shims to doublets with NAS1738B4 rivets; install rivets with wet zinc chromate primer.
- e. Remove Cleco fasteners and install doublers with NAS1738B4 rivets. Rivets may be installed from inside or outside engine compartment; install rivets with wet zinc chromate primer.
- f. Remove all debris from work area; inspect modification of longerons for discrepancies.
- g. Reinstall heat blanket/firewall with existing fasteners.
- h. Record compliance with Part II of this Notice in Compliance Record of helicopter Log Book.

NOTE:
TRIM UP TO 3.00 INCHES MAXIMUM AS SHOWN
ON SHIM NO. 136812-7, FOR 369MD HELICOPTER
EQUIPPED WITH INFRARED SUPPRESSOR SYSTEM.
