SERVICE BULLETIN

REWORK OF COOLING BLOWER MOUNTING BRACKET

500D Model 369D Helicopter Serial No. 0003D through 0509D

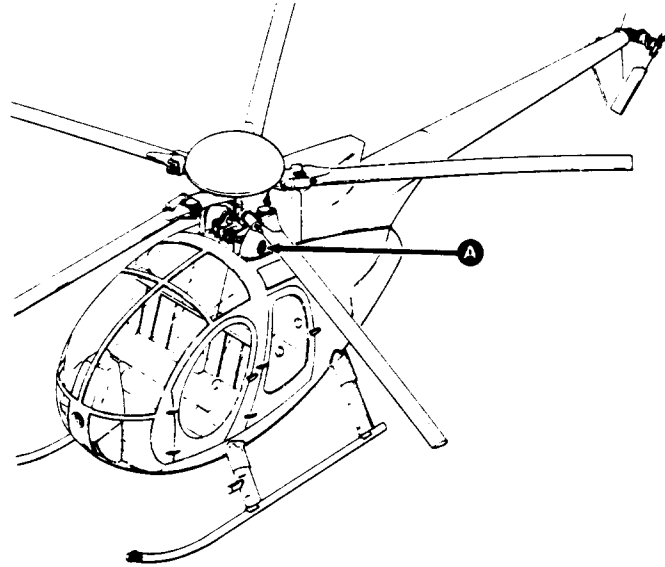
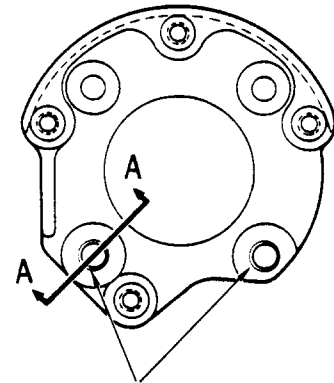
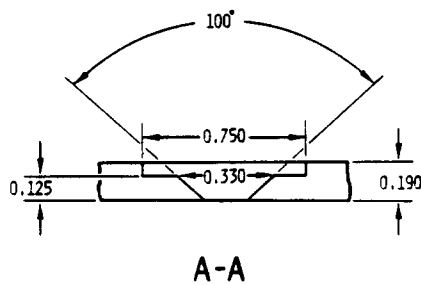
Figure 1. Rework of Cooling Blower Mounting Bracket

The information given in this Service Information Notice lists a procedure for reworking the cooling blower mounting bracket P/N 369D25626, to provide increased clearance for the blower drive belt and preclude interference between bracket and belt. This revision is issued to clarify the dimensions of the spotface as shown in Figure 1.

- d. Rework mounting bracket as follows: (See Figure 1)
 - 1. Increase spotface of two lower holes to 0.750-inch diameter and to 0.125-inch material thickness.

- 2. Countersink two spotfaced holes, using 100 degree countersink to 0.330 inch diameter. Remove any burrs as required.
- e. Install reworked mounting bracket as shown in Figure 2. Install two bolts and two washers retained above in upper holes of bracket and safety wire with MS20995-C32 wire. Install two NAS1164-2L screws and two MS2106C6 washers in reworked holes.

0.750 DIA SPOTFACE TO
0.125 MATERIAL THICKNESS
100° X 0.330 DIA COUNTERSINK
TYP 2 PLACES
