SERVICE BULLETIN

DATE: 22 AUGUST 1980

PERIODIC INSPECTIONS AND BONDING PROCEDURE – TAIL ROTOR DRIVE FORK ELASTOMERIC TEETER BEARINGS, PN 369A1724

All 500D Model 369D Helicopters equipped with PN 369D21610 Four Bladed Tail Rotor Installation

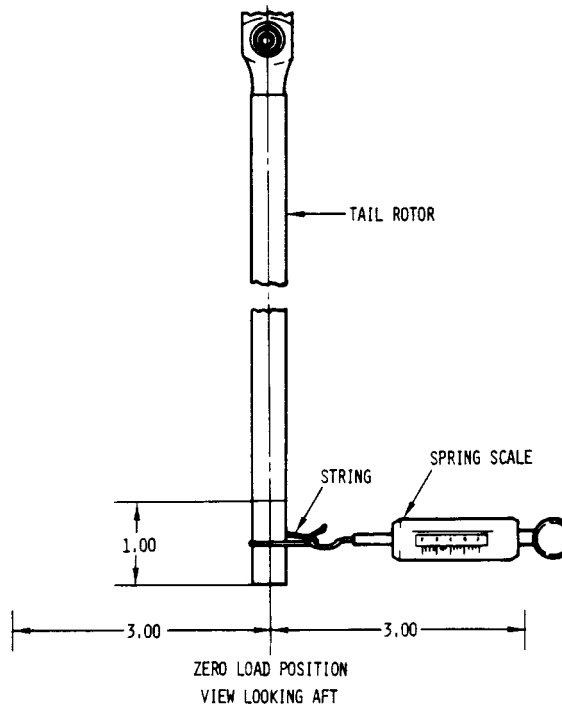
Figure 1. Measurement of Blade Flapping Resistance

a. Measure flapping resistance of the inboard and outboard blades, using a spring scale attached within 1.00 inch inboard of the blade tip. (See Figure 1.)

1. Tail rotor pedals in full left position.
2. Record spring scale value when blade tip is 3.00 inches from the zero load position. Record for both inboard and outboard directions (pulling 90° to the plane of rotation).
3. The load measured at the tip with 3.00 inches deflection from the zero load position should be 1.5 lbs to 5.0 lbs.

NOTE: If the measured loads are not within the above limits, the bearings of the applicable inboard, or outboard blade set must be replaced.

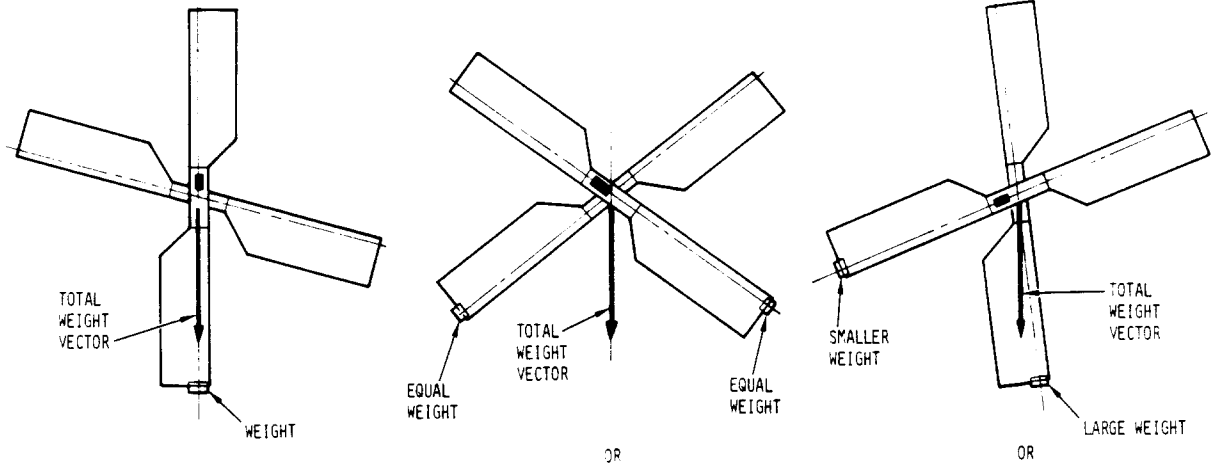
Figure 2. Strobe Pattern As Seen When Directed At Tail Rotor

- (a) Add weights to blade tips only. Divide weights as necessary between the two lower blades to make the total weight vector in the downward direction. (See Figure 2.)

NOTE:
IF WHEN ADDING WEIGHTS OUT OF BALANCE VIBRATION
LEVEL INCREASES, ADD WEIGHTS TO THE TOP BLADE OR BLADES.

NOTE: If more than 15 grams of tip weight (including screw) is necessary on any one blade, use the "long method" balance procedure per Part II of this Notice.

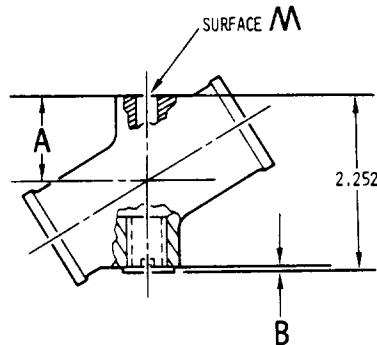
Figure 3. Centering of Tail Rotor Hub and Drive Fork

a) After torquing 369A1604 thread bushing to 55-65 inch-lbs, measure dim A on hub and calculate shim thickness B using formula

$$B = 2.252 - (2 \times A)$$

b) If $(2 \times A)$ is greater than 2.252 add shim B as shown. If $(2 \times A)$ is less than 2.252 add shim B to surface M.

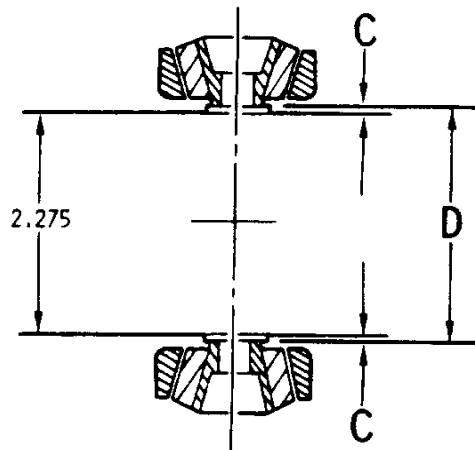
Figure 4. Preload of Elastomeric Bearings

a) Measure distance D on fork assembly and calculate thickness of shim C using formula

$$C = \frac{D - 2.275}{2}$$

b) Install shim C on both sides of fork as shown in Figure 4.

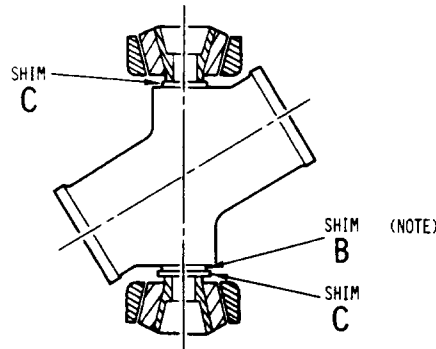
Figure 5. Hub and Fork Installation

c) Install hub assembly to fork using shims B and C as shown in Figure 5.

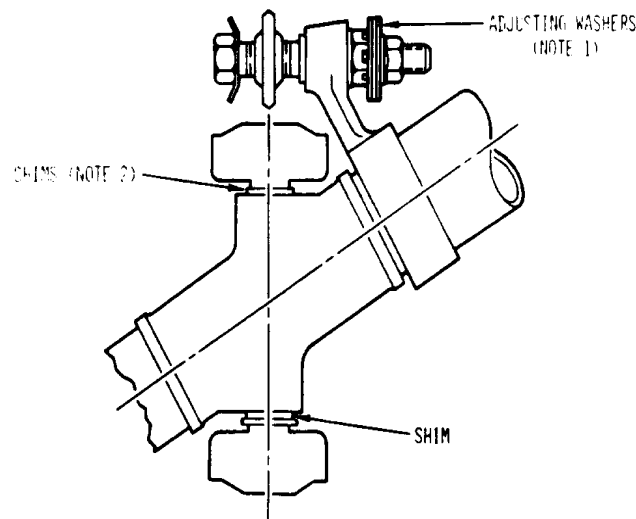
Figure 6. Long Method Balance Check - Inboard Blade Only

1. With outboard blade removed, balance inboard blade by adjusting tip weights and HS306-225L washers at pitch arm bolt to achieve 0.10 IPS (0.85 MIL) or less vibration level at 2100 rpm (input shaft of gear box). This corresponds to a tail rotor rpm of 2168.

1. MAXIMUM ALLOWABLE NUMBER OF WASHERS AT PITCH ARM BOLT IS 32. WHENEVER THIS LIMIT IS REACHED AND REQUIRED BALANCE CANNOT BE MET, SHIFT THE CENTER OF THE HUB BY TRANSFERRING SHIMS THICKNESS OF 0.010 FROM PITCH ARM SIDE TO THE OPPOSITE SIDE AS SHOWN AND RECHECK BALANCE, STARTING FROM ZERO WASHERS.
2. REMOVE 0.010 THICK SHIM FROM PITCH ARM SIDE AND TRANSFER THE SHIM TO THE OPPOSITE SIDE.

Change Note 1 to read ... Maximum allowable number of washers at pitch arm bolt is 23.(was 32)

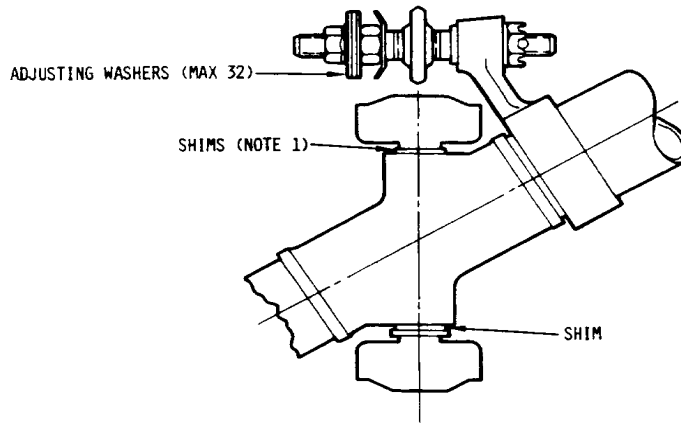
Figure 7. Long Method Balance Check - Outboard Blade Only

2. Install outboard blade and hub assembly; check balance of outboard blades by adjusting weights to obtain 0.10 IPS (0.85 MIL) vibration level or less, using the same method as used for inboard blade balancing, except as shown in Figure 7 below.

1. REMOVE 0.010 THICK SHIM FROM PITCH ARM SIDE AND TRANSFER THE SHIM TO THE OPPOSITE SIDE.
2. DURING BALANCING OF OUTBOARD BLADES, WEIGHTS ON INBOARD BLADES MUST NOT BE CHANGED.

Change drawing callout to read....Adjusting washers (Max 23) was 32.

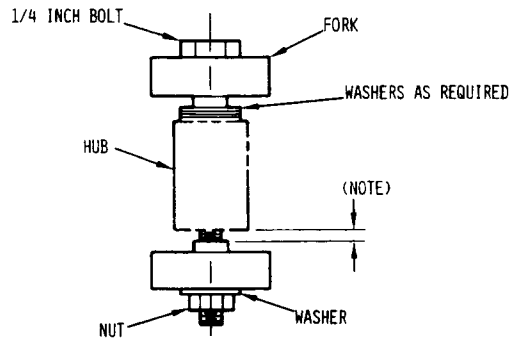
Figure 8. Bonding Set Up

e. Apply mixed EA9314 adhesive to faying surfaces. Place one ply of 108 glass fabric scrim cloth on faying surface of bearing. Insert bearing in to fork. Align, using 1/4-inch diameter bolt and cure for one hour minimum at $200^{\circ} \pm 10^{\circ}$ F. Alternate cure is 24 hours at ambient temperature. (See Figure 8.)

NOTE: Spring loading is required to maintain force during cure.

NOTE:
SECURE CLEARANCE OF .0047-.0027
AND TORQUE TEETERING NUT UNTIL
SPACER SITS ON BEARING.
