SERVICE BULLETIN

SUBJECT: FARGO AUXILIARY FUEL TANKS P/N - A1066-1082

FARGO SERVICE NOTICE NUMBER 2 ; Revision No.1
30 December 1985

SUBJECT: Leaks in Fargo Auxiliary Fuel Tanks

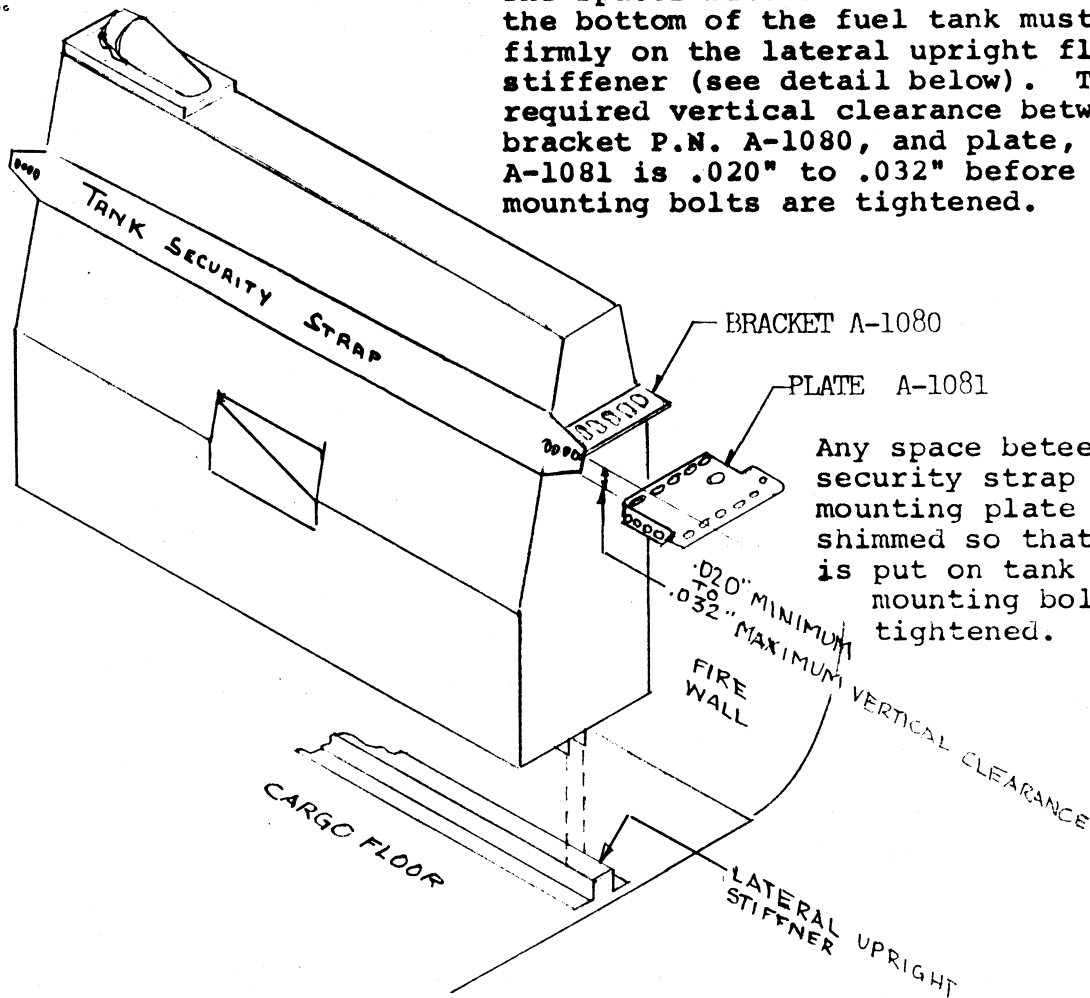
DETAIL 1

BACKGROUND: Leaks have been reported in Fargo Auxiliary Fuel Tanks. An investigation of those leaks reported indicates that insufficient contact of the tank bottom with the cabin floor can cause these leaks to develop. Specifically, if the spacer blocks located on the underside of the tank do not rest firmly on the lateral upright (hat-section stiffener) of the cabin floor, leaks can develop with continued service.

The spacer blocks in the "U" channel on the bottom of the fuel tank must rest firmly on the lateral upright floor stiffener (see detail below). The required vertical clearance between bracket P.N. A-1080, and plate, P.N. A-1081 is .020" to .032" before the mounting bolts are tightened.

- (2) Provide a .020" to .032" vertical clearance between each tank mounting bracket (P/N A-1080, item 2) and its mating mounting plate (P/N A-1081, items 19 and 20). See Details on Page 6 of this notice.

Cut 3/4" wide slots at each spacer block location.

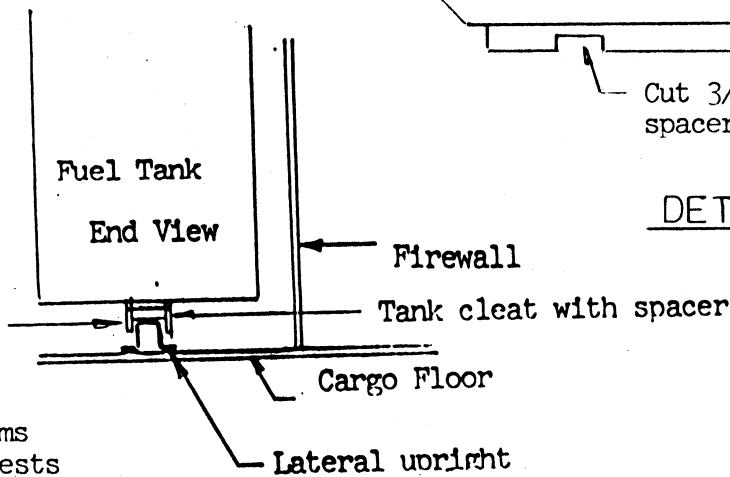
DETAIL 2

2. If there is any space between the bottom of a spacer block and the floor stiffener, repair steps I through M must be performed. See Figure 1, Detail 2, Page 6 of 6.

- I. Machine two (2) separate spacers from aluminum that will:
 - (1) Fill the space between the bottom of the spacer blocks and the floor stiffener, and,

- J. Remove the paint from the bottom of the spacer blocks under the auxiliary fuel tank.
- K. With a two (2) part epoxy glue suitable for metal-to-metal bonding, glue the new spacers to the bottom of the old spacer blocks.

If airspace exists when tank is placed in position, use additional spacer shims to insure that tank rests firmly on the upright floor stiffener.
