DN-148.1\*  
EN-36.1\*  
FN-25.1\*

# SERVICE BULLETIN

DATE: 30 OCTOBER 1987  
PAGE 1 OF 6

**SUBJECT:** INSPECTION OF MAIN TRANSMISSION OUTPUT SHAFT ASSEMBLY RING GEAR CARRIER (P/N 369D25132-BSC or -5).

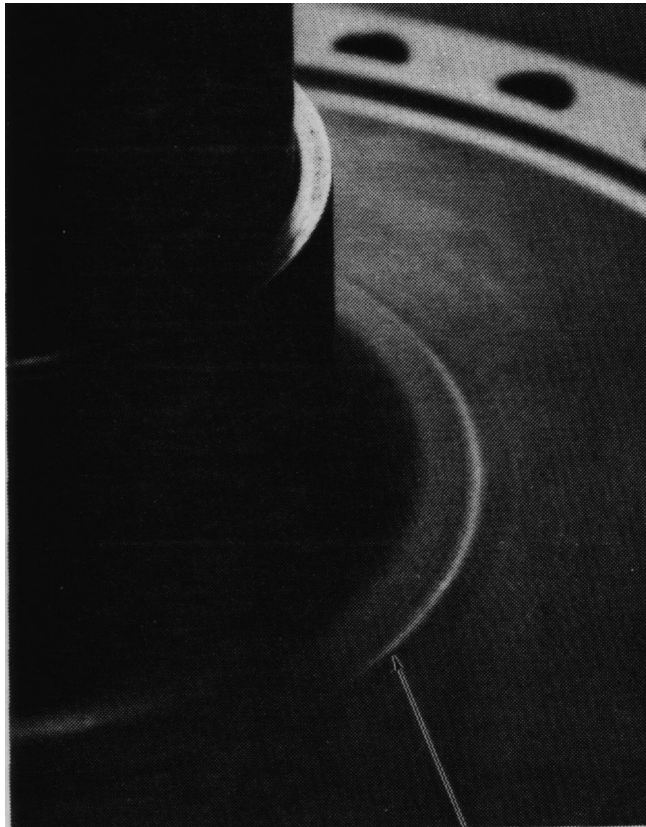
**UNACCEPTABLE**

- 1. Inspect the upper surface of shaft for bulging or raised surfaces in the area noted in Figure 2.

ANY BULGING OR RAISED  
SURFACE IN THIS AREA  
IS NOT ALLOWED ON THE  
UPPER DISK SURFACE  
(INSPECT TOTAL  
CIRCUMFERENCE)

- Any shafts with bulging or raised surfaces in this area shall be rejected for service and returned to MDHC.
    - If any indication of cracking is noted in step 2 or 3 below (see Figure 3), discard shaft and install 369D25132-3 shaft.
    - Those shafts which have questionable indications shall be sent to MDHC Warranty and Repair for interpretation.

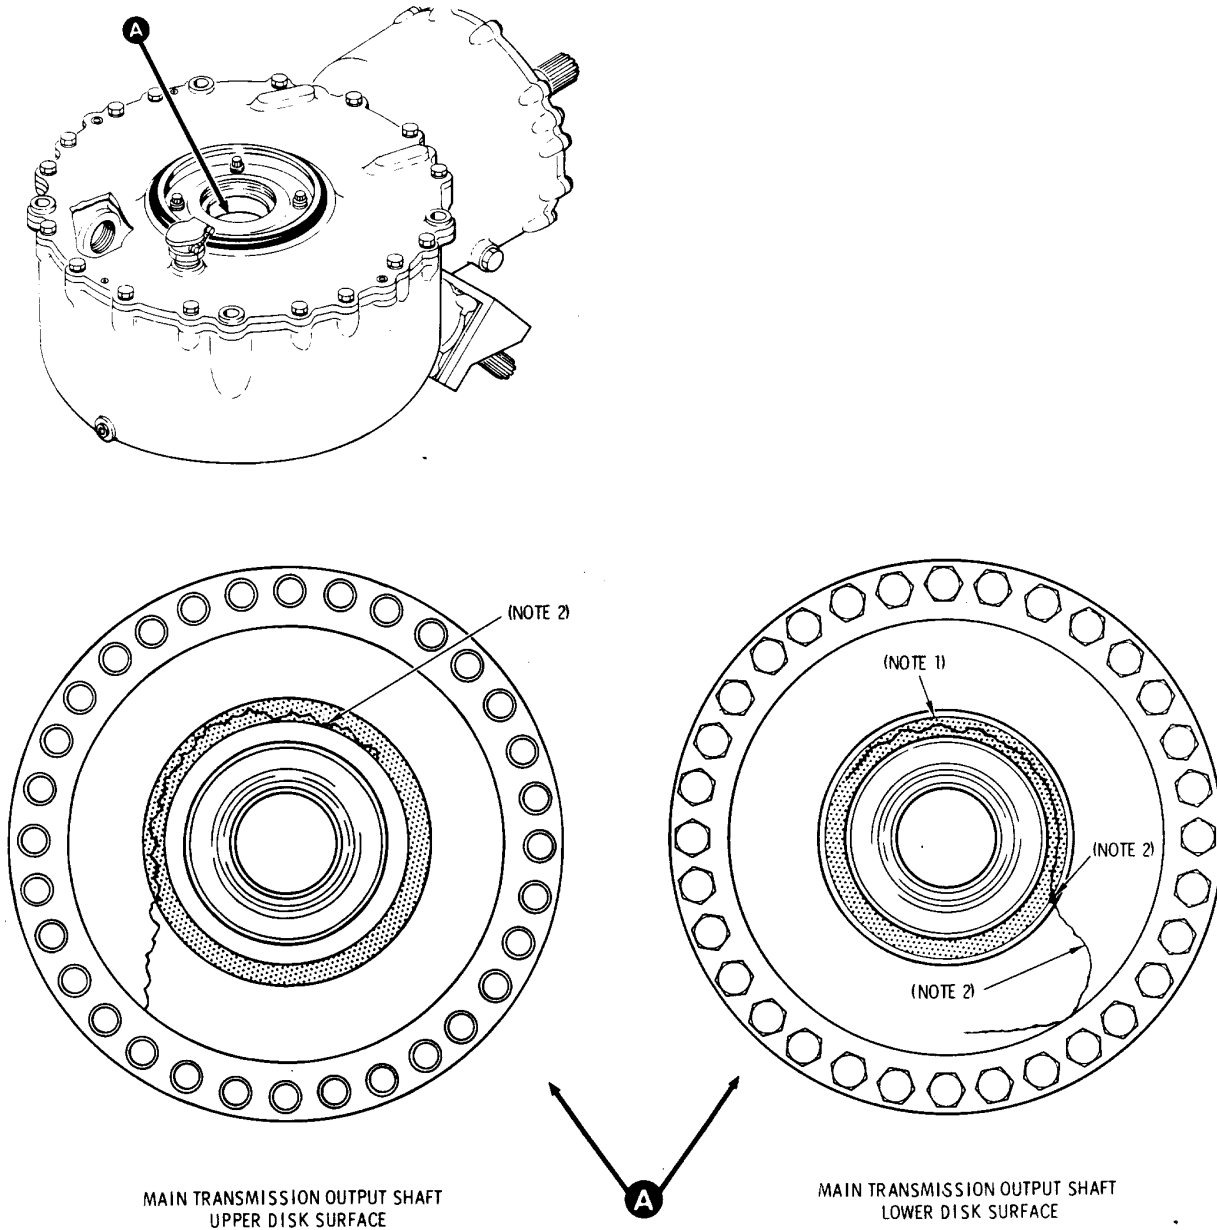
Figure 3. Periodic Inspection of Transmission Output Shaft

- 2. Using a 10X magnifying glass, visually inspect upper surface of shaft for indications of cracks in the area noted in Figure 3.

1. PAY PARTICULAR ATTENTION FOR CRACKS IN AREA OF ELECTRON BEAM WELD WHICH ATTACHES LOWER DISK TO OUTPUT SHAFT (SHADED AREA 360°).
2. PAY PARTICULAR ATTENTION FOR CRACKING OR CHIPPING IN FLAT SURFACE OF DISKS. SIMULATED CRACK PROPAGATION AND CHIPPING IS SHOWN.
