DN-166.1*
EN-57.1*
FN-45.1*

SERVICE BULLETIN

SUBJECT: One-time Inspection and Replacement of **Air Industries** MS21250-04036 Bolts **AND** Verification of Proper Installation of All MS21250-04036 Bolts in Main Transmission.

MODELS AFFECTED: All McDonnell Douglas Helicopter Company (MDHC) 369D, 369E (Serial No. 0001E thru 0352E) and 369F/FF (Serial No. 0001F thru 0067FF) Series helicopters.

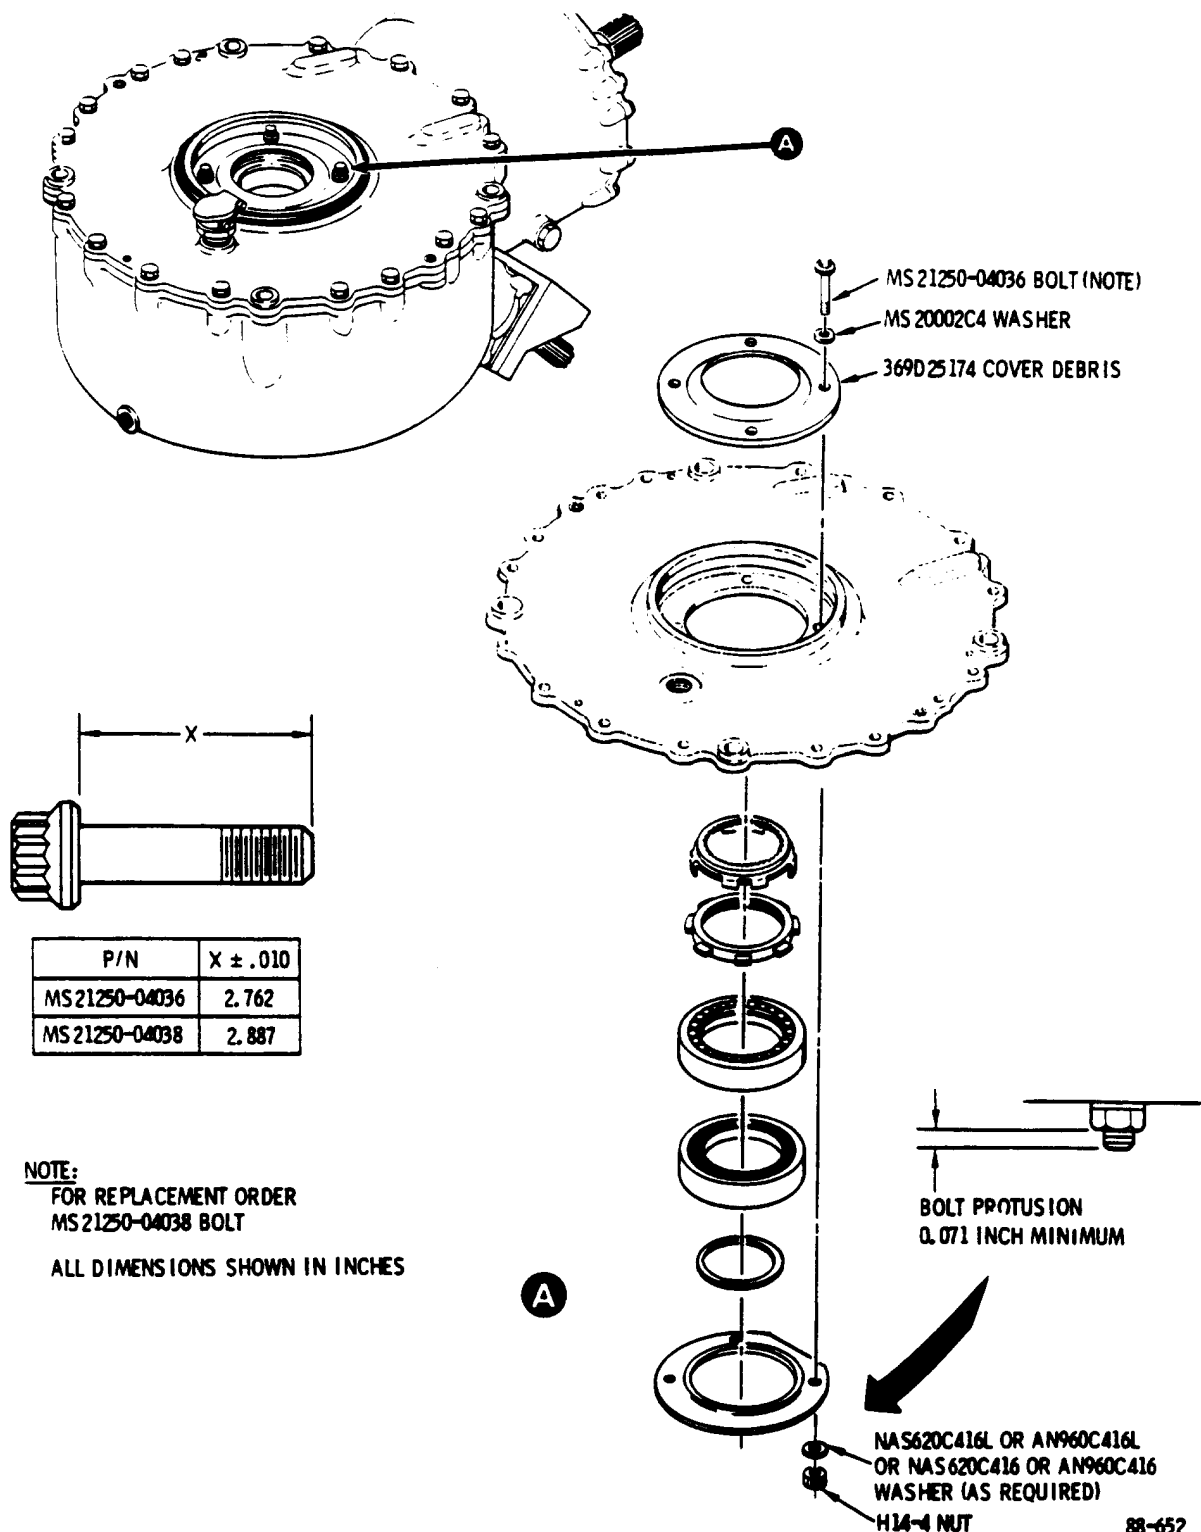
Figure 1. Inspection/Replacement of Main Transmission Output Driveshaft Bearing Assembly Bolts

To identify a -04038 bolt, the length is 2.887 +/- .010 inch. (See Figure 1.)

- After installation, bolts shall protrude through the nut for a length equivalent to two full threads (0.071 inch minimum), including the
- If necessary, replace bolts with MS21250-04038 bolts. The maximum bolt protrusion from the nut end is four (4) threads.
- Bolts manufactured by Air Industries that have drilled (safety-wire holes) heads are acceptable.

- Bolts must protrude through the nut for a length equivalent to two full threads (0.071 inch minimum), including the chamfer. Thread protrusion must not exceed four (4) threads. The H14-4 nut may be installed without a washer.
- To prevent possible dislocation of clamp-up shims on main rotor output drive assembly, remove unacceptable bolts individually.

- d. Inspect bolts for proper thread protrusion through the H14-4 nuts. If proper thread protrusion cannot be obtained, replace bolts with MS21250-04038 bolts.

- e. Install acceptable MS21250-04038 bolts, washers and nuts (Ref. CSP-DEF-5). Torque bolts **50-70 inch-pounds**. Verify that bolts protrude through the nut for a length equivalent to two full threads (0.071 inch minimum), including the chamfer. If more than 4 threads protrude through the nut, add NAS620C416L or NAS620C416 (or acceptable alternate per Parts List) washer(s) under the nut as required.

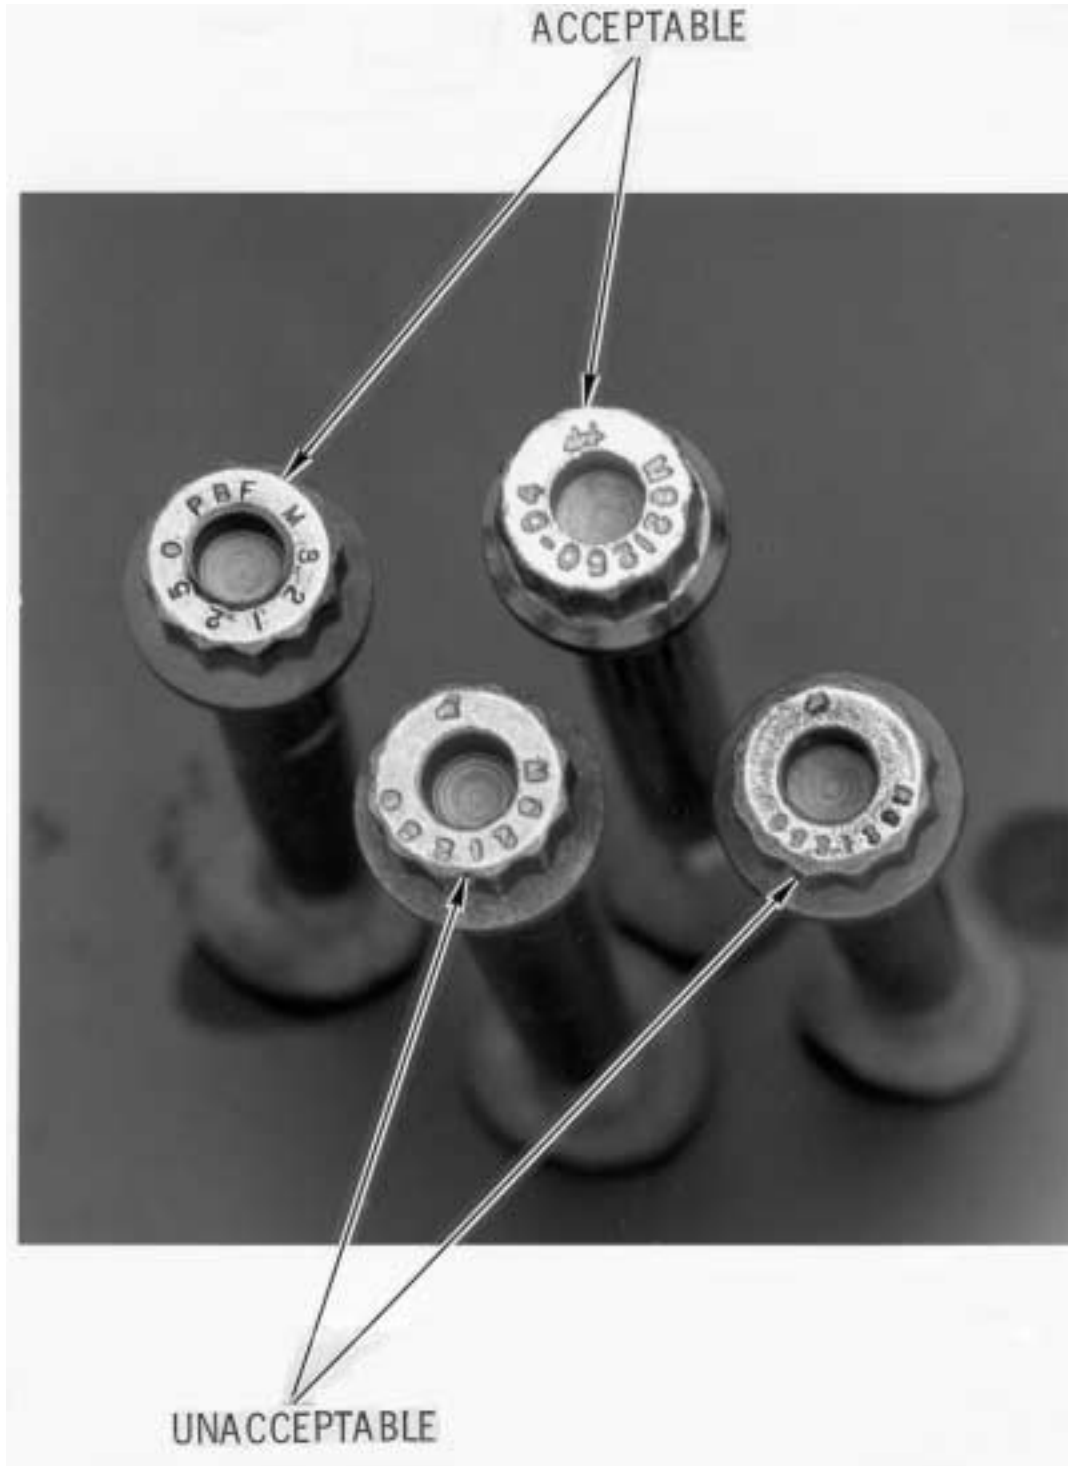
Figure 2. Inspection/Definition of Bolt Heads

PREFACE: MDHC has determined that some bolts manufactured by **Air Industries** and delivered since August 1988 may not meet industry standards. Therefore, MDHC is requiring operators to perform the following one-time inspection and/or replacement of these suspect bolts.

- a. Remove main rotor transmission per HMI - Vol I.
- b. Disassemble tail rotor drive assembly, two nozzles and main rotor drive assembly (Ref. CSP-DEF-5).
- c. Inspect MS21250-04036 bolt head inscriptions for unacceptable bolt head markings (refer to Figure 2). Replace unacceptable bolts with MS21250-04038. Deform and scrap unacceptable bolts to prevent bolts from re-entering service.
