SERVICE BULLETIN

SUBJECT: ONE-TIME CHECK/PERIODIC INSPECTION/REPLACEMENT OF TAIL ROTOR SWASHPLATE BEARING SET

MODELS AFFECTED: All MDHC 369D, 369E and 369F/FF Series helicopters.

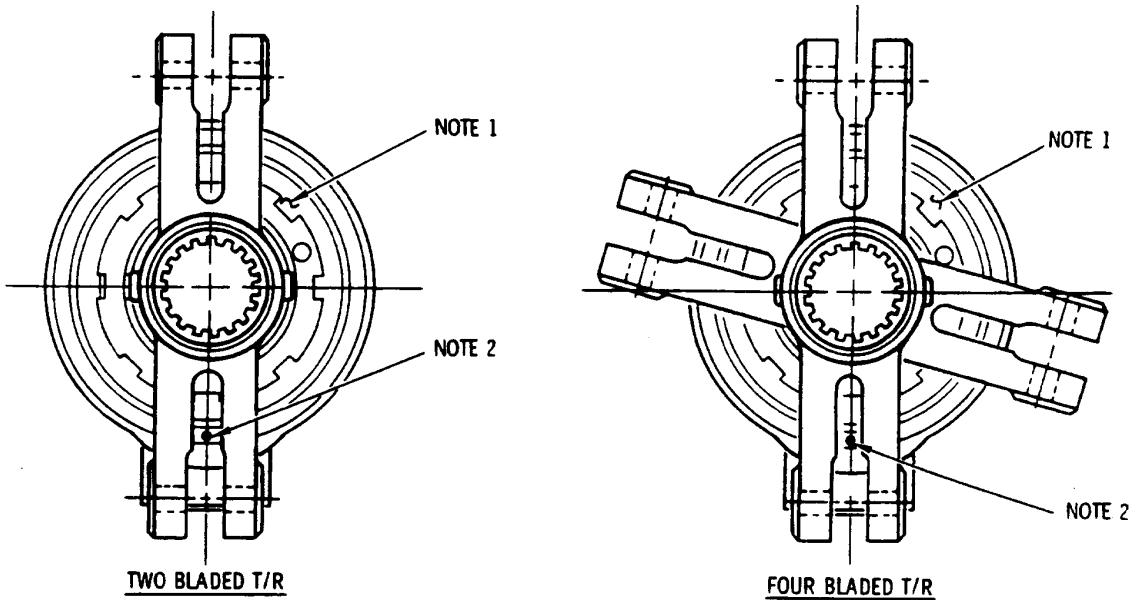
Figure 1. Inspection of Tail Rotor Assembly.

a. Check tail rotor swash plate bearing assembly to determine which color bearing seal is installed. (Refer to Figure 1)

- Bearing seal can be observed by looking into the outboard end of the T/R swashplate bearing assembly.
- If necessary, clean the face of the bearing seal with a dry cotton swab (Q-Tip) so that bearing seal color can be determined.

1. VERIFY BEARING SEAL IS GREEN OR YELLOW. BEARINGS WITH BLACK SEALS SHALL BE REMOVED AND REPLACED OR SUBJECTED TO THE 10-HOUR RECURRING INSPECTION.
2. APPLY A WHITE DOT TO PITCH CONTROL HOUSINGS WITH ACCEPTABLE BEARING WITH BLACK SEALS AS SHOWN.

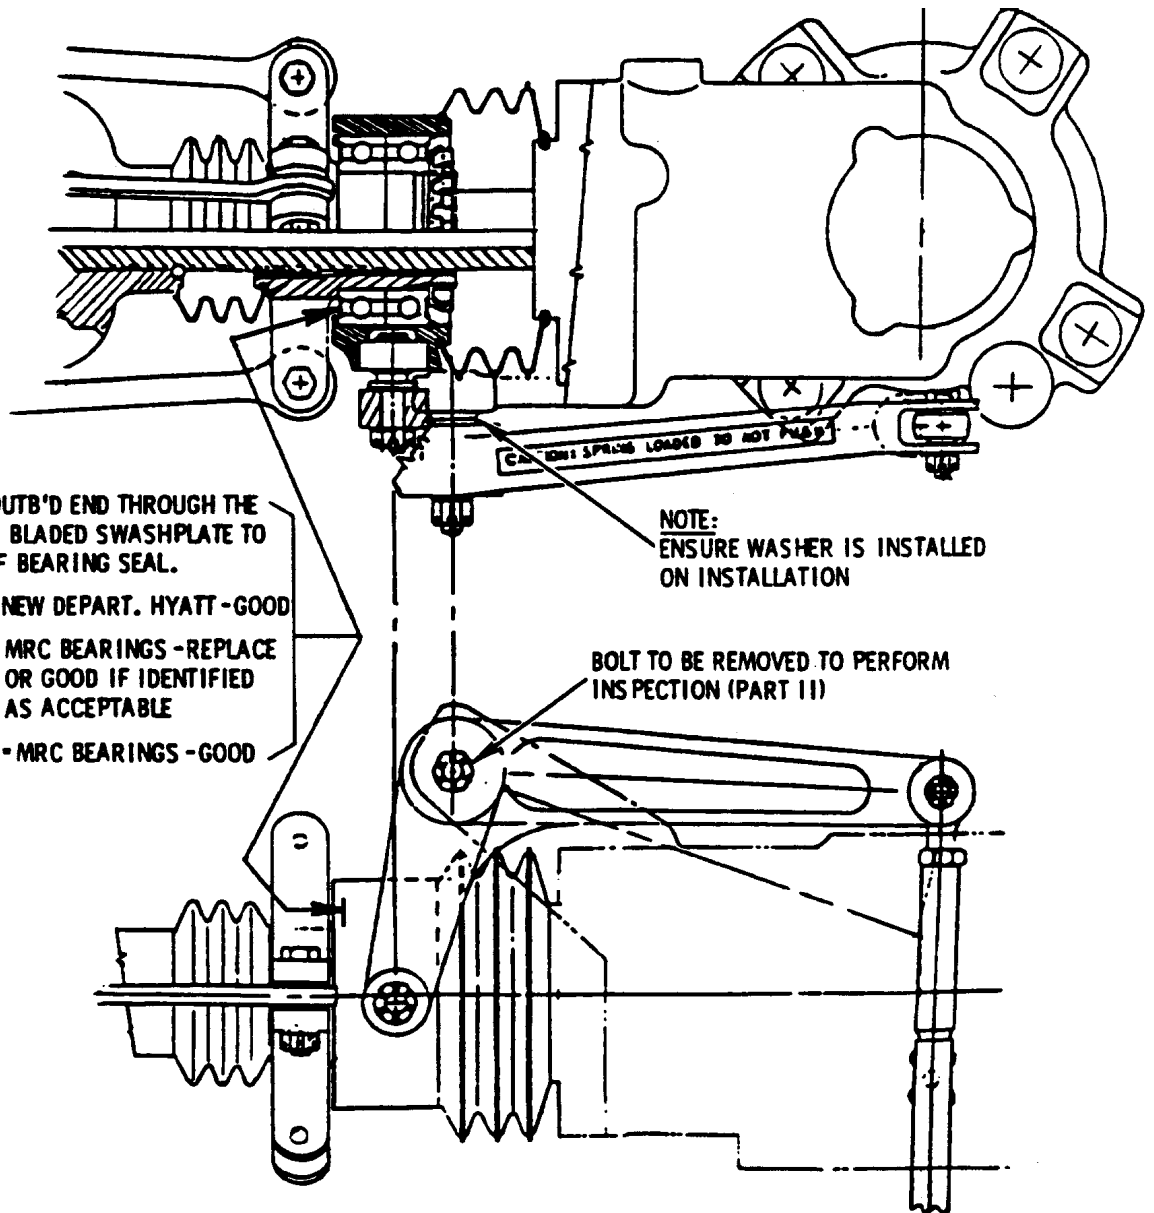
Figure 2. Inspection of Tail Rotor Assembly.

- a. Disconnect outboard end of bellcrank (refer to Figure 2).
- b. Disconnect dust boot from inboard end of pitch control assembly. (This will allow rotation of tail rotor swash plate housing.)
- c. While applying a down load on top of the housing by hand, slowly rotate pitch control housing to verify smoothness of operation. Bearing must rotate smoothly and without roughness to be acceptable.

A slight feeling of grit in the grease, with smooth areas in between, is considered acceptable for continuing an additional ten hours of operation. If the gritty feeling is continuous, replace the bearings.

- d. If roughness occurs, replace tail rotor swashplate bearing before further flight with an acceptable bearing set provided by MDHC per the Component Overhaul Manual. If an acceptable black seal bearing has been installed apply a white dot (approximately 1/8 inch dia.) on the outside face of the housing as shown in Figure 1 per the applicable Handbook of Maintenance Instructions.
- e. Install and lockwire dust boot on inboard end of pitch control housing.
- f. Service the tail rotor swashplate pivot bearing assembly with acceptable grease per the Handbook of Maintenance Instructions.
- g. Reconnect bellcrank to outboard end of pitch control assembly per the Handbook of Maintenance Instructions.
