DN-183.2\*  
EN-75.2\*  
FN-62.2\*

# SERVICE BULLETIN

DATE: 27 JANUARY 1993  
PAGE 1 OF 4

## MAIN ROTOR BLADE REPLACEMENT

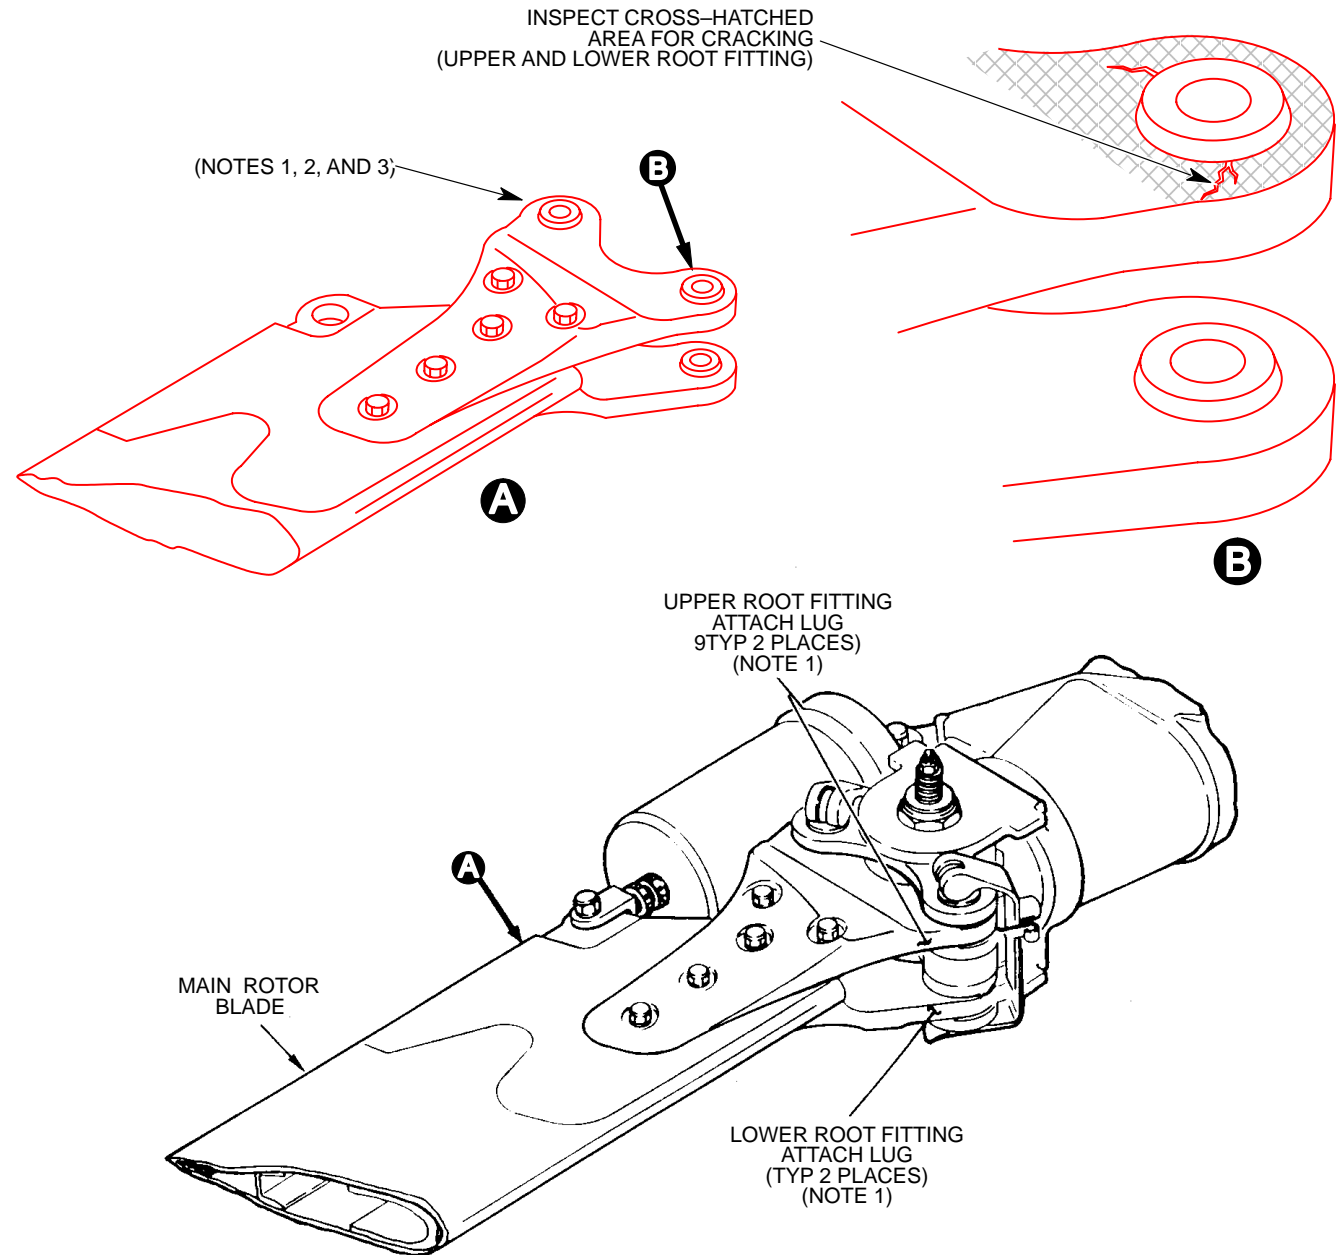
**Figure 1. Inspection of main rotor blade root fitting attach lugs.**

To prevent the possibility of a main rotor blade root fitting crack.

1. VISUALLY INSPECT AREAS OF ALL ROOT FITTINGS FOR CRACKS OR BREAKS. INSPECT BLADE ATTACH BUSHINGS FOR LOOSENESS.
2. PAY PARTICULAR ATTENTION TO AREA AROUND ATTACH PIN HOLES IN LUGS.
3. SEAL ALL JUNCTIONS BETWEEN BUSHINGS AND ATTACH LUGS WITH ZINC CHROMATE PRIMER, REFER TO MATERIALS TABLE.
