SERVICE BULLETIN

DATE: 1 JUNE 1984

INSPECTION, PN 369A7011 LONGITUDINAL MIXER CONTROL ROD; REPLACEMENT OF PN 369D22509-51 DOUBLER WITH 369DSK169-3 REPAIR DOUBLER

500E Model 369E Series Helicopters Serial No. 0001E through 0027E, 0029E through 0036E and 0038E through 0043E.

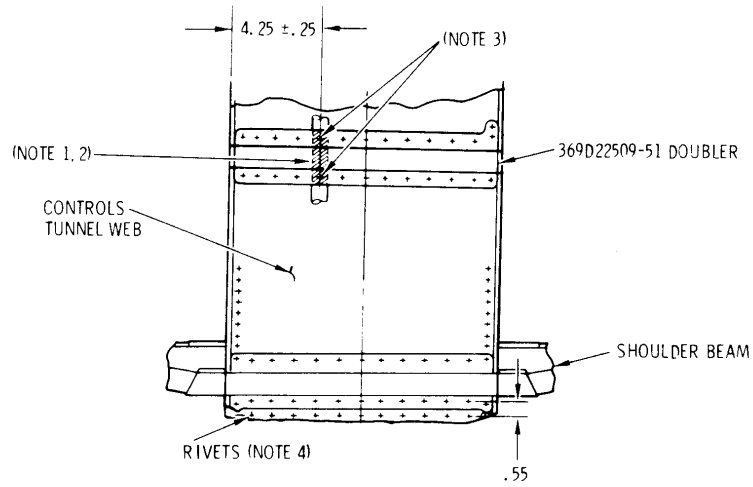
Figure 1. Interference Check and Rivet Removal; Check for Missing Rivets

Information in this Notice gives procedures for a one time check of the longitudinal mixer control rod for interference by rivets attaching the 369D22509-51 doubler to the control rod tunnel web, and modification of the doubler installation, or replacement of the doubler to prevent such interference.

- d. Release cyclic friction; with hand on rivets, (shown in shaded area of Figure 1) connecting 369D22509-51 doubler to controls tunnel web, move cyclic control stick full forward, then slowly to the full aft position. If any movement of the 369D22509-51 doubler is felt, perform Part II of this Notice. Control rod must be repaired or replaced if any damage is noted. If no movement is detected, complete Part I of this Notice.

- f. Using flashlight, observe longitudinal mixer control rod through holes left by rivet removal, while slowly moving cyclic control stick full aft. If any scratches, nicks or other damage to rod is evident, perform Part II of this Notice.

- a. Remove all crew compartment interior trim from controls tunnel (Section 4, HMI Vol 1).
- b. Remove controls access door (Section 2, HMI Vol 1).
- c. Check 369D22509-21 web below shoulder.. beam for presence of 11 rivets as shown in Figure 1. If rivets are missing, install 11 NAS1738B4 rivets as shown.

- e. Move cyclic stick to full forward position; using portable drill or grinder, carefully drill out or grind heads off any rivets connecting 369D22509-51 doubler to controls tunnel web in area shown in Figure 1. Carefully press rivet shanks out of holes.

1. PLACE FINGERS ON RIVETS IN SHADED AREA WHILE MOVING CYCLIC STICK FULL AFT TO CHECK FOR CONTROL ROD INTERFERENCE.
2. REMOVE ANY RIVETS IN THIS AREA.
3. LEAVE THESE HOLES OPEN. (2 PL)
4. IF RIVETS NOT INSTALLED, INSTALL 11 NAS1738B4 RIVETS AS SHOWN.
