SERVICE BULLETIN

REWORK OF HORIZONTAL STABILIZER ASSEMBLY (P/N 421-087-503 AND -505).

All McDonnell Douglas Helicopter Company (MDHC) 369E and 369F/FF Series helicopters.

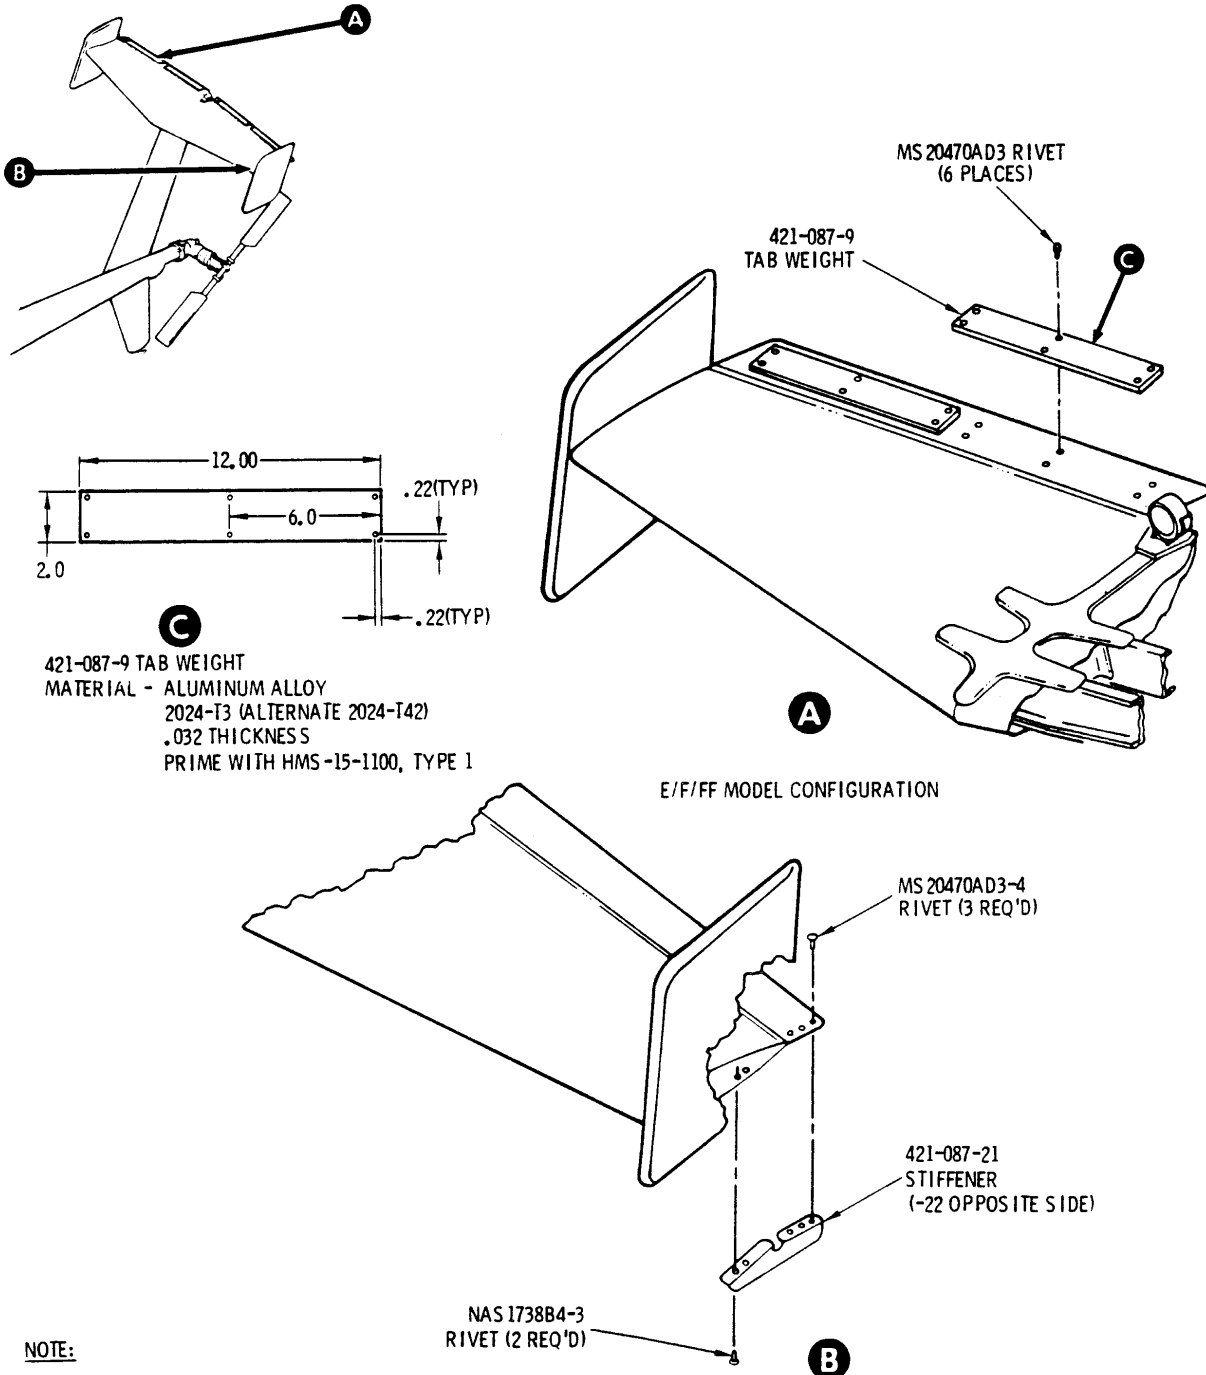
Figure 1. Horizontal Stabilizer Rework.

MDHC has received reports of the horizontal stabilizer skin and tabs cracking as a result of a vibration at the outboard ends of the horizontal stabilizer tabs. Therefore, MDHC is requiring operators to perform the following rework of the horizontal stabilizer assembly.

421-087-9 TAB WEIGHT
MATERIAL - ALUMINUM ALLOY
2024-T3 (ALTERNATE 2024-T42)
.032 THICKNESS
PRIME WITH HMS-15-1100, TYPE 1

- b. Install stiffeners on outboard ends of horizontal stabilizer as shown in Figure 1 and the following instructions:
 1. Drill out existing NAS1738B4-3 rivets as shown in Figure 1 using #27 size drill bit.

2. Position stiffeners as shown in Fig. 1 and drill remaining holes using #40 size drill bit.
 3. Apply zinc-chromate primer to holes.
 4. Install NAS1738B4-3 and MS20470AD3-4 rivets per Figure 1.

- f. If tab resonance occurs and tail rotor balancing is unacceptable, fabricate, apply primer to non-bonding surfaces and install (2) 421-087-9 tab weights adjacent and immediately inboard from the existing tab weights (if installed, see the following note) per the following instructions and as shown in Figure 1.

- If tab resonance is not evident and the tabs weights are not installed, proceed to Step h.
 - If the outboard tab weights have been previously removed, install weights in the outboard locations as shown in Figure 1. If required, a maximum of two sets of tab weights may be installed to eliminate tab resonance.

1. Clean all tab weight and horizontal stabilizer bonding surfaces down to the primer in the area to be bonded.
 2. Apply adhesive to tab weights and horizontal stabilizer and position tab weights as shown in Figure 1. Fair in edges with adhesive squeeze out.

3. Install rivets in the same pattern as existing tab weights prior to adhesive curing. Allow adhesive to cure and touch up finish to match adjacent area.
