SERVICE BULLETIN

DATE: 24 DECEMBER 1976
PAGE 1 OF 4

INSPECTION - TALL ROTOR DRIVE SHAFT DAMPER, PN 369A5506

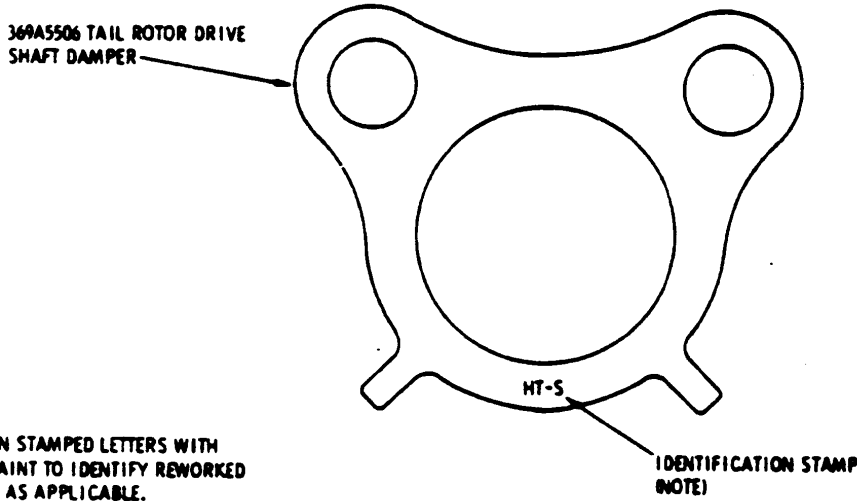
Figure 1. Inspection - Tail Rotor Drive Shaft Damper, PN 369A5506

- (1). Remove tail rotor, tail rotor transmission, tail rotor drive shaft and tail rotor drive shaft damper assembly, per Basic HMI
- (2). Visually inspect drive shaft damper as follows:
 - (a). Damper block identified with stamp "HT-S", or a heat lot number on opposite side from "HT" stamp, is acceptable for continued service (see Figure 1).
 - (b). Damper block not having letter "S" in identification stamp, or not having heat lot number on opposite side from "HT" stamp, must be reworked or replaced.

NOTE: If reinstalled, a damper block not identified with letter "S" or heat lot number must be inspected periodically (Part II) until rework (Part III) or replacement (Part IV) is accomplished.

- (6). Fill stamped letters on damper with red paint to identify reworked part.
- (7). Reassemble and install parts and assemblies, per Basic HMI.
- (8). Perform operational check of tail rotor system.
- (9). Record compliance with Part III of this Service Information Notice in Compliance Record of Helicopter Log Book.

NOTE:
FILL IN STAMPED LETTERS WITH
RED PAINT TO IDENTIFY REWORKED
PART, AS APPLICABLE.
