# SERVICE BULLETIN

## WIRING MODIFICATION – UTILITY LIGHT CIRCUIT AND TRANSMISSION OIL PRESSURE AND TEMPERATURE WARNING LIGHT CIRCUIT

All 500 Model 369H, 369HE and 369HS Helicopters

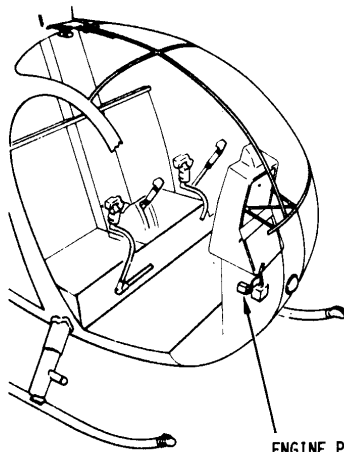
**Figure 1. Wiring Modification - Utility Light And Transmission Warning Light**

The information given in this Service Information Notice lists a procedure for rewiring the utility light circuit and the transmission oil pressure temperature warning light circuit on Model 369H, 369HE and 369HS helicopters. The purpose of the wiring modification is to eliminate deactivation of the utility light and transmission warning light circuits in the event the engine power out (EPO) unit is deactivated by tripping the EPO circuit-breaker.

- d. Disconnect electrical wiring harness connector from EPO warning unit plug (P19). (Refer to Section 19, Basic HMI. )
- e. Disconnect existing transmission warning light circuit wire No. E518A22 from pin K of P19 wiring harness connector plus (or from pin K of P3 plug if VAPAIR EPO unit is installed).

- f. Connect wire No. E518A22 to PNL LT circuit breaker CB104-2, using terminal lug MS25036-149.
- g. Remove existing UTIL LT circuit wire No. L531A22 (or MAP LT circuit wire No. E531A22 on early helicopters) from ENG OUT circuit breaker CB106-2 on panel; connect wire No. L531A22 (or E531A22) to N2 GOV circuit breaker CB103-2 on panel.
