SERVICE BULLETIN

HN-212.2*
DN-153.2*
EN-43.2*
FN-32.2*

DATE: 21 APR 1989
PAGE 3 OF 4

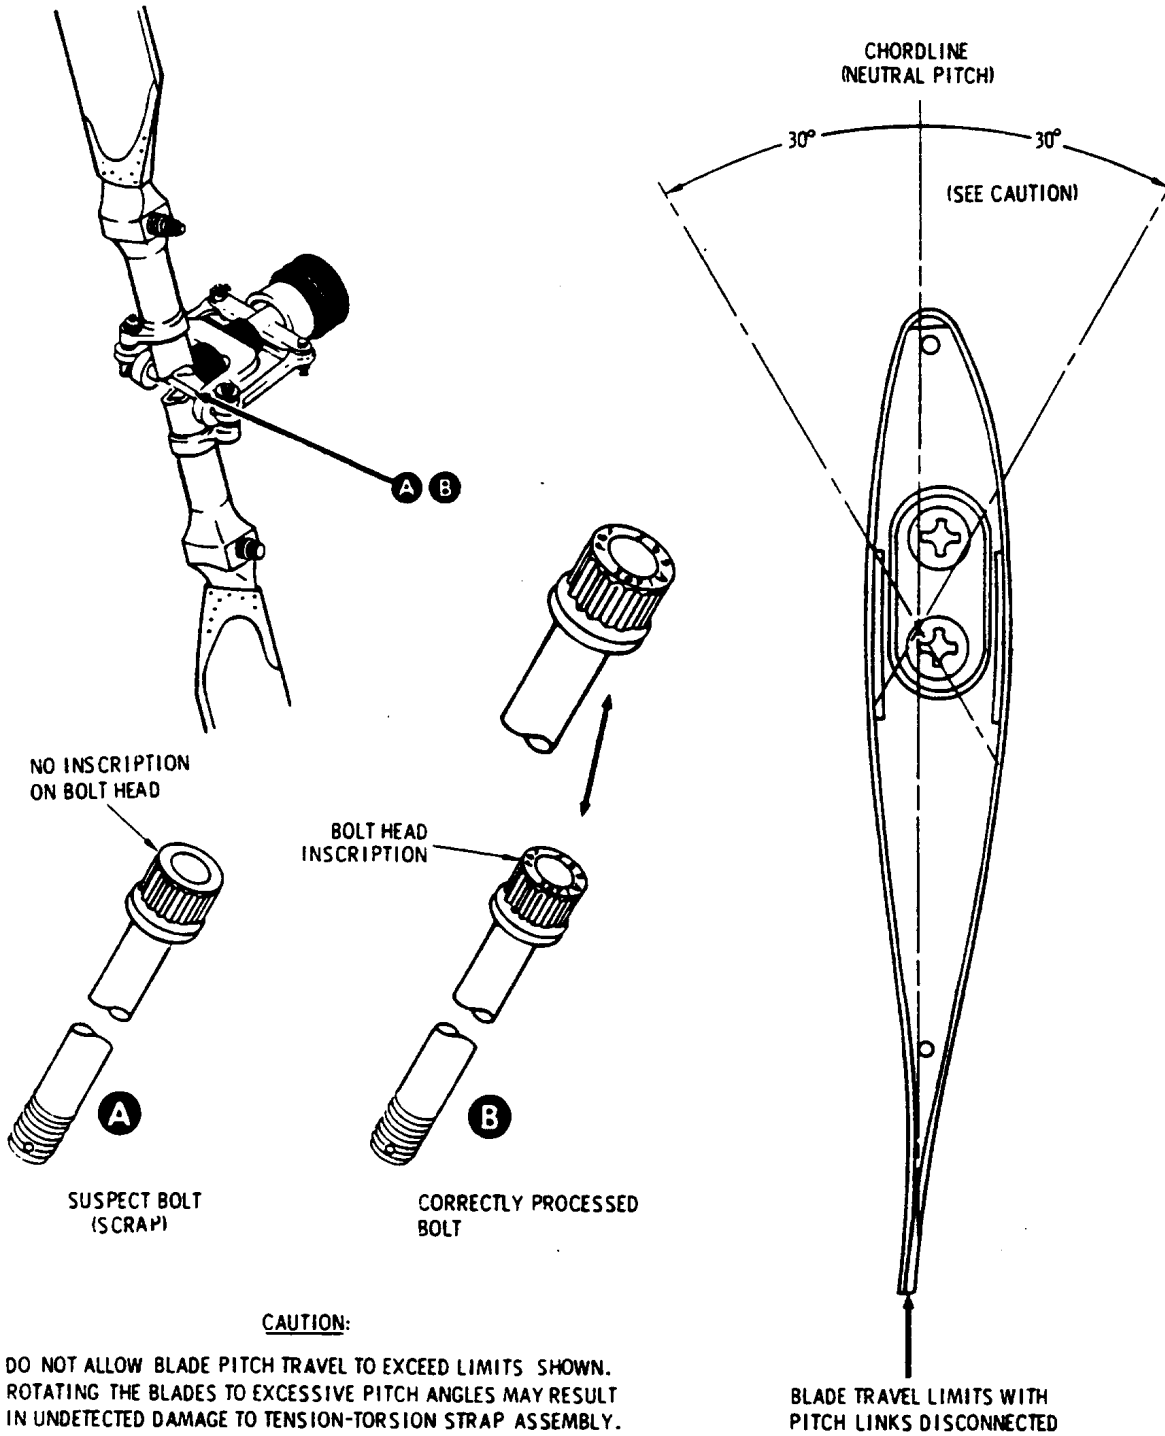
- a. Visually inspect all Spares inventories and tail rotor fork bolts installed on helicopters and tail rotor assemblies for proper inscription on the head of the bolt (see Figure 1).

Figure 1. Inspection of Tail Rotor Fork Bolt.

- Uninscribed tail rotor fork bolts on helicopters shall be replaced, proceed to **Part II**.
- Remove all uninscribed tail rotor fork bolts from Spares inventories and scrap those fork bolts.

- A MS21206C4 washer must be installed with a 369A1602-3 tail rotor fork bolt.
4. Install a 369A1602-3 fork bolt along with a MS21206C4 washer with the countersunk side towards the bolt head and reassemble hub and fork unit (HMI Appendix C and Component Overhaul Manual, Part VII).
 5. Perform testing and balancing procedures (HMI Appendix C, Part VIII and Component Overhaul Manual, Part VII).
- b. Record compliance with Part II of this Notice in the Compliance Record section of the helicopter Log Book.
