HN-215.2\*  
DN-156.2\*  
EN-46.2\*  
FN-34.2\*  
NN-010

# SERVICE BULLETIN

## OVERRUNNING CLUTCH OUTER RACE INSPECTION

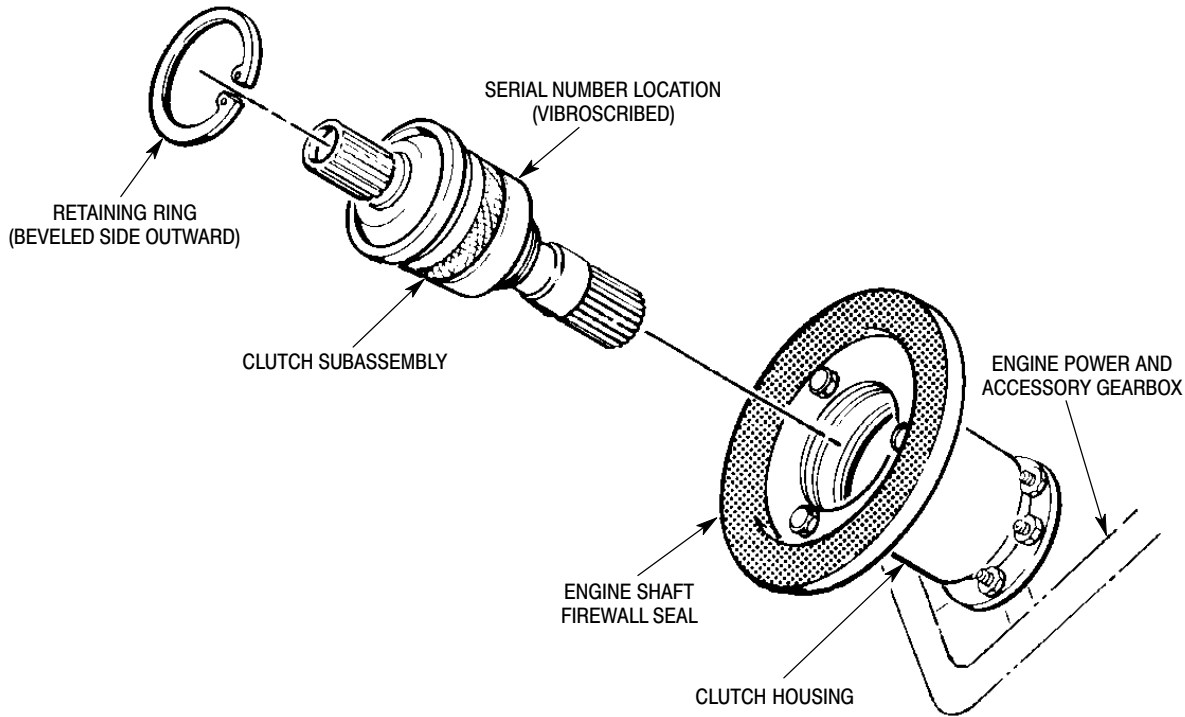
Figure 1. Inspection of Overrunning Clutch Assembly Outer Race.

Serial numbers are clearly vibroscribed on outer surface of the outer race on affected parts. (See Figure 1.)

D. If the outer race serial number is not 0692 thru 0927, proceed to step F. If the outer race serial number is 0692 thru 0927, proceed to step E.

- E. Replace outer race of overrunning clutch assembly per Part CSP-COM-5 (369D/E/F/500N) or Basic HMI, Appendix C (369H).
- F. Reinstall clutch sub-assembly into clutch housing per CSP-HMI-2, Section 63-10-00 (369D/E/FF/500N) or Section 9 of HMI (369H).
