SERVICE BULLETIN

DATE: 26 SEPTEMBER 1994
PAGE 1 OF 6

FIREWALL FUEL FITTING MODIFICATION

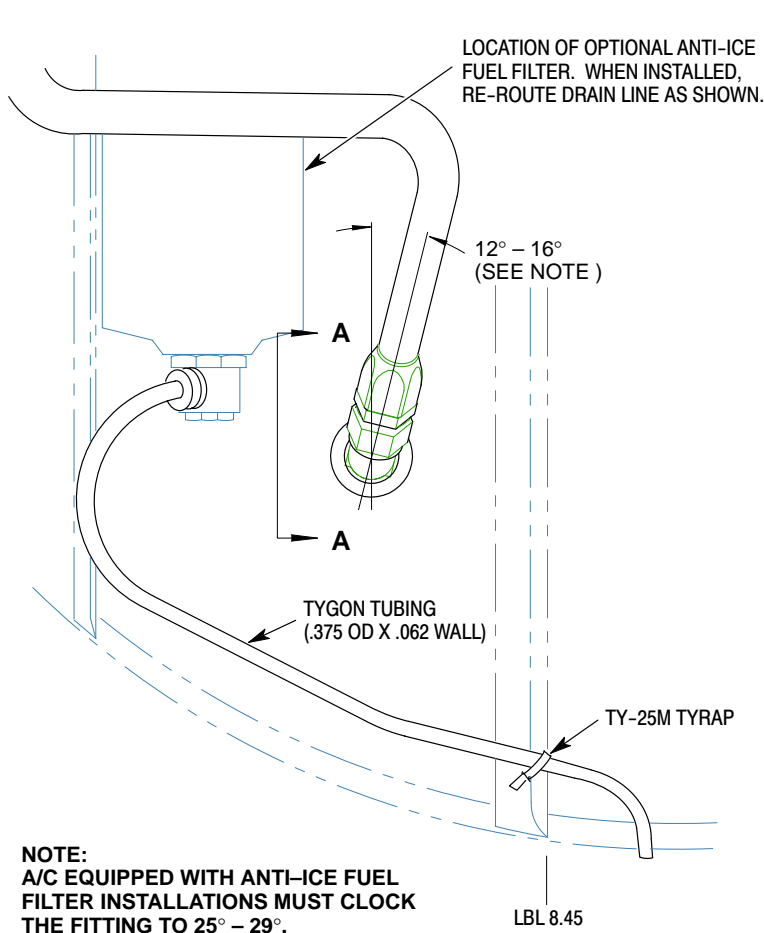
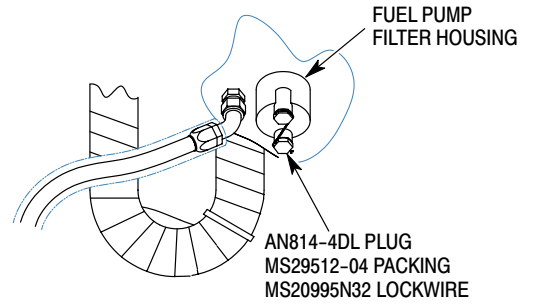
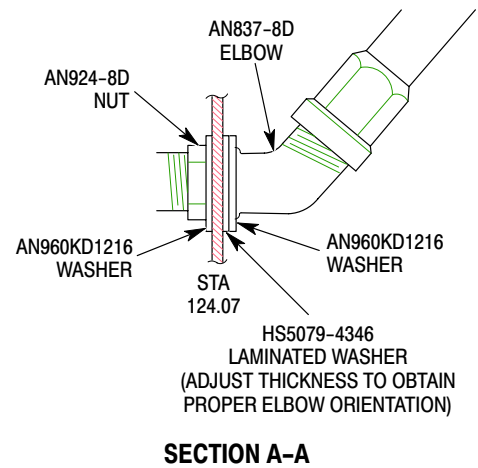
Figure 1. Firewall Fuel Fitting Modification (Installation).

MDHI has received reports from the field of the station 124 firewall fuel fitting interfering with the landing gear brace. As a result, there is a possibility of the fuel fitting becoming damaged, thus creating a potential for fuel leakage. Therefore, MDHI is requiring all operators to modify their aircraft according to procedures contained in this Notice.

NOTE:
A/C EQUIPPED WITH ANTI-ICE FUEL FILTER INSTALLATIONS MUST CLOCK THE FITTING TO 25° - 29°.

- (3). Install AN924-8D (nut), (2) AN960KD1216 (washers), HS5079-4346 (laminated washer) and AN837-8D (elbow) as shown in Figure 1.
- (4). Ensure that AN837-8D is clocked 12° to 16° (25° to 29° for fuel systems equipped with anti-ice fuel filter installations) inboard as shown in Figure 1.

NOTE: HS5079-4346 shim thickness may be adjusted to obtain proper elbow orientation.

- (5). Reassemble fuel cell lacing per the HMI Vol. I, Section 28-00-00.
- (6). Re-install hoses to the AN837-8D fitting (see Figure 1). Torque hoses per the HMI-CSP-2, Vol. I, Section 28-00-00.

- (7). Install AN814-4DL plug, MS29512-04 packing and MS20995N32 lockwire to engine fuel pump housing 369A8100-507 configurations only at location shown in Figure 1.
- (8). Re-fuel aircraft per servicing instructions contained in the Handbook of Maintenance Instructions (HMI).
