SERVICE BULLETIN

DATE: 20 JULY 2010

INSPECTION OF SHORT EDGE MARGIN CONDITION ON 369D23500 TAILBOOM ASSEMBLY

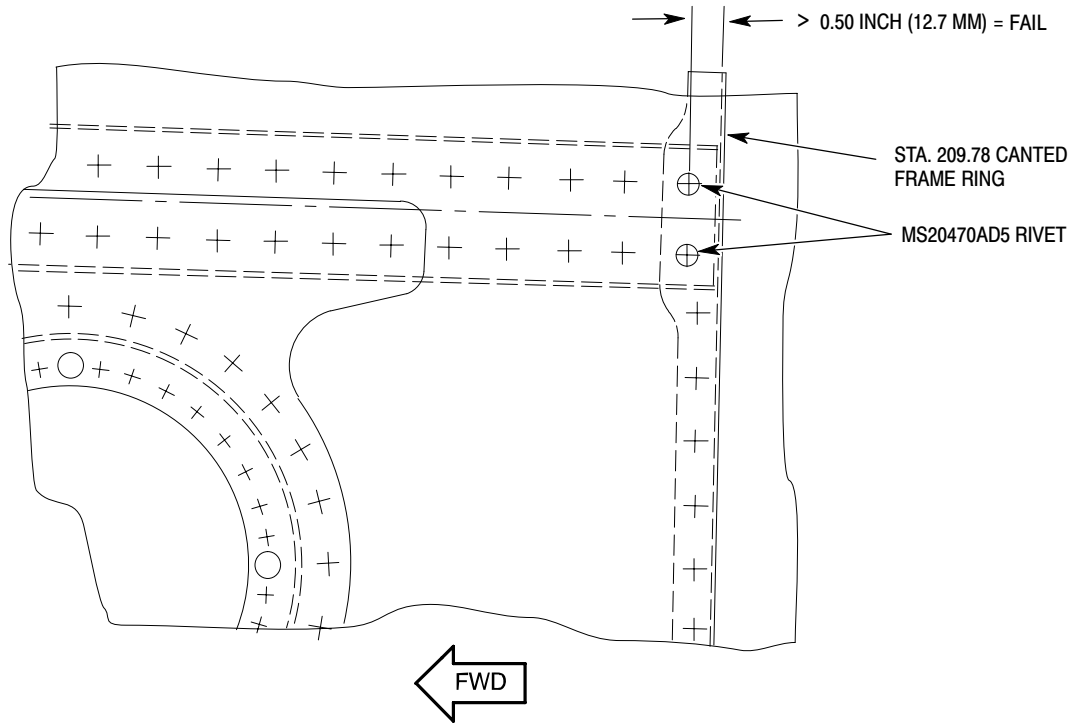
Figure 2. STA 209.78 Frame Ring to Rivet Measurement

If either of the two aft rivets for a longeron is more than 0.50 inches (12.7mm) from the forward face of the frame ring, there is an unsatisfactory edge margin condition.

- Measure the distance from the forward face of the STA 209.78 frame ring to the center of the two aft rivet locations on each longeron.
