SERVICE BULLETIN

DATE: 3 MAY 2004

FORWARD AND CENTER THRUSTER CONTROL CABLE ASSEMBLIES CONNECTOR ONE TIME INSPECTION

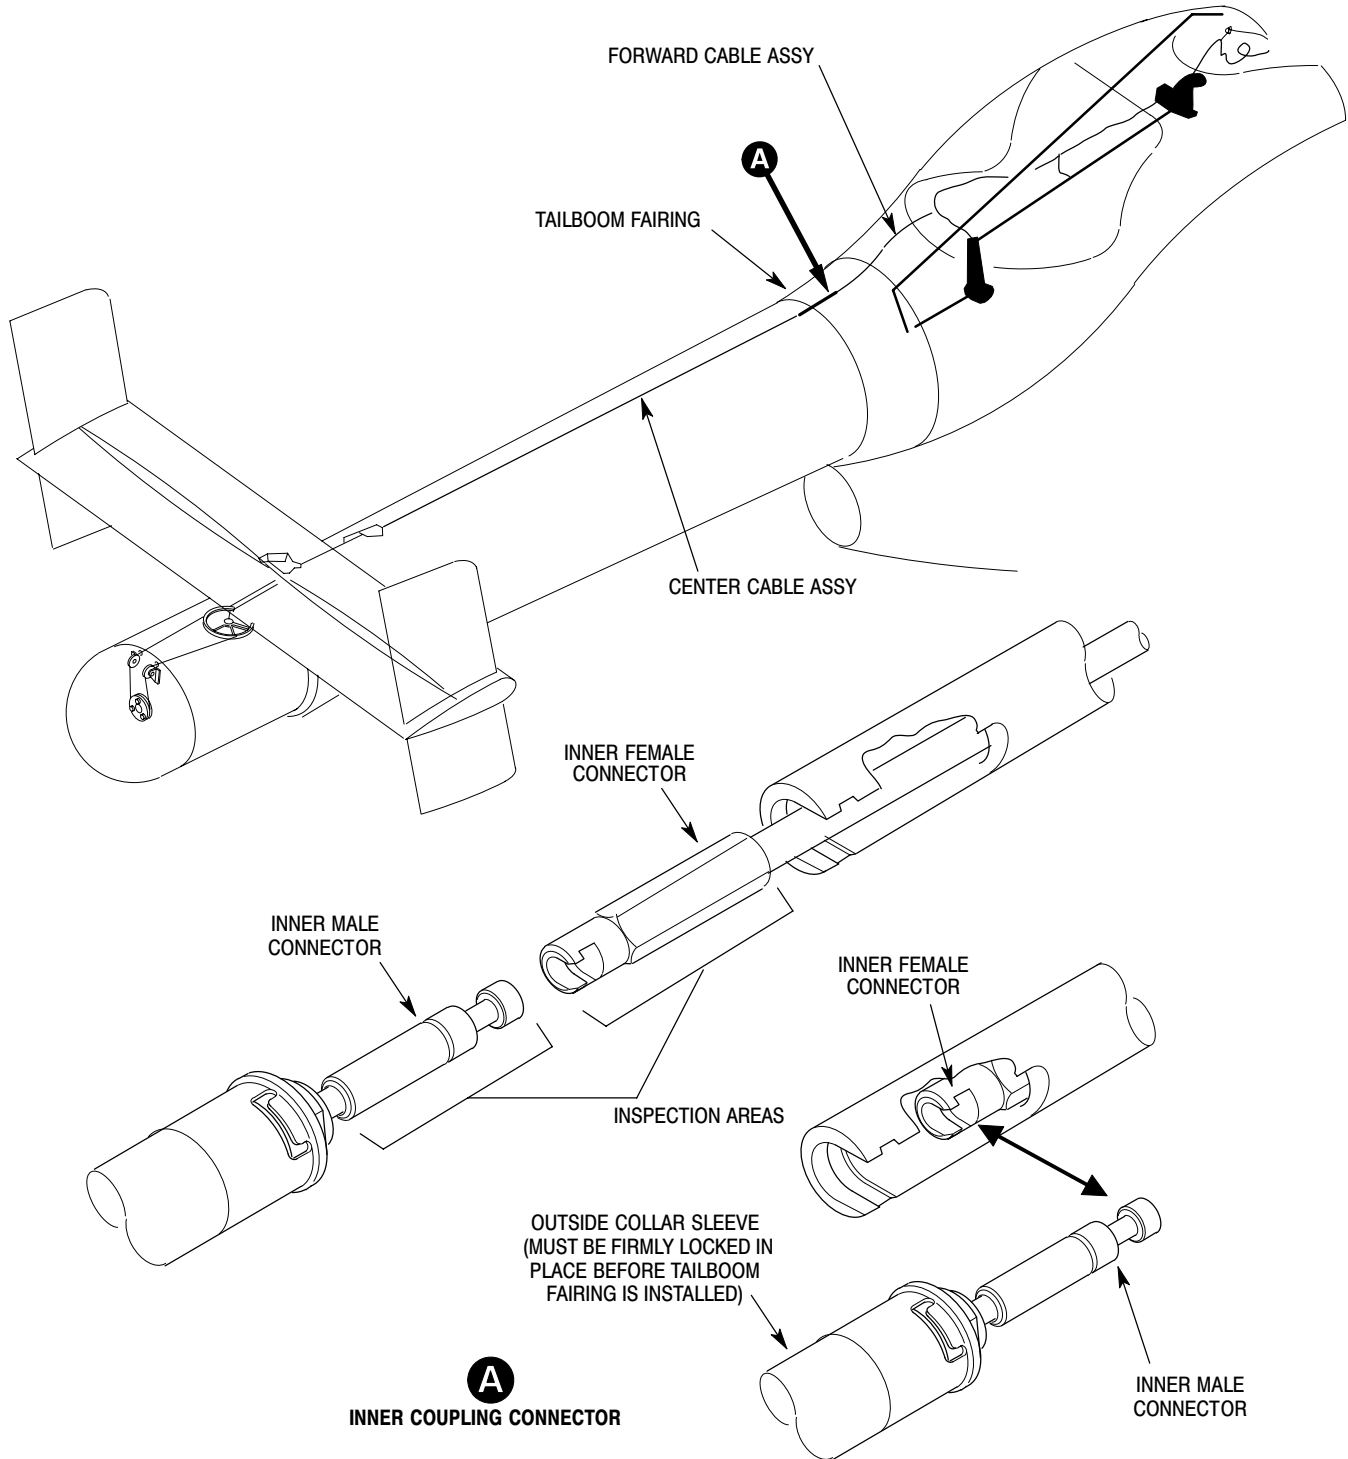
Figure 1. Forward and Center Thruster Cable Assembly Connector Inspection

A fractured inner female connector on a forward thruster control cable assembly, due to stress corrosion cracking, has been reported.

- (a). Move inner cables as required to fully expose inner connectors.
- (b). Using a bright light and 10x magnifying glass, inspect male and female connectors for corrosion pitting and cracking.

- (c). If corrosion pitting or cracking is found, replace forward and/or center cable assemblies (Ref. CSP-HMI-2, Section 67-20-30, Forward Cable Assembly Replacement and/or Center Cable Assembly Replacement).
- (6). Reconnect forward and center control cable couplings.
