SERVICE BULLETIN

ENGINE COOLING IMPROVEMENT

Boeing 600N helicopters, serial numbers RN003 thru RN017.

Engine Oil System Installation (P/N 369D28300-509).

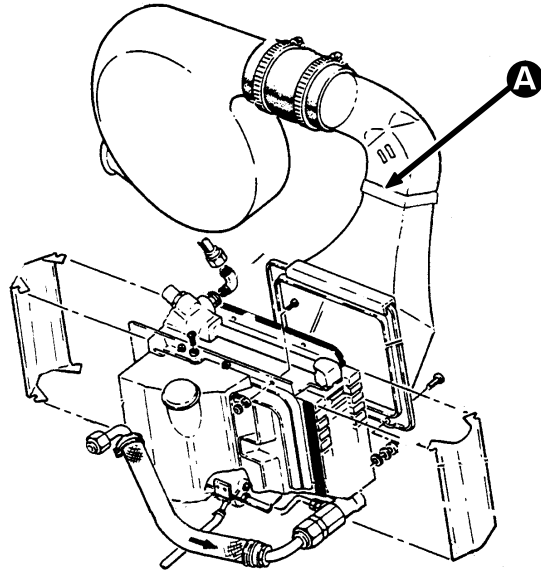
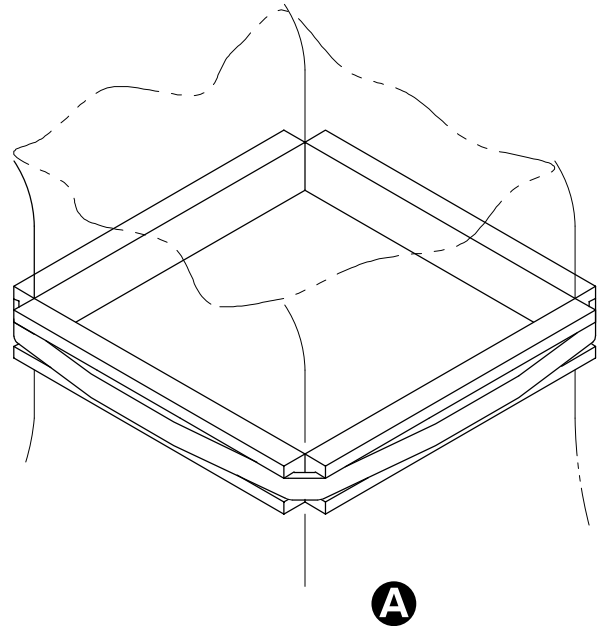
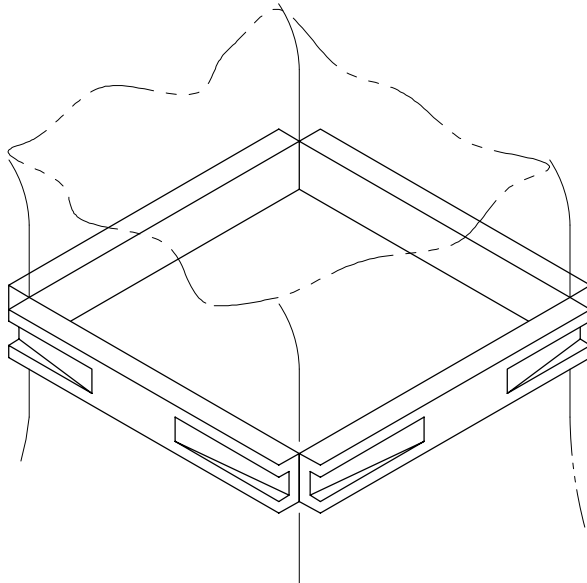
Figure 1. Engine Cooling Improvement Modification

To improve engine oil cooling allowing an increase in the ambient temperature operating environment to 125°F at sea level. Compliance with the requirements of this Bulletin shall increase the allowable operating temperature environment (refer to Rotorcraft Flight Manual, CSP-600RFM-1, Revision 3 or later. See Section II, Figure 2-1 Ambient Temperature Envelope). Accomplishing the requirements of this Bulletin makes the oil cooler duct installation equivalent to a 369D28300-511 installation.

- (1). Remove interior and stress panels, as required, to gain access to the engine oil cooling duct area.
- (2). Remove the two MS3367-6-9 ty-straps that hold the 369D28303 engine oil cooler duct connector in place.
- (3). Refer to Figure 1. Install four 600N8301-1 oil cooler duct seal stiffeners underneath each of the ty-straps (one on each of the four sides, two places) and tighten ty-straps.
