# SERVICE BULLETIN

DATE: 28 APRIL 1998  
PAGE 1 OF 3

## LANDING GEAR FAIRING MODIFICATION

All McDonnell Douglas Helicopter Systems (MDHS) MD600 helicopters, serial number RN003 thru RN029.

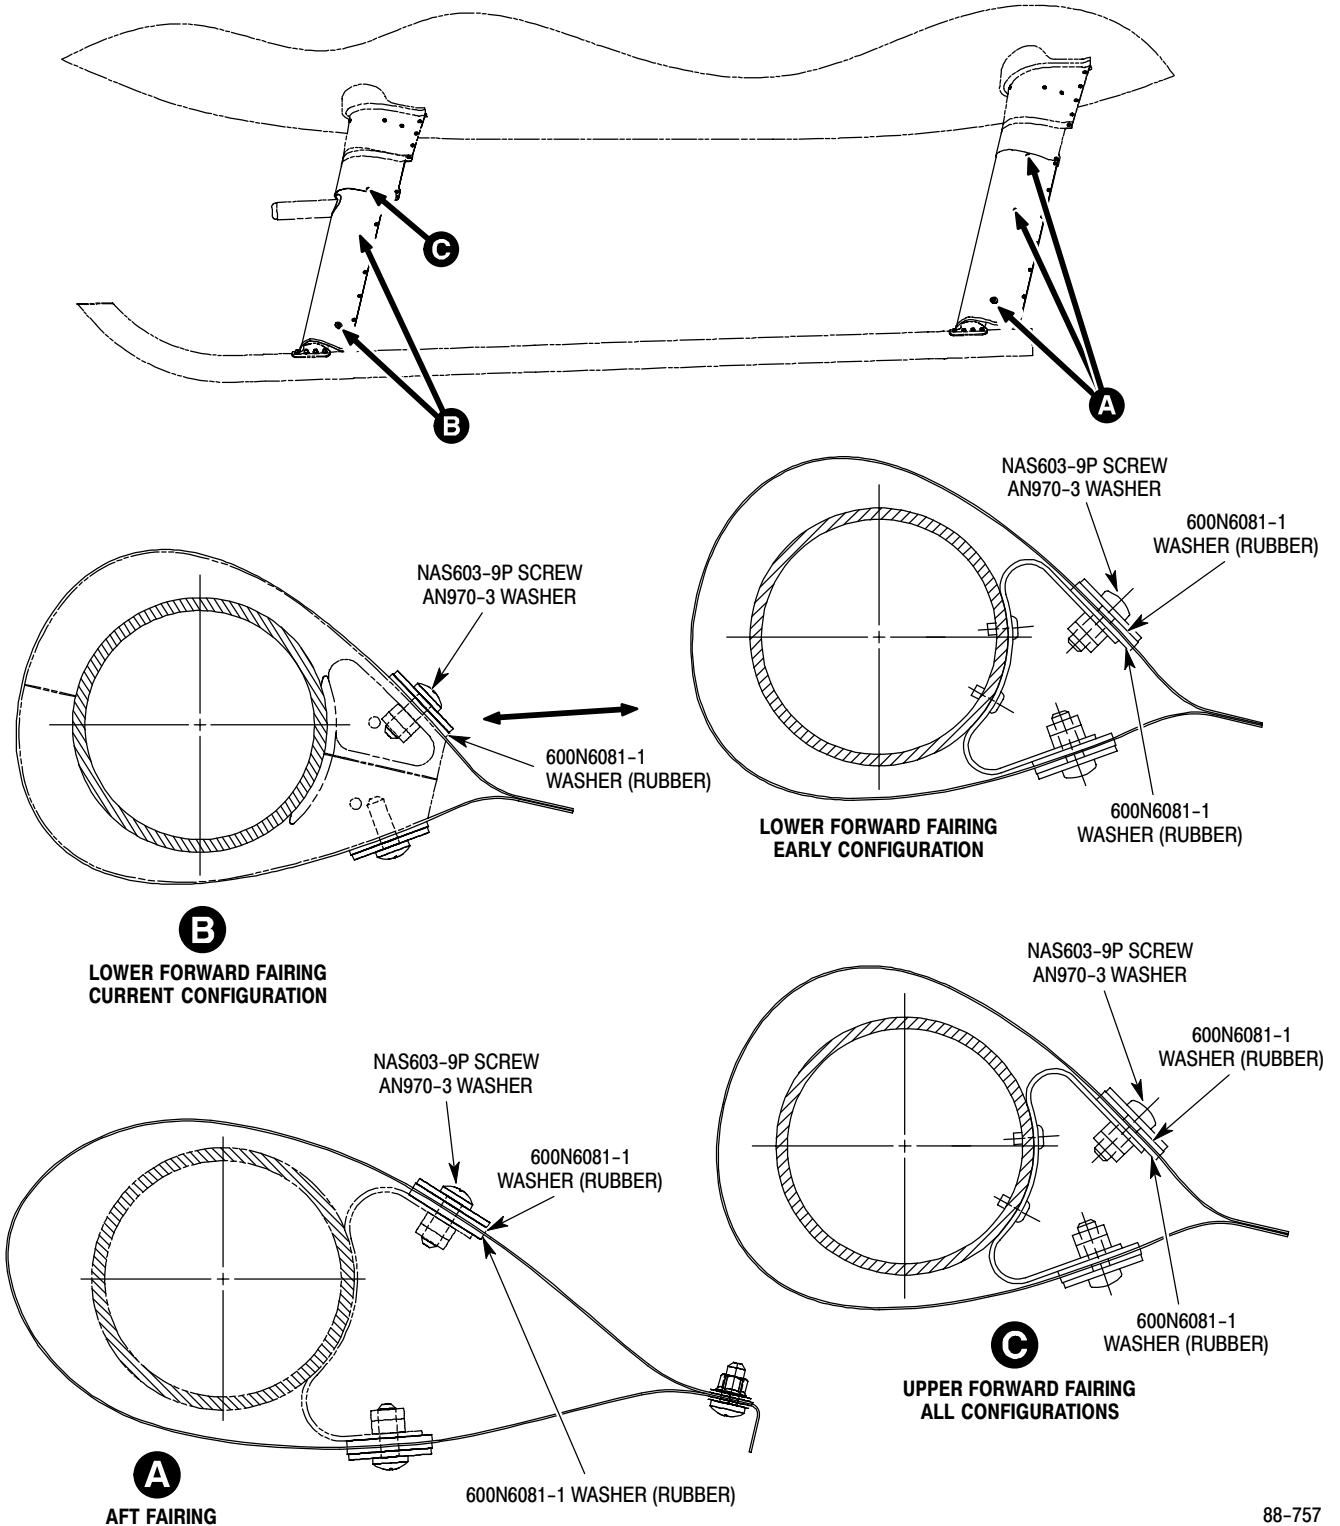
**Figure 1. Landing Gear Modification Hardware Installation**

To prevent possible cracking of the landing gear fairing. Failure to comply with the requirement of this Bulletin may lead to the development of cracks in the landing gear fairings.

- (1). Remove existing screws and washers from forward and aft landing gear struts at locations shown in Figure 1.
- (2). Install replacement hardware as shown in Figure 1.
- (3). Apply touch-up paint as required.
- (4). Record compliance to this Service Bulletin in the Compliance Record section of the helicopter Log Book.
