SERVICE BULLETIN

CYCLIC CONTROL MIXER LINKS REPLACEMENT (EIGHT DEGREE PHASE SHIFT RECOVERY)

All McDonnell Douglas Helicopter Systems (MDHS) MD600N helicopters, serial number RN003 thru RN014 and RN016 thru RN037.

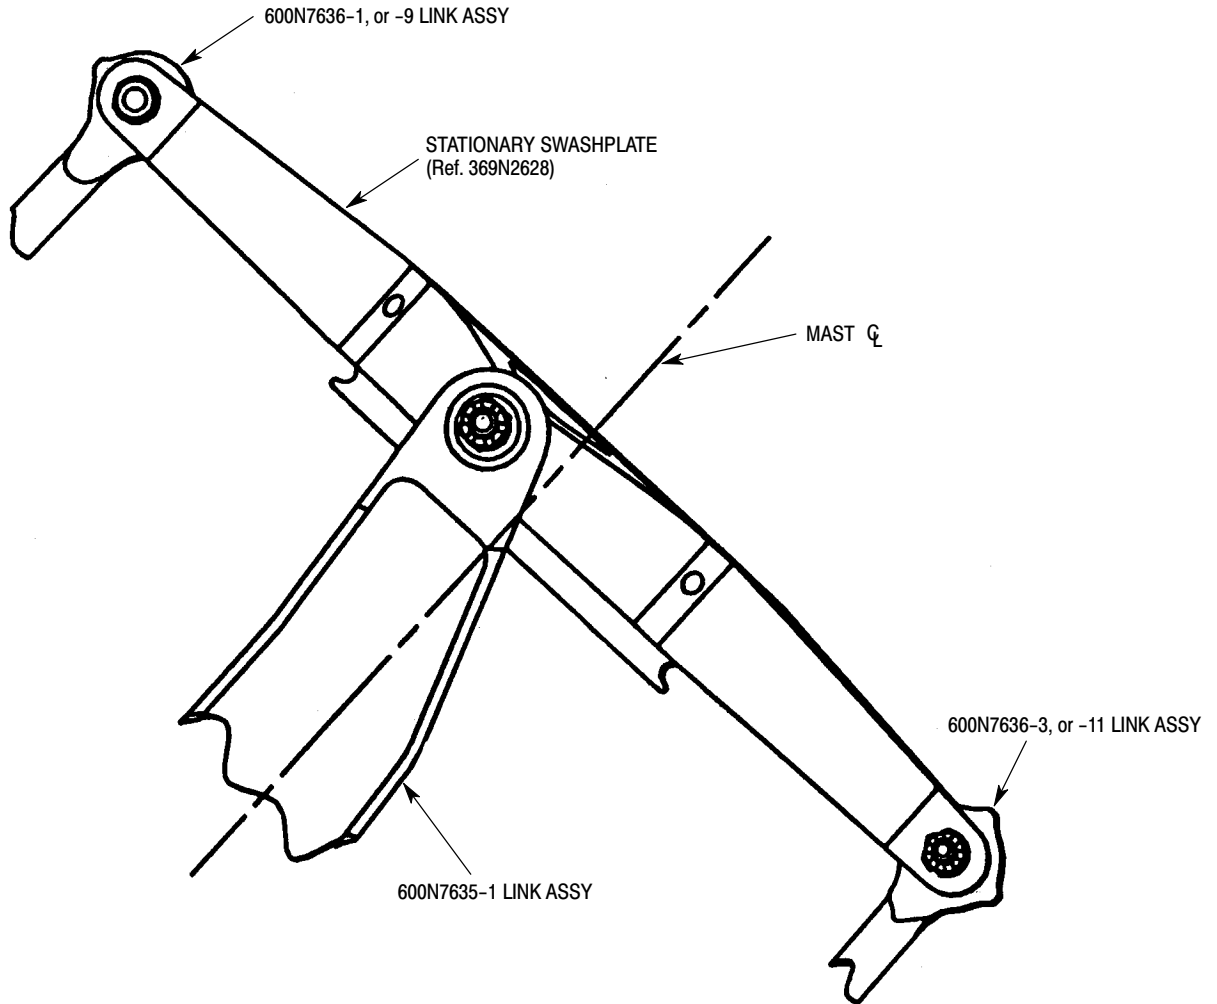
Figure 1. Cyclic Control Mixer Links Replacement.

To recover the cyclic phase shift caused by adding the sixth blade to the main rotor system. Complying with the requirements of this Bulletin will result in reduced pilot workload.

Procedures in this Bulletin provide owners and operators with information pertaining to replacing various longitudinal and lateral mixer output links in the main rotor control system.
