SERVICE BULLETIN

ENGINE FUEL CONTROL BOX ATTACHMENT BOLT REPLACEMENT

All MD Helicopters, Inc. (MDHI) 600N helicopters, serial number RN003 thru RN026.

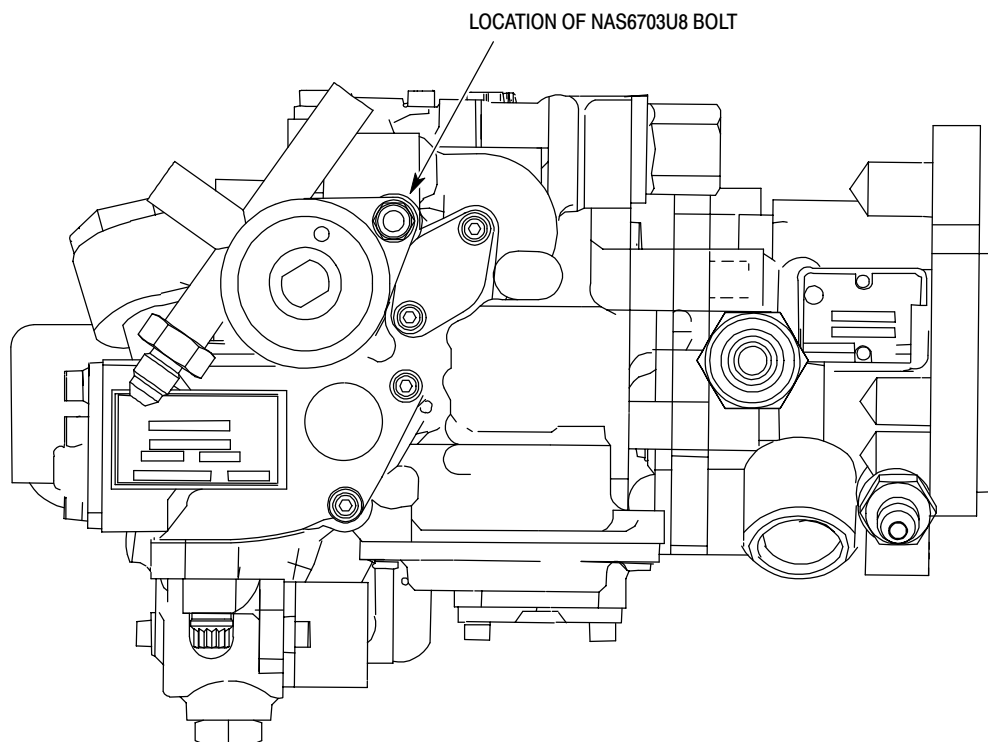
Figure 1. Engine Fuel Control Box Attachment Bolt Replacement.

Inspection of an aircraft after a recent ground run revealed that the subject bolt had fallen out. A longer bolt will provide proper thread engagement and eliminate this from happening. Failure to comply with the requirements of this Service Bulletin may result loss of engine throttle control. This condition may result in a precautionary/emergency landing situation.

- (1). Replace NAS6703U6 bolt with NAS6703U8 bolt per instructions contained in the Handbook of Maintenance Instructions (CSP-600HMI-2/3) Section 76-00-00 (ref. to Figure 1 below). **NOTE:** This installation is also shown in the Illustrated Parts Catalog (CSP-IPC-4, Section 71-00-60, Figure 3).
- (2). Record compliance to this Service Bulletin in the Compliance Record section of the helicopter Log Book.
