SERVICE BULLETIN

FADEC MANUAL SWITCH GUARD MODIFICATION

All McDonnell Douglas Helicopter Systems (MDHS) MD600N helicopters, serial number RN003 thru RN044.

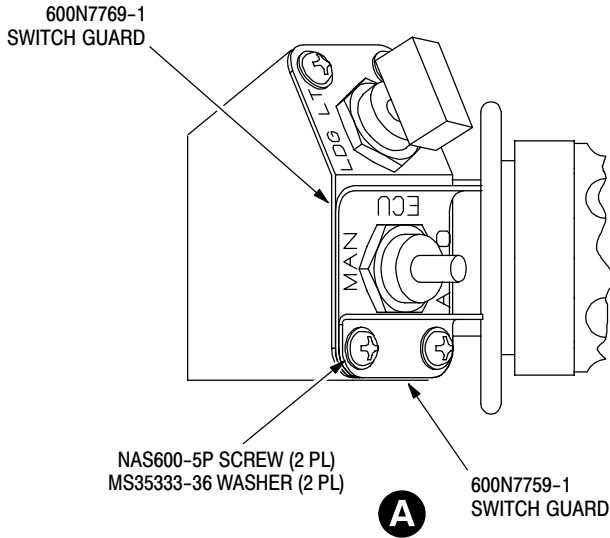
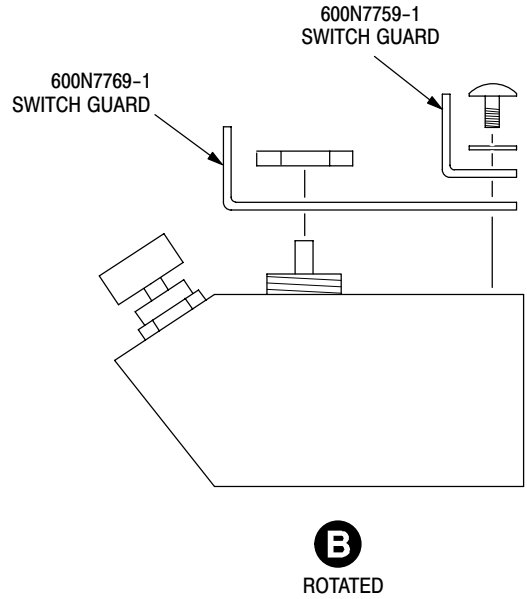
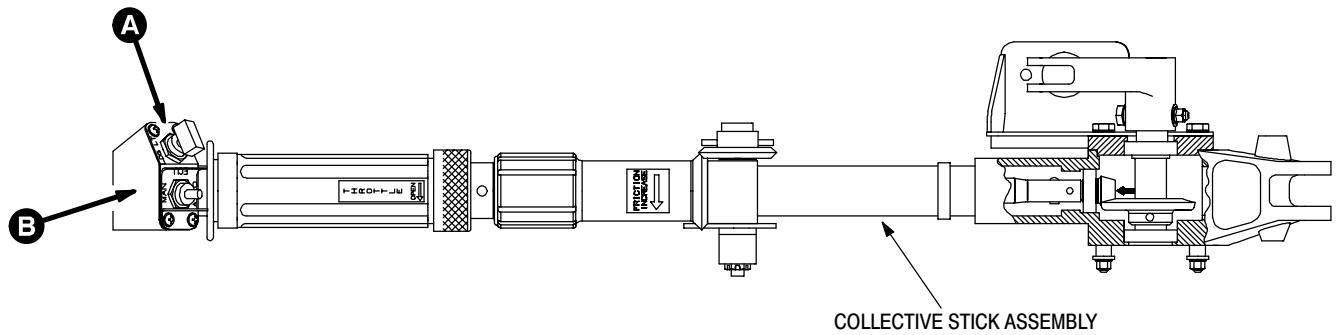
Figure 1. ECU Switch Guard Modification.

To install an additional guard near the Engine Control Unit (ECU) (manual/auto) switch located on the collective stick assemblies. The new guard provides additional protection against inadvertant ECU switch activation. Failure to comply with the requirements of this Bulletin may result in the switch being turned to manual mode during flight which could cause unanticipated speed-up or slow down the engine with associated changes in rotor RPM leading to possible overspeed.

- (1). Remove existing switch guard (P/N 600N7759-1)
- (2). Remove nut securing the switch.
- (3). Place the new switch guard (P/N 600N7769-1) over the switch and reinstall switch nut.
- (4). Place the old switch guard on top of new guard and install washers and screws provided by MDHS.
- (5). Record compliance to this Service Bulletin in the Compliance Record section of the helicopter Log Book.
