SERVICE BULLETIN

TORQUE PRESSURE TRANSDUCER HIGH INTENSITY RADIATED FIELDS (HIRF) PROTECTION MODIFICATION

* Supersedes Service Bulletin 600N-018, dated 08 October 1998. Expanded aircraft effectivity to ensure an accurate torque indication system for all affected helicopters and corrected connector part number. Aircraft which have complied with SB600-018 have met the intent of this revision.

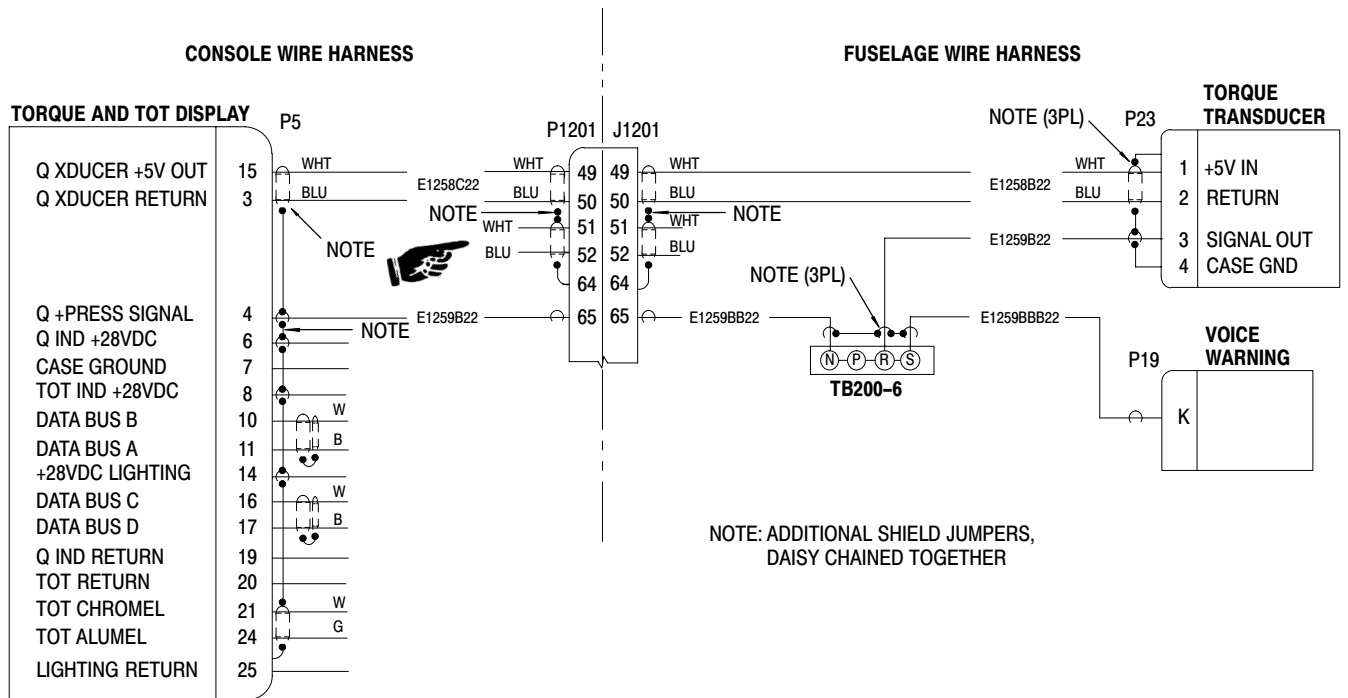
Figure 2. Wiring Modification, Torque Pressure Transducer

To prevent possible inaccuracy of the torque indicating system caused by high intensity radiated fields and to comply with JAA Interim HIRF Policies INT/POL/27 & 29/1, Issue 2, dated 01 June 1997.

- (1). Access P23 and remove existing connector.
- (2). Cut the shield jumper pigtail from the shield sleeve at J1201-50. Leave the pigtail attached to the shield sleeve at J1201-51.
- (3). Replace existing E1258B22 with M27500-22SD2T23 two conductor shielded wire.
- (4). Replace existing torque pressure transducer P/N PX9606 with new P/N PX10126 torque pressure transducer (Ref. CSP-HMI-2).
- (5). Terminate new E1258B22 with M39029/58-360 (J1201) pins (tool item no.7), M39029/57-354 (P23) sockets (tool item no.8) and install M83519/2-8 shield jumpers.
- (6). At J1201 insert the white wire into J1201-49 and the blue wire into J1201-50.
- (7). Insert jumper from J1201-51 into new shield sleeve at J1201-50 and heat shrink shield sleeve.

- (8). At P23 place M85049/17-08N02 backshell over E1258B22 and shield jumper.
- (9). At P23 insert the white wire into P23-1 and the blue wire into P23-2.

- (10). Replace existing E1259B22 with M27500-22SD1T23 single conductor shielded wire.
- (11). Terminate new E1259B22 with M39029/57-354 (P23) socket (tool item no.8).

- (12). At P23 insert E1259B22 through M85049/17-08N02 backshell.
- (13). At P23 install M83519/2-8 shield jumper onto E1259B22, insert conductor into P23-3 and daisy chain shield jumper with shield of E1258B22.

- (14). Using previously removed 24 AWG single conductor wire, fabricate a shield jumper pigtail of sufficient length to jumper the shield on E1259B22 and P23-4.

- (15). At P23 terminate fabricated shield jumper with M39029/57-354 socket (tool item no.8) and insert into P23-4.
- (16). Insert remaining end of fabricated shield jumper into shield sleeve on E1259B22.

- (17). At P23 ensure all shield jumpers are in place and heat shrink shield sleeves.
- (18). Terminate the shield jumper from E1258B22 into the shield termination area of P23 backshell.

- (19). Terminate new E1259B22 with M39029/22-191 (TB200) socket (tool item no.6) and M83519/2-8 shield jumper.
- (20). Insert E1259B22 into TB200-6-R.
- (21). Replace existing E1259BBB22 with M27500-22SD1T23 single conductor shielded wire.

- (22). Terminate new E1259BBB22 with M39029/22-191 (TB200) socket (tool item no.6) and M39029/32-259 (P19) socket (tool item no.5).

- (23). Install M83519/2-8 shield jumper onto E1259BBB22 at TB200.
- (24). At TB200 insert E1259BBB22 into TB200-6-S.
- (25). At P19 insert E1259BBB22 into P19-K
- (26). Replace existing E1259BB22 with M27500-22SD1T23 single conductor shielded wire.
- (27). Terminate new E1259BB22 with M39029/22-191 (TB200) socket (tool item no.6) and M39029/58-360 (J1201) pin (tool item no.7).

- (28). Install M83519/2-8 shield jumper onto E1259BB22 at TB200.
- (29). At TB200 insert E1259BB22 into TB200-6-N.
- (30). At J1201 insert E1259BB22 into J1201-65
- (31). At TB200 ensure shield jumpers from TB200-6-S, R, and N are daisy chained together and heat shrink shield sleeves.
