SERVICE BULLETIN

DATE: 23 APRIL 1999

FADEC WIRE HARNESS STAND-OFF INSTALLATION INSPECTION AND MODIFICATION

All MD Helicopters, Inc. (MDHI) MD600 helicopters, serial number RN003 thru RN040.

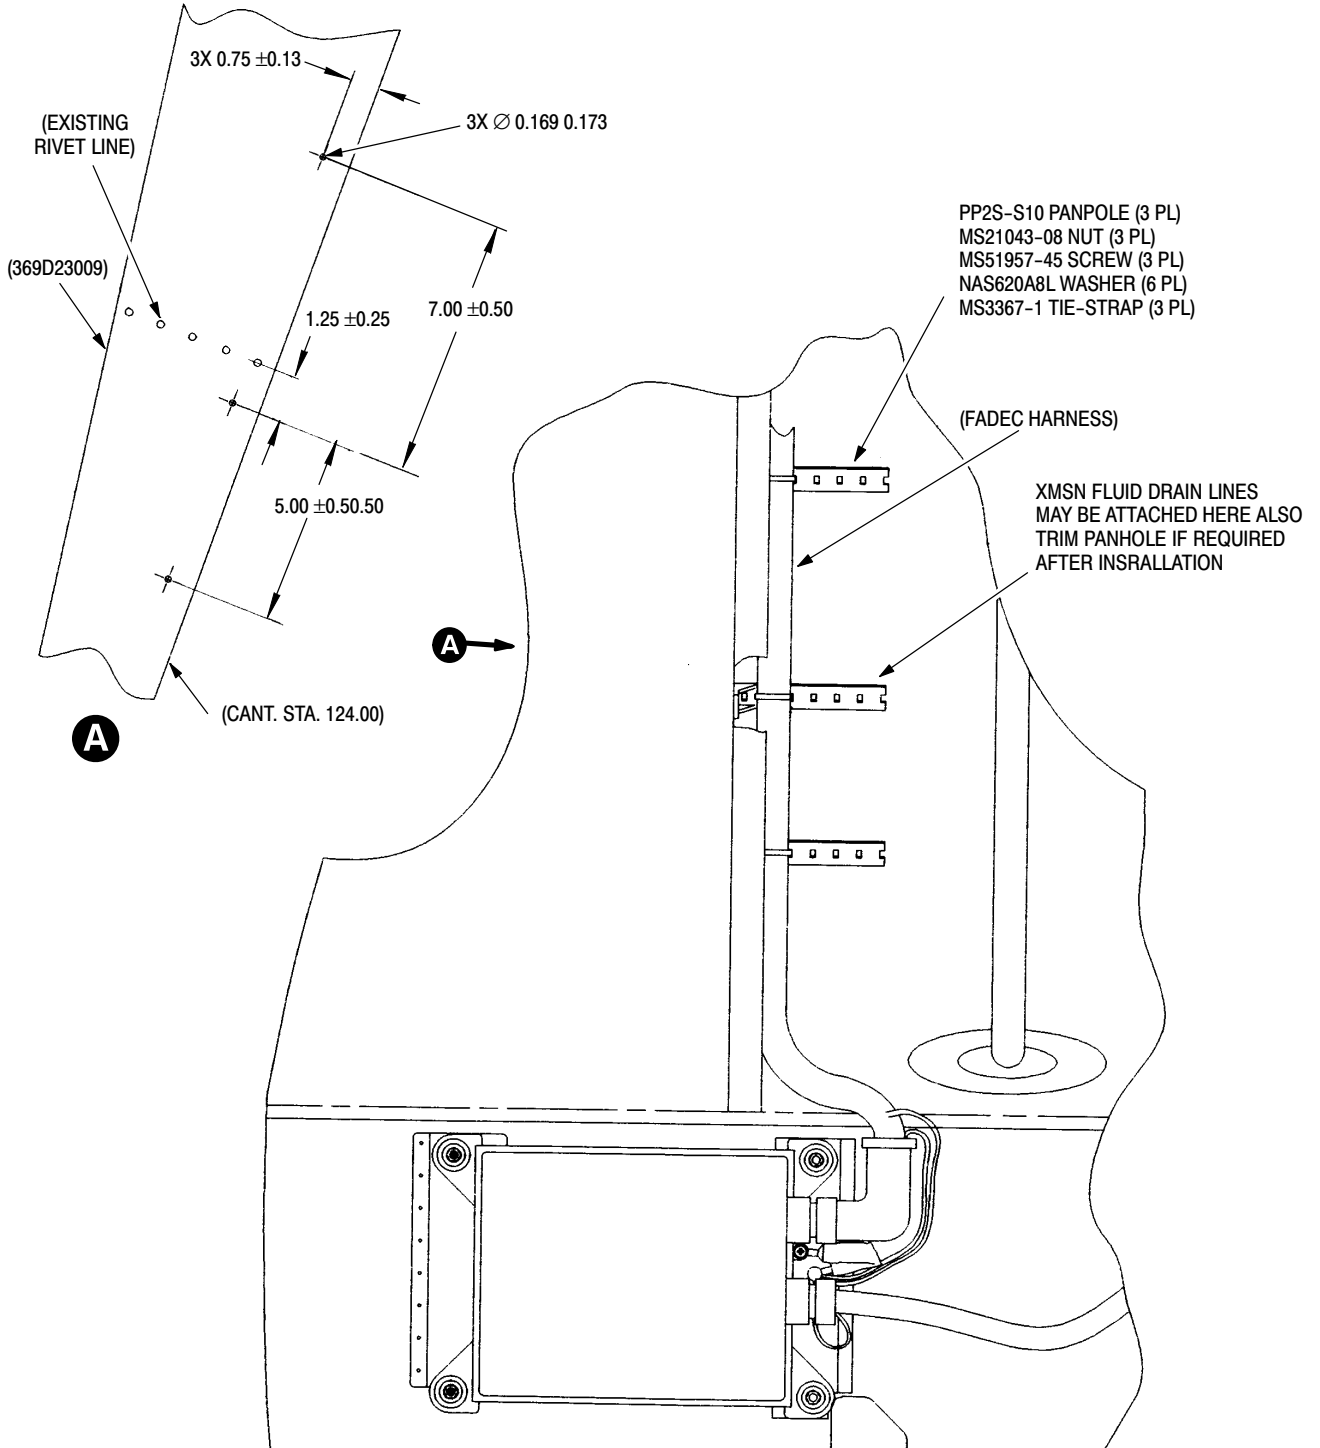
Figure 1. FADEC Wire Harness Routing Rework.

MDHS has discovered that a possible internal wire harness shorting condition may occur if a longer length screw is substituted for the proper screw in the aft compartment trim above the FADEC ECU, in the drive shaft closeout area. Failure to comply with the requirements of this Bulletin could cause FADEC fault lights to illuminate and/or prevent the ship from starting due to FADEC faults.

- (3). Locate and install the three Pan Pole standoffs as shown on Figure 1.
- (4). Secure FADEC wire harness to the standoffs using tie straps. **NOTE:** The transmission drain lines may be secured to these standoffs as well for convenience. It is not necessary to remove the existing tie bases in the rework area.
