SERVICE BULLETIN

TORQUE TRANSDUCER ELECTRICAL CONNECTOR ONE TIME INSPECTION

Model 600N Helicopters, serial number RN003 thru RN061.
Serial numbers RN003 thru RN047 must be in compliance with Service Bulletin SB600N-018R1 or later revision prior to accomplishing this Bulletin.

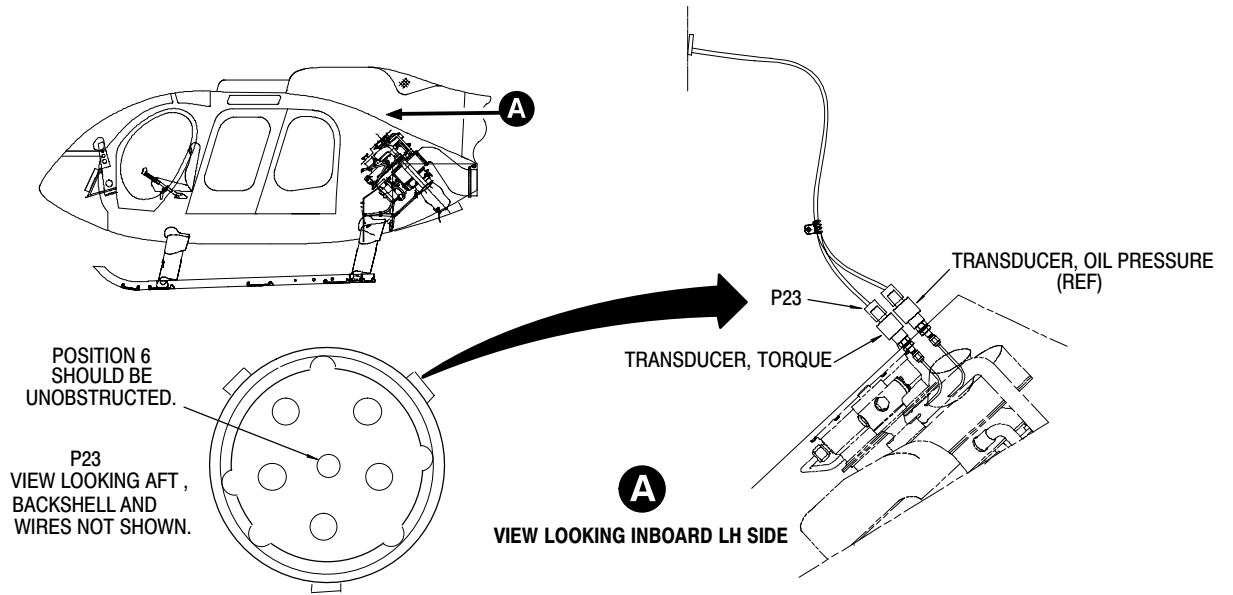
Figure 1. Torque Transducer Electrical Connector Location

Some torque transducer electrical connectors were installed with a sealing plug or a contact in the center contact position, which may block the transducer ambient pressure port. This condition may cause erroneous torque meter indications with changes in altitude.

- (1). Remove engine inlet screen (Ref. CSP-HMI-2, Section 71-10-00, Engine Inlet Screen Removal (600N)) or remove particle separator (Ref. CSP-HMI-2, Section 71-10-60, Particle Separator Removal).
(Ref. Figure 1)
- (2). Unplug connector, P23 from torque transducer.
- (3). Remove backshell from connector.
- (4). Verify that center contact position (position 6) of connector is open and unobstructed.
- (5). If contact position is obstructed, remove sealing plug or extract contact.
- (6). Reassemble backshell and connector, and verify that shield terminations are not damaged.
- (7). Install reassembled connector on torque transducer mating connector.
- (8). Install engine inlet screen (Ref. CSP-HMI-2, Section 71-10-00, Engine Inlet Screen Installation (600N)) or install particle separator (Ref. CSP-HMI-2, Section 71-10-60, Particle Separator Installation).
