# SERVICE BULLETIN

DATE: 2 NOVEMBER 2001  
PAGE 1 OF 9

## TAILBOOM ASSEMBLY ATTACH FITTING ONE TIME INSPECTION AND REPAIR

Model 600N Helicopters, serial number RN003 thru RN063.

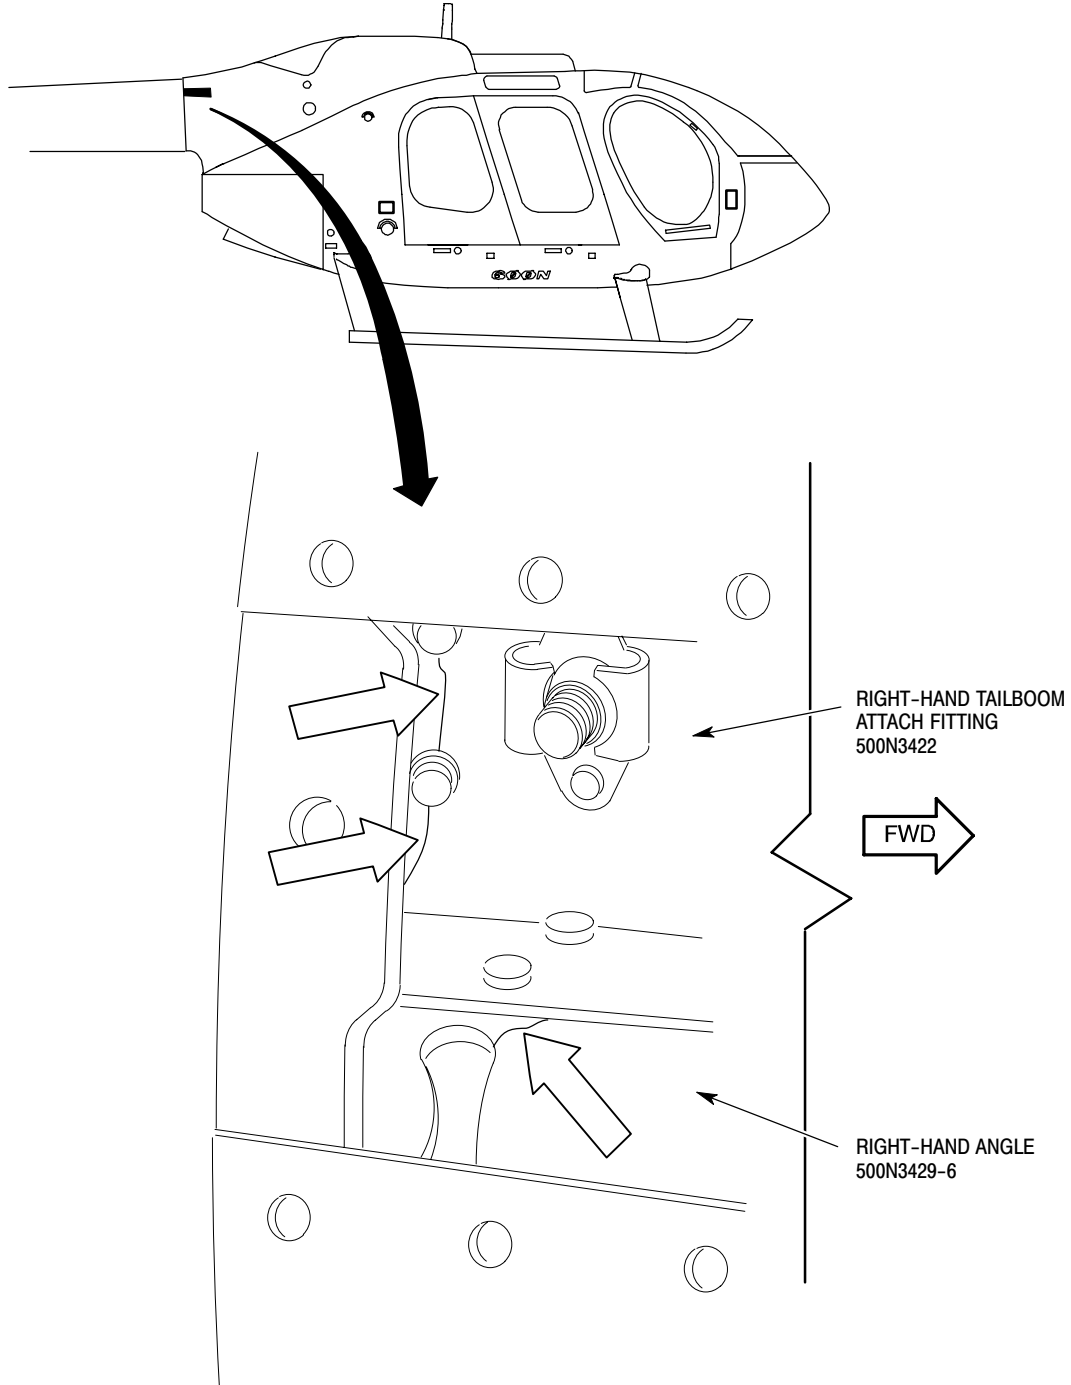
**Figure 1. Tailboom Attach Fitting and Angle Inspection**

- (2). Drill out rivets attaching **upper** left-hand and right-hand access covers.  
(Ref. Figure 1)
- (3). Inspect upper left-hand and right-hand tailboom attach fittings.

- (a). Using 10X magnification and bright light inspect for cracks. Pay particular attention to area around aft rivet holes. No cracks are allowed.
  - (b). If any cracks are found, contact MDHI Field Service Dept. for replacement instructions.

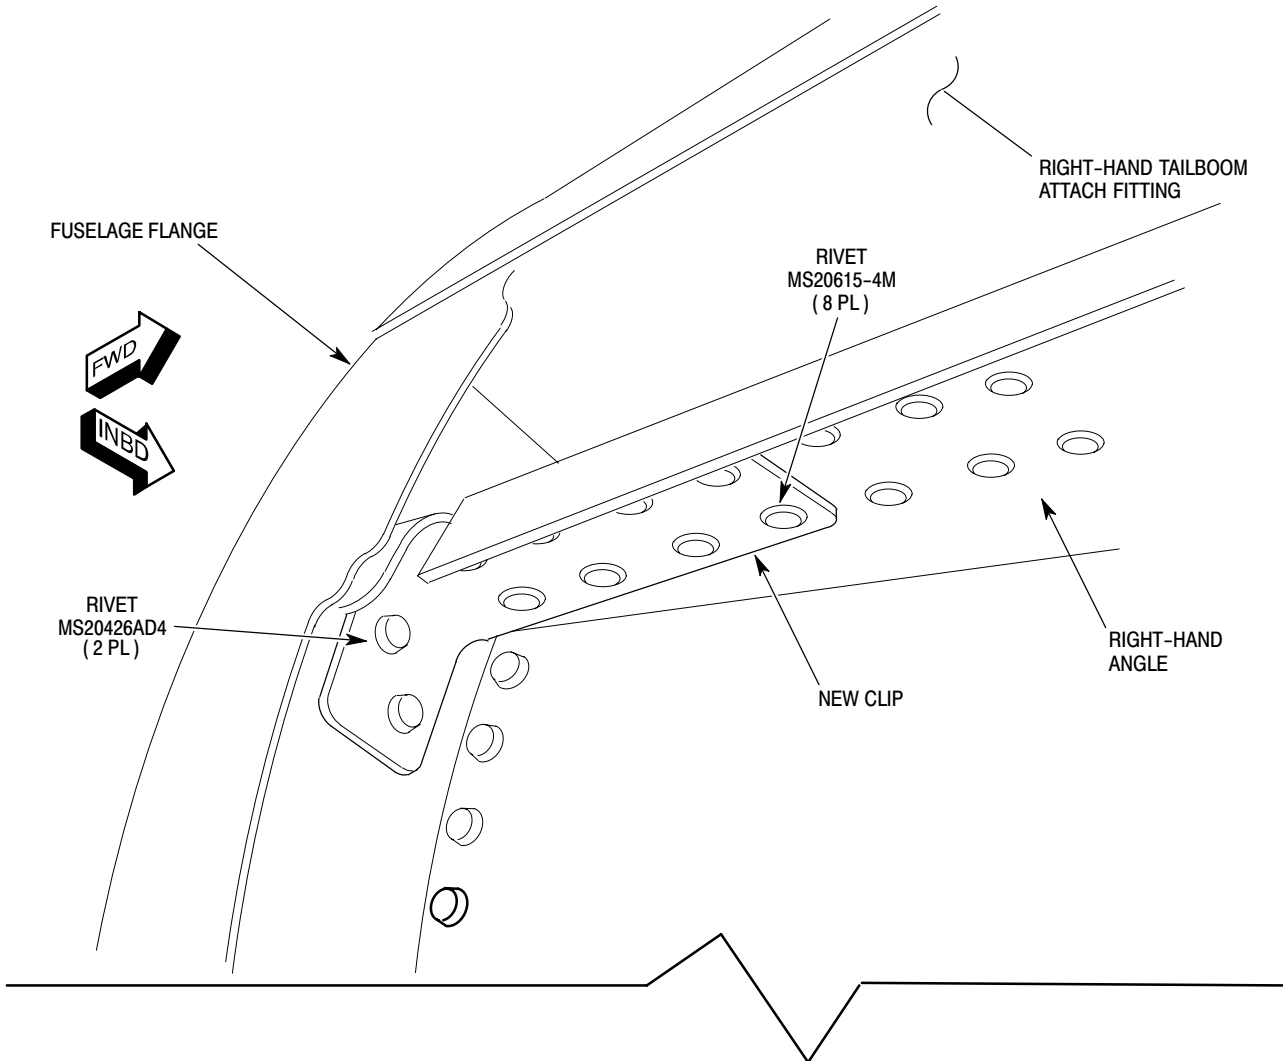
**Figure 2. Clip Installation**

- (c). If any cracks are found on right-hand angle, proceed as follows:

- 1). Drill out top three rows of rivets (six rivets) securing outer skin below tailboom attach fitting and pull skin to access angle.
- 2). Drill out rivets securing clip to angle and tailboom attach fuselage flange. Remove clip.
- 3). Fabricate new clip from 301 1/4 hard stainless steel, as shown. (Ref. Figure 3).
- 4). Install new clip with two (2) MS20426AD4 and eight (8) MS20615-4M rivets. Install rivets wet with primer. (Ref. Figure 2).
