# SERVICE BULLETIN

## EXHAUST DUCT INSPECTION

Model 600N Helicopters, serial number RN003 thru RN067.

Exhaust Duct (P/N 369D28630-BSC, -501).

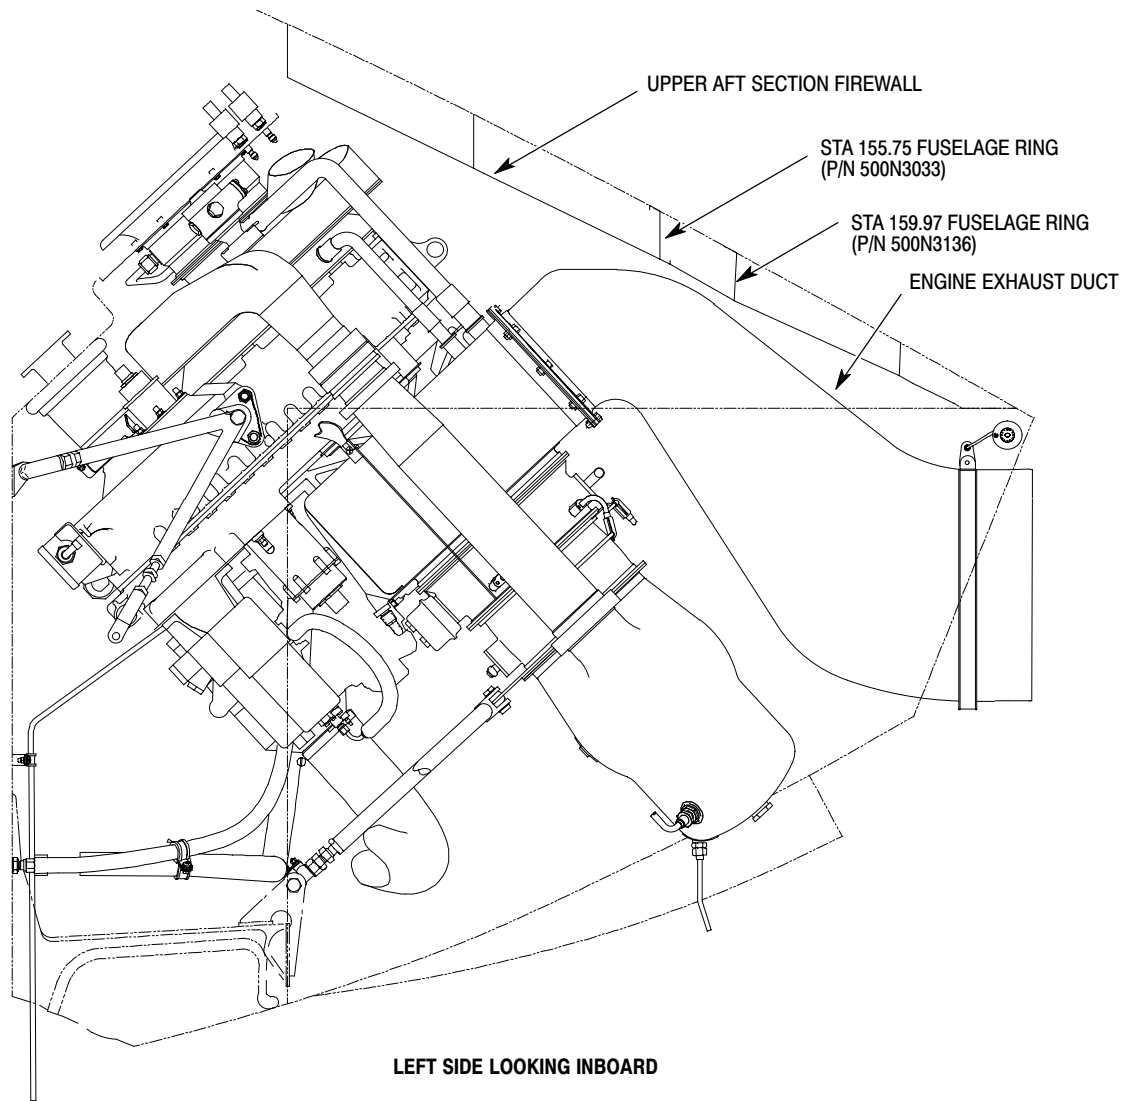
**Figure 1. Engine Exhaust Duct Inspection**

An operator has reported airframe damage in the vicinity of the engine exhaust duct.

- (3). Using flashlight and mirror, look in engine bay through engine access doors and look through engine oil filter access cutout.
- (4). Inspect top of engine exhaust duct for contact marks and bottom of upper aft section firewall for contact marks with discoloration, holes or tears. Pay particular attention to firewall blanket retainer clips at Sta. 155.75 fuselage ring.

- (a). If there is no evidence of contact or damage, no further action is required.
  - (b). If there is evidence of contact with discoloration, estimate minimum gap between top of engine exhaust duct and upper aft section firewall at Sta. 155.75 fuselage ring and contact MDHI Field Service Department for further instructions.

- (c). If there is a hole or tear in the firewall blanket, maintenance is required before next flight. Contact MDHI Field Service Department for further instructions.
