SERVICE BULLETIN

LATERAL MIXER OUTPUT LINK ASSEMBLY, ONE TIME INSPECTION

All Model 600N Helicopters.

Lateral Mixer Output Link Assembly (P/N 600N7636-1, -3).

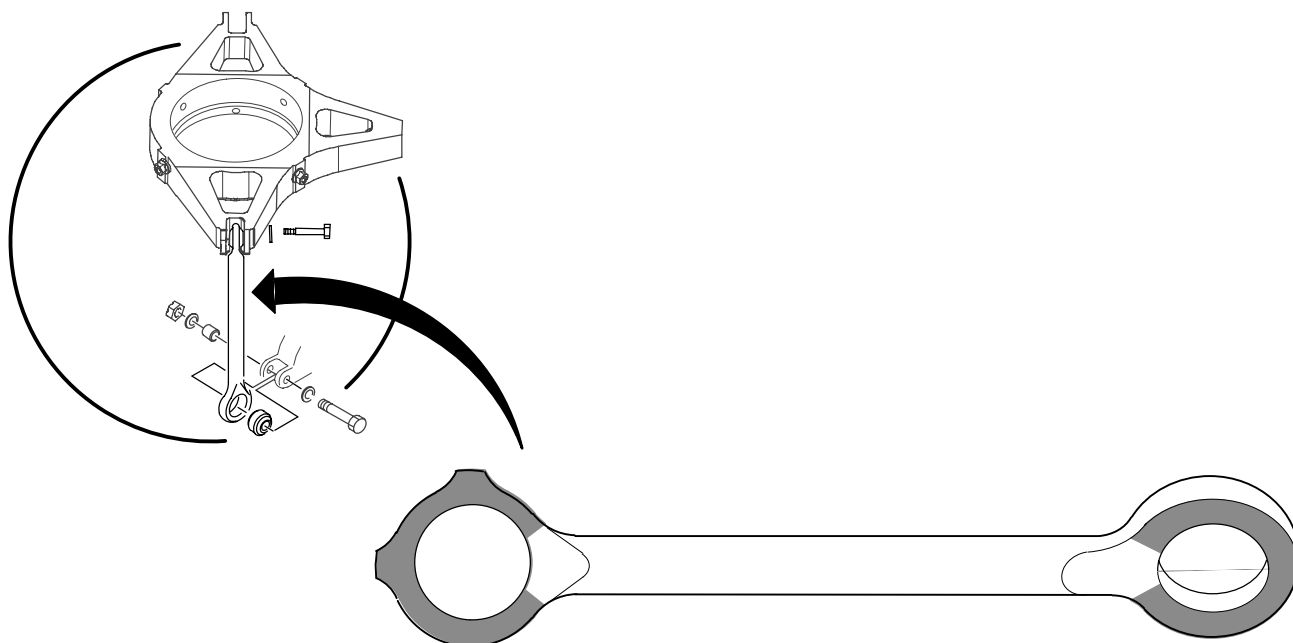
Figure 1. Attach Point Access**3. IDENTIFICATION**

Visual inspection of the lateral mixer output link assembly has shown that cracks may be present radiating from the bearing bores on the link ends. Failure to comply with this bulletin may result in loss of main rotor controllability.

- (2). Using a bright light and a 10x magnifier, inspect link end shaded areas on both sides of the link assembly around bearing bore for indication of cracking. Replace and link assemblies suspected of cracks.
- (3). Reinstall lateral mixer link assembly.

- In the following step, cleaning of the link assembly may be necessary to complete inspection.
 - Eddy current is to be performed by a Level II technician certified by either ASNT-TC-1A or MIL-STD-410 in eddy current and active in eddy current inspection within the last 12 months.
- (2). Perform eddy current inspection of the shaded areas on both sides of the link assembly.
 - (3). Install lateral mixer output link assembly (Ref. CSP-HMI-2, Sec. 62-30-60).
