# SERVICE BULLETIN

DATE: 18 SEPTEMBER 2000

## AUDIO WARNING SYSTEM MODIFICATION

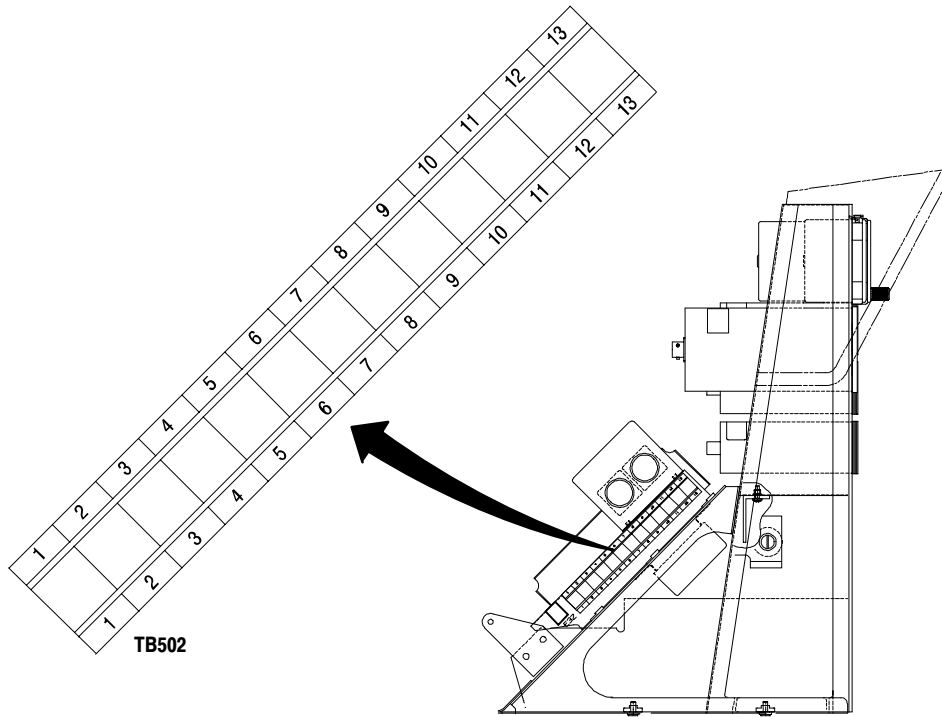
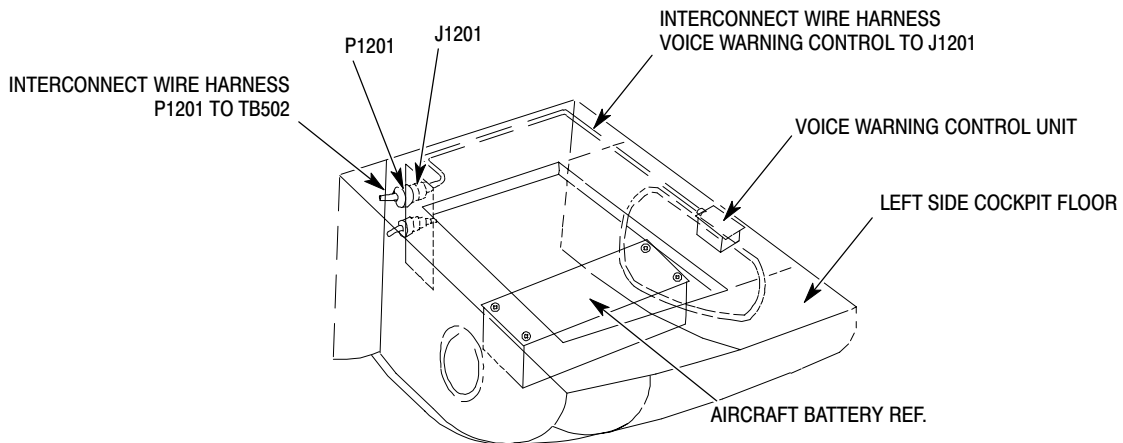
**Figure 1. Component Locations**

**Part 1** - Replacement of the Voice Warning LRU P/N 600N4514-3 with P/N 600N4514-5 or P/N 600N4515-1 provides increased voice warning volume output and a second voice warning audio output channel. This allows the Voice Warning to interrupt the the ICS System and enunciate warning messages when necessary. Failure to comply with Part 1 may result in insufficient voice warning volume during high noise operations e.g. doors off.

- (1). Disconnect P19 from voice warning control unit. Bag or cap P19 to prevent FOD.
- (2). Remove four (4) bolts and washers attaching existing voice warning LRU. Retain hardware for reinstallation of new voice warning LRU.
- (3). Install 600N4514-5 or 600N4515-1 voice warning LRU using four (4) bolts and washers. Torque bolts per the Handbook of Maintenance Instructions (CSP-HMI-2, Section 20-00-00).

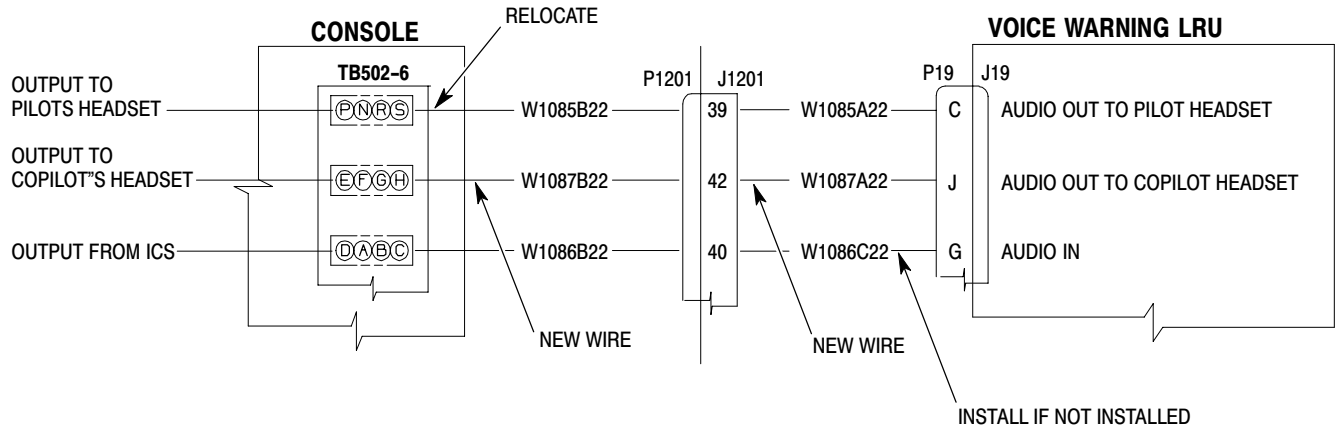
**Figure 2. Wiring Modification**

**Part 2** - Modification for routing the Intercommunications System (ICS) output through the Voice Warning LRU. This incorporates the second voice warning audio output channel provided by the 600N4514-5 or 600N4515-1 Voice Warning LRU. Failure to comply with part 2 may result in ICS communications partially obscuring the voice warning enunciations with certain stereo systems.

- (a). Visually verify if wire W1086C22 is installed from J1201-40 to P19-G. If not installed, install new wire.
- (b). Install wire W1087A22 from J1201-42 to P19-J.
- (4). Modify console wiring harness as follows:

- (a). Relocate W1085B22 from TB502-6F to TB502-6S.

- (b). Install W1087B22 from P1201 to TB502-6H.
- (5). Reconnect P19 to voice warning control unit.
- (6). Secure any opened areas.
- (7). Record compliance to this Service Bulletin in the Compliance Record section of the helicopter Log Book.
