SERVICE BULLETIN

DATE: 11 JANUARY 2000

TURBINE OUTLET TEMPERATURE (TOT) WIRE HARNESS, ONE TIME INSPECTION

600N helicopters, S/N RN003 thru RN056.

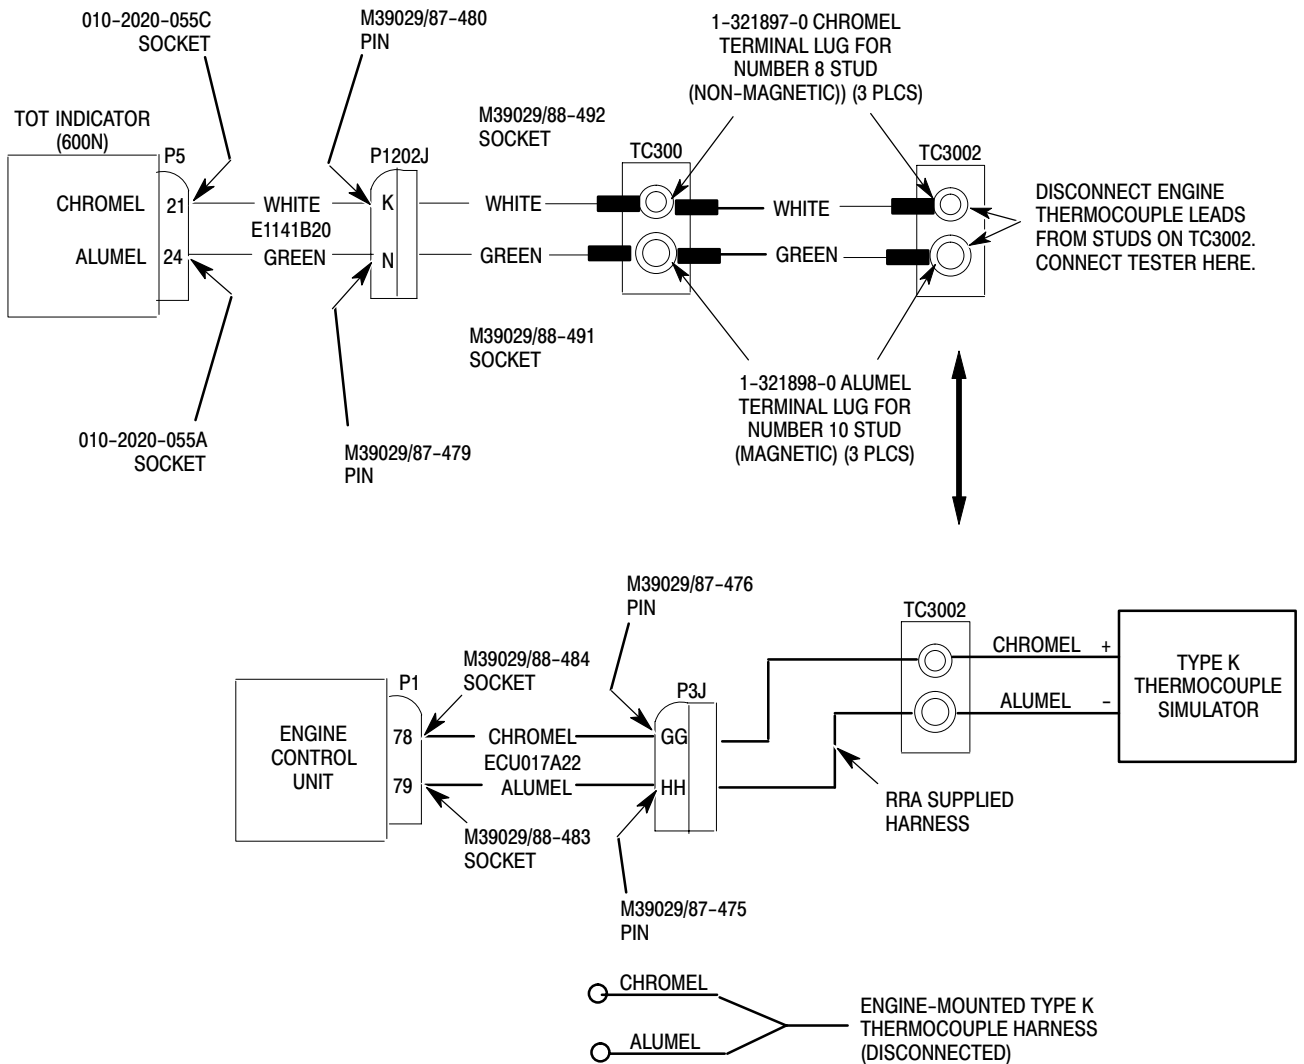
Figure 1. TOT Wire Harness Termination Verification

There have been reports from the field of erroneous turbine outlet temperature (TOT) readings on aircraft equipped with analog/digital TOT indicators. To verify TOT system calibration and prevent the possibility of erroneous TOT indications. Failure to perform the requirements of this Bulletin may result in a condition that could damage critical engine components.

Procedures in this Bulletin provide owners and operators with information pertaining to verifying the installation of proper termination hardware in the aircraft TOT wiring circuitry.

- (1). Disconnect the engine thermocouple wire harness at the TC3002 terminal block located on the aft-right face of the engine fireshield.
- (2). Connect tester (Ref. Figure 1) to TC3002.
 - (a). Connect tester wire to #8 stud on TC3002 (white chromel wire) (yellow lead for Fluke and Omega, red for Barfield).
 - (b). Connect tester wire to #10 stud on TC3002 (green alumel wire) (red lead for Fluke and Omega, black for Barfield).

- (1). Disconnect airframe thermocouple wire harness from TC3002 terminal block.
- (2). Using a magnet, verify that the terminal attached to the Chromel wire (white jacket) is not attracted to the magnet and that the terminal is silver (not gold) in color.
- (3). Using a magnet, verify that the terminal attached to the Alumel wire (green jacket) is attracted to the magnet and that the terminal is silver (not gold) in color.

- (4). If either is discrepant, replace the terminal lug(s) with the correct terminal lug(s).
- (5). Reconnect the airframe thermocouple wire harness to the TC3002 terminal block.
- (6). Disconnect airframe thermocouple wire harness from TC300 terminal block.
- (7). Using a magnet, verify that the terminal attached to the Chromel wire (white jacket) is not attracted to the magnet and that the terminal is silver (not gold) in color.
- (8). Using a magnet, verify that the terminal attached to the Alumel wire (green jacket) is attracted to the magnet and that the terminal is silver (not gold) in color.
- (9). If either is discrepant, replace the terminal lug(s) with the correct terminal lug(s).
