# SERVICE BULLETIN

## TAIL ROTOR FORK INSPECTION, FOUR-BLADED

All MD Helicopters, Inc. (MDHI) MD369D and MD369E Series helicopters equipped with four-bladed tail rotor assemblies.

Tail Rotor Fork Assembly, Four-Bladed, P/N 369D21701-21, with the two ridges on each of the long fork arms machined off.

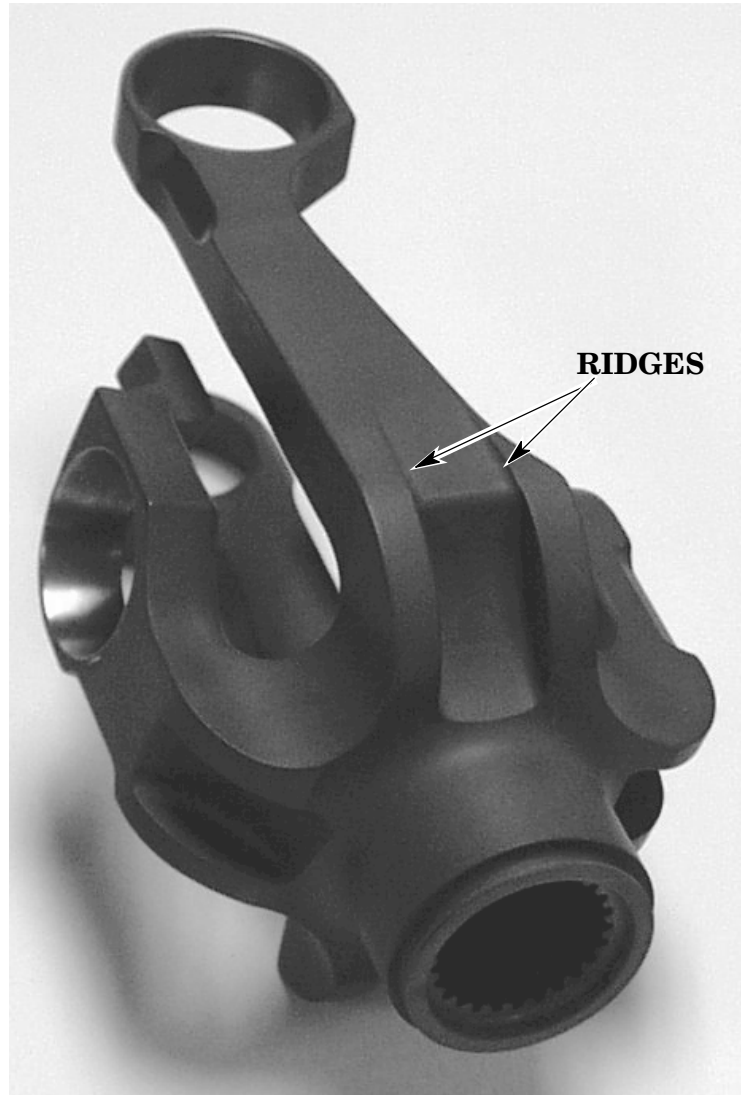
**Figure 1. Fork Assembly with ridges (Sheet 1 of 2).**

- (1). Inspect tail rotor fork assembly for ridges on the two long arms which support the outboard tail rotor hub.
- (2). Parts with ridges are acceptable and do not require any further inspection.

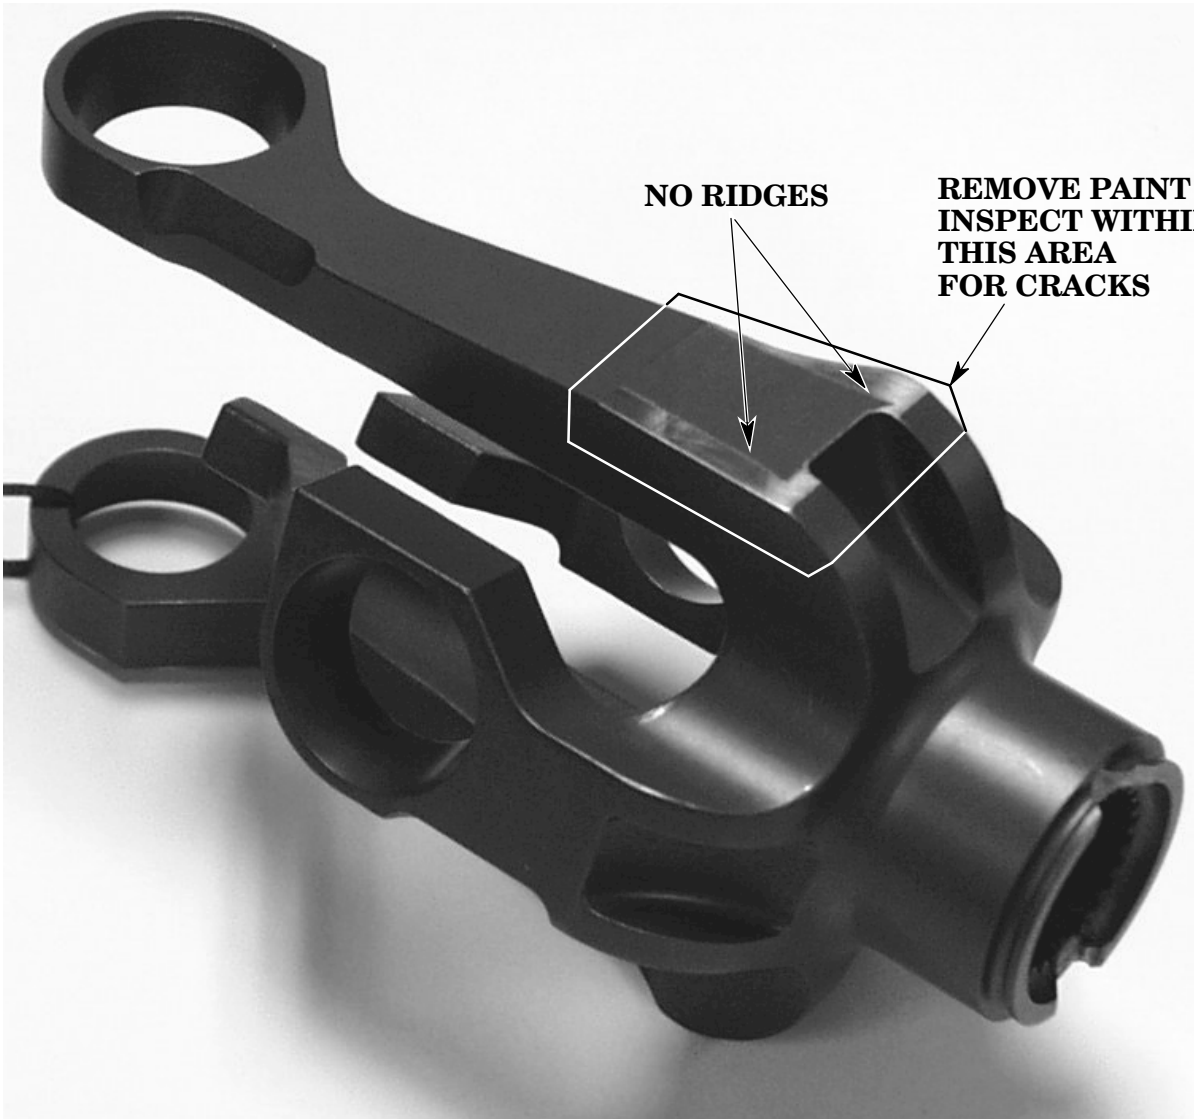
**Figure 1. Fork Assembly without ridges (Sheet 2 of 2).**

MDHI has discovered that a number of P/N 369D21701-21 tail rotor forks may develop cracks during normal service. Failure to perform the requirements of this Bulletin may result in loss of the tail rotor and directional control of the helicopter.

- (3). Parts without ridges must perform the following inspection:

- (a). Chemically remove paint from machined area. Do not use any abrasive materials.
- (b). Perform a dye penetrant inspection in accordance with MIL-I-25135 in area of paint removal. Fork assemblies that show any indications of cracking must be replaced.
- (c). Using a 10X magnifying glass inspect for cracks in area of paint removal. Fork assemblies that show any indications of cracking must be replaced.
- (d). Repeat step (3).(c). at each subsequent 50 hours of helicopter operation until fork assembly has been replaced with an acceptable fork assembly.
