# SERVICE BULLETIN

DATE: 25 SEPTEMBER 1998  
PAGE 1 OF 6

\* Supercedes Service Bulletins SB369E-090, SB369F-077, SB500N-017 and SB600N-014, dated 06 July 1998. The reason for this revision is to clarify locations of various electrical components.

## SOCKET CONTACT ASSEMBLY INSPECTION

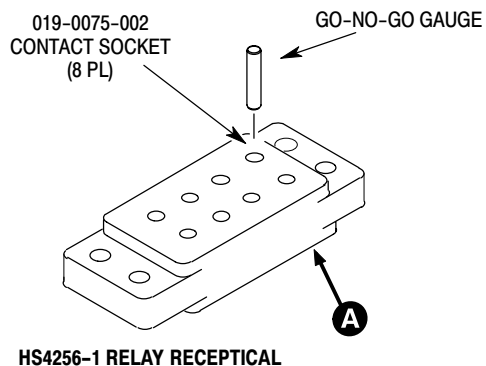
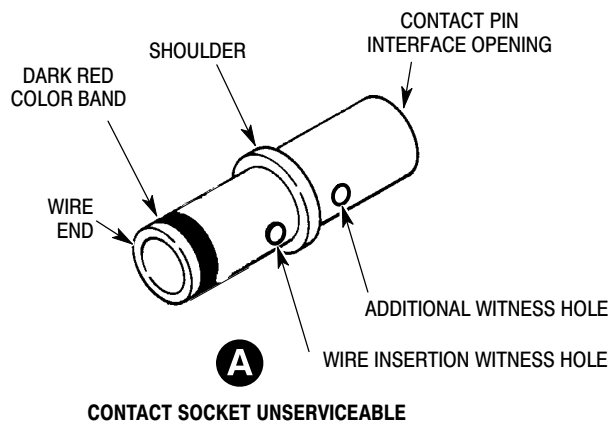
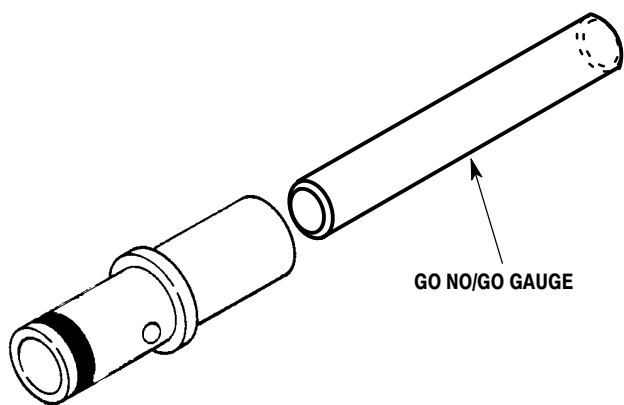
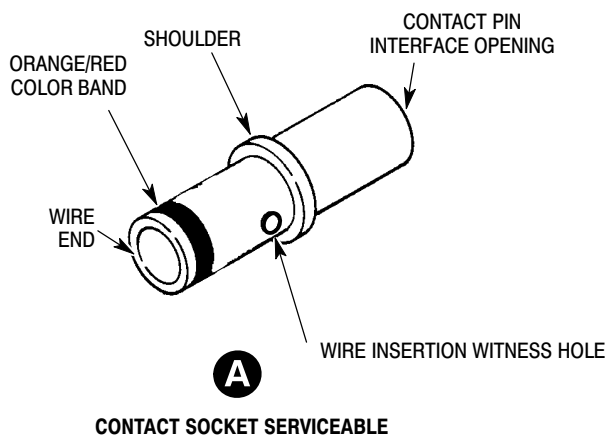
**Figure 1. Contact Socket Inspection**

- The sockets that do not fit the pins have a larger opening, which is evident when viewed with the naked eye and are very loose when inserted on the relay pin.
- Discrepant sockets have two witness holes, one in the wire crimp area and another in the relay pin contact area. The correct sockets have one witness hole in the crimp area and no witness hole in the relay pin contact area.
- The color of the red paint on the discrepant socket band is dark red. The color of the paint on the correct socket is red/orange.

- (3). Insert the GO NO/GO gauge into every socket of relay receptacle. If gauge goes into socket, the socket is to be replaced.
- (4). Reinstall relay into socket (Ref. CSP-HMI-3).
- (5). Reinstall any panels removed for access.
- (6). Record compliance with this Bulletin in the Rotorcraft Logbook.

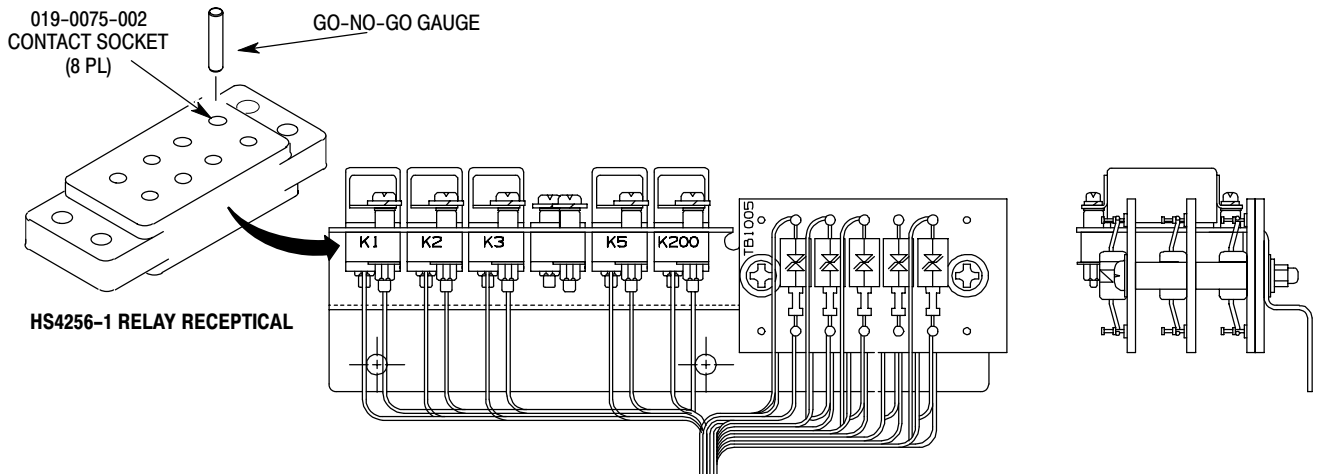
369D24255-501 TERMINAL BOARD, RELAY, ASSY

1. INSPECT CONTACT SOCKETS ON THE K1 FADEC START RELAY, K2 ECU FAIL RELAY, K3 ENGINE OUT RELAY, K5 MANUAL MODE RELAY AND K200 BATTERY HI-TEMP RELAY.
2. THERE IS NO K104 RELAY ON THE MD600N.

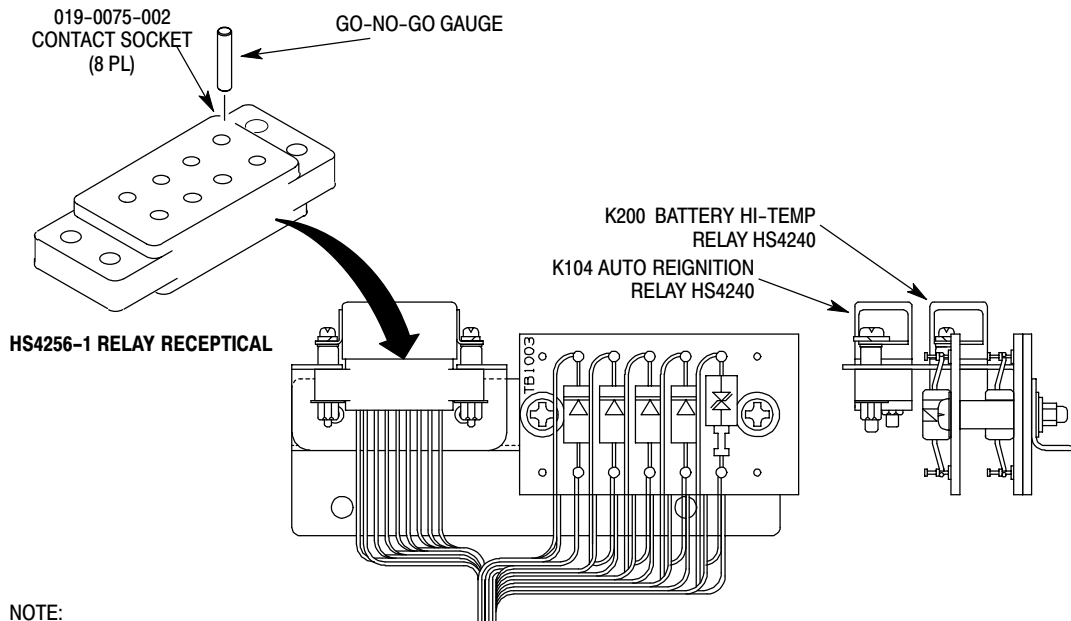
TERMINAL BOARD AND RELAY ASSEMBLY  
EFFECTIVE: 500N/369E - 384 & SUBS/369FF - 76 & SUBS

1. INSPECT CONTACT SOCKETS ON THE K104 AUTO IGNITION RELAY AND K200 BATTERY HI-TEMP RELAY
