SERVICE BULLETIN

FORWARD AND CENTER THRUSTER CONTROL CABLES, CONDUIT CAP RELIEF AREA, INSPECTION

* Supersedes SB500N-020R1, SB600N-027R1 dated 24 November 1999.
Revision 2 corrects typographical errors Aircraft which have complied with SB500N-020R1, SB600N-027R1 meet the intent of this revision.

DATE: 24 APRIL 2000

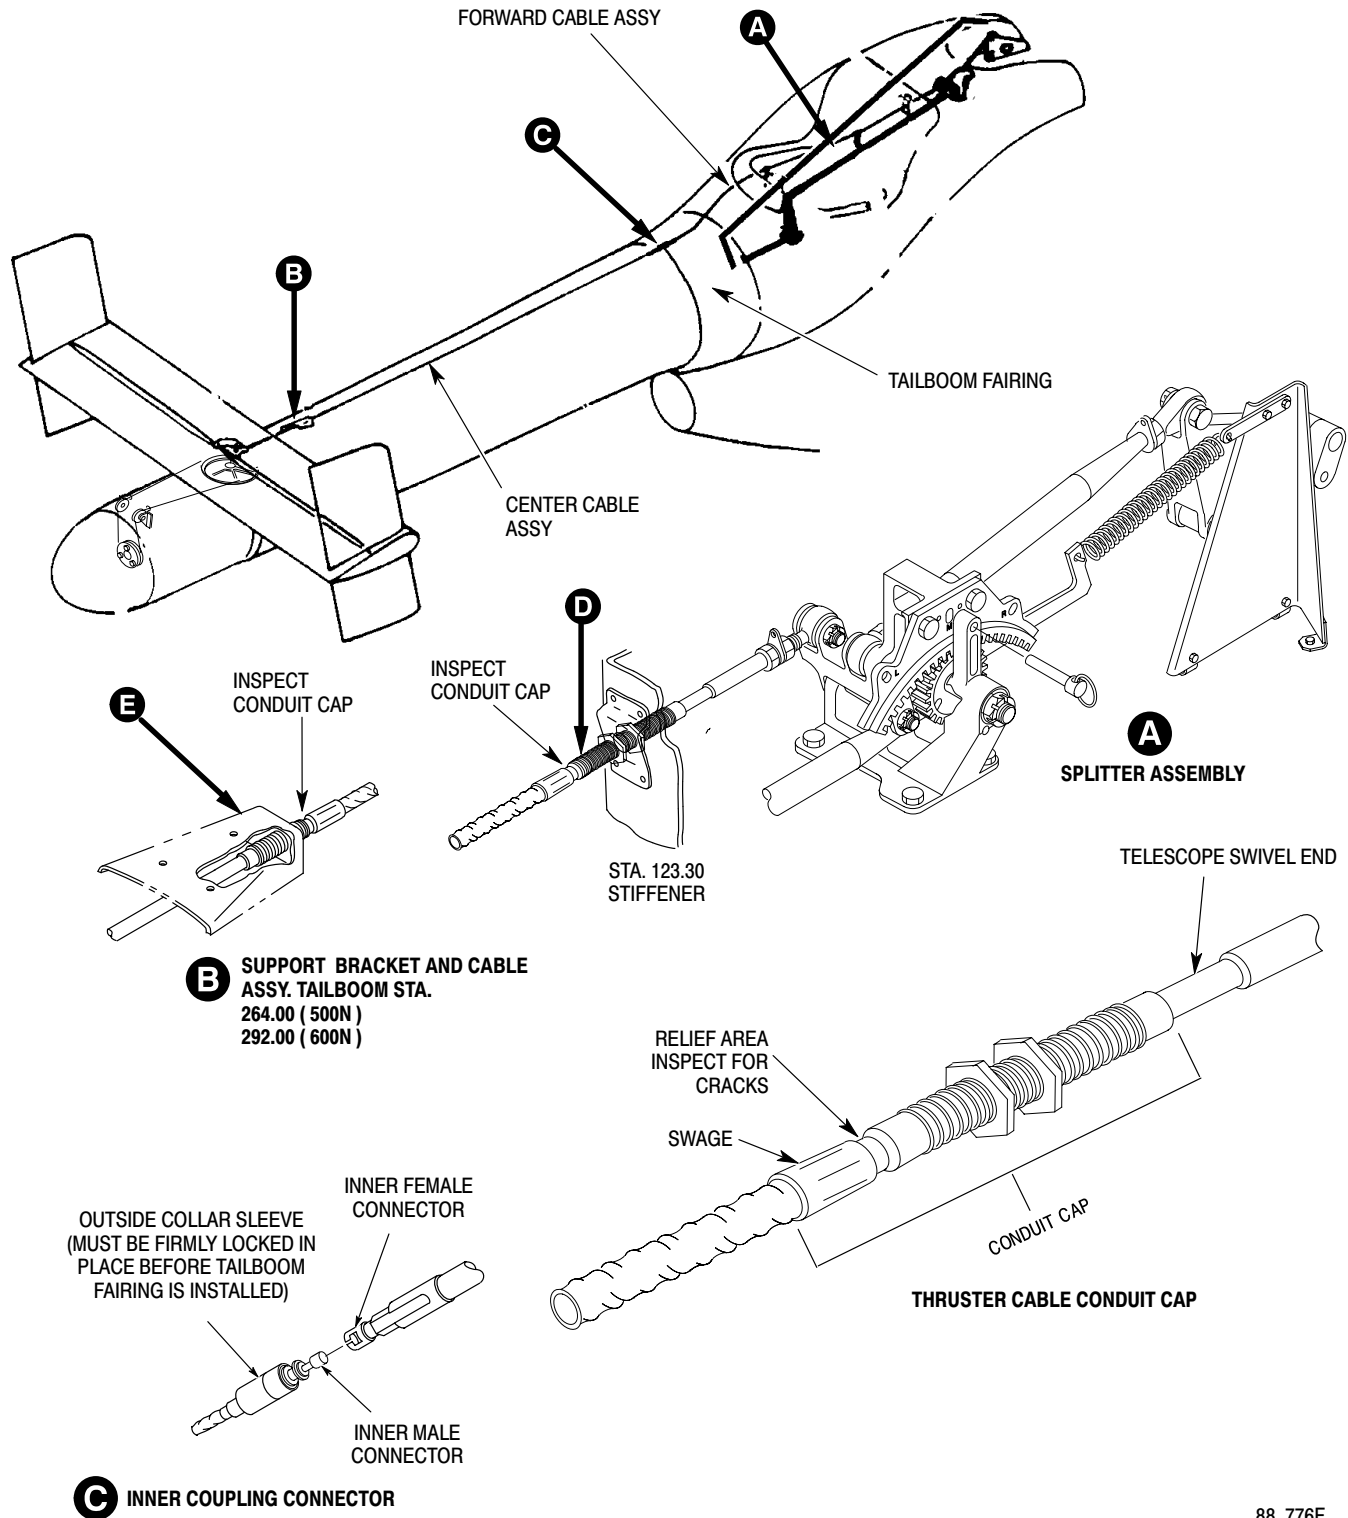
Figure 1. Forward and Center Cable Relief Area Inspection (Sheet 1 of 2)

Operators have experienced stress corrosion cracks in the relieved area of the thruster control cable conduit cap. Cracks have been found between the swage and threads of both the forward cable at Sta. 123.30 (500N/600N) and the center thruster cable at Sta. 264.00 (500N) or Sta. 292.00 (600N).

- (1). 600N - Remove the engine air particle separator.
500N - Open the engine air particle separator bypass door.
- (2). Locate forward thruster cable on left side of plenum area.
- (3). Using a bright light, locate thruster control cable on left side of plenum area. Inspect relief area of cable conduit cap, just aft of mount bracket, between threads and swage for cracks or evidence of corrosion.

- (4). If corrosion is found, clean corrosion area and inspect relieved area for crack.
- (5). Damage criteria requiring cable removal:
 - (a). Cable conduit cap which has separated at the relief area is not allowed.
 - (b). Any total crack length that exceeds more than 180 degrees around the conduit cap is not allowed.
- (6). If separation or an unacceptable crack is found, remove the cable and mark as scrap for return to MDHI. Replace with a serviceable cable which has been inspected per the requirements of this Bulletin.
- (7). Install two secondary safety clamps (AN742D6) as follows:
(Ref. Figure 1, View D and F)

- (1). Remove stationary and rotating thruster cones (Ref. CSP-HMI-2).
- (2). Using a bright light and a mirror, locate thruster control cable inside tailboom. Inspect conduit cap relief area, just forward of mount bracket, between threads and swage for evidence of corrosion.

- (3). If corrosion is found, clean corrosion area and inspect conduit cap relief area for cracks.
- (4). Damage criteria requiring cable removal:
 - (a). Cable conduit cap which has separated at the relief area is not allowed.
 - (b). Any total crack length that exceeds more than 180 degrees around the conduit cap is not allowed.

If the cable conduit cap has separated at the relief area, cable must be removed from service and a serviceable cable installed ***before further flight***.

- (5). If separation or an unacceptable crack is found, remove the cable and mark as scrap for return to MDHI. Replace with a serviceable cable which has been inspected per the requirements of this Bulletin.
- (6). Install two clamps (AN742D6) as follows:
(Ref. Figure 1, View E and F)
