SERVICE BULLETIN

DATE: 19 NOVEMBER 1999

FORWARD AND CENTER THRUSTER CONTROL CABLES, CONDUIT CAP AT TELESCOPIC SWIVEL END, INSPECTION

500N helicopters, LN001 thru LN099 and 600N helicopters, RN003 thru RN074.

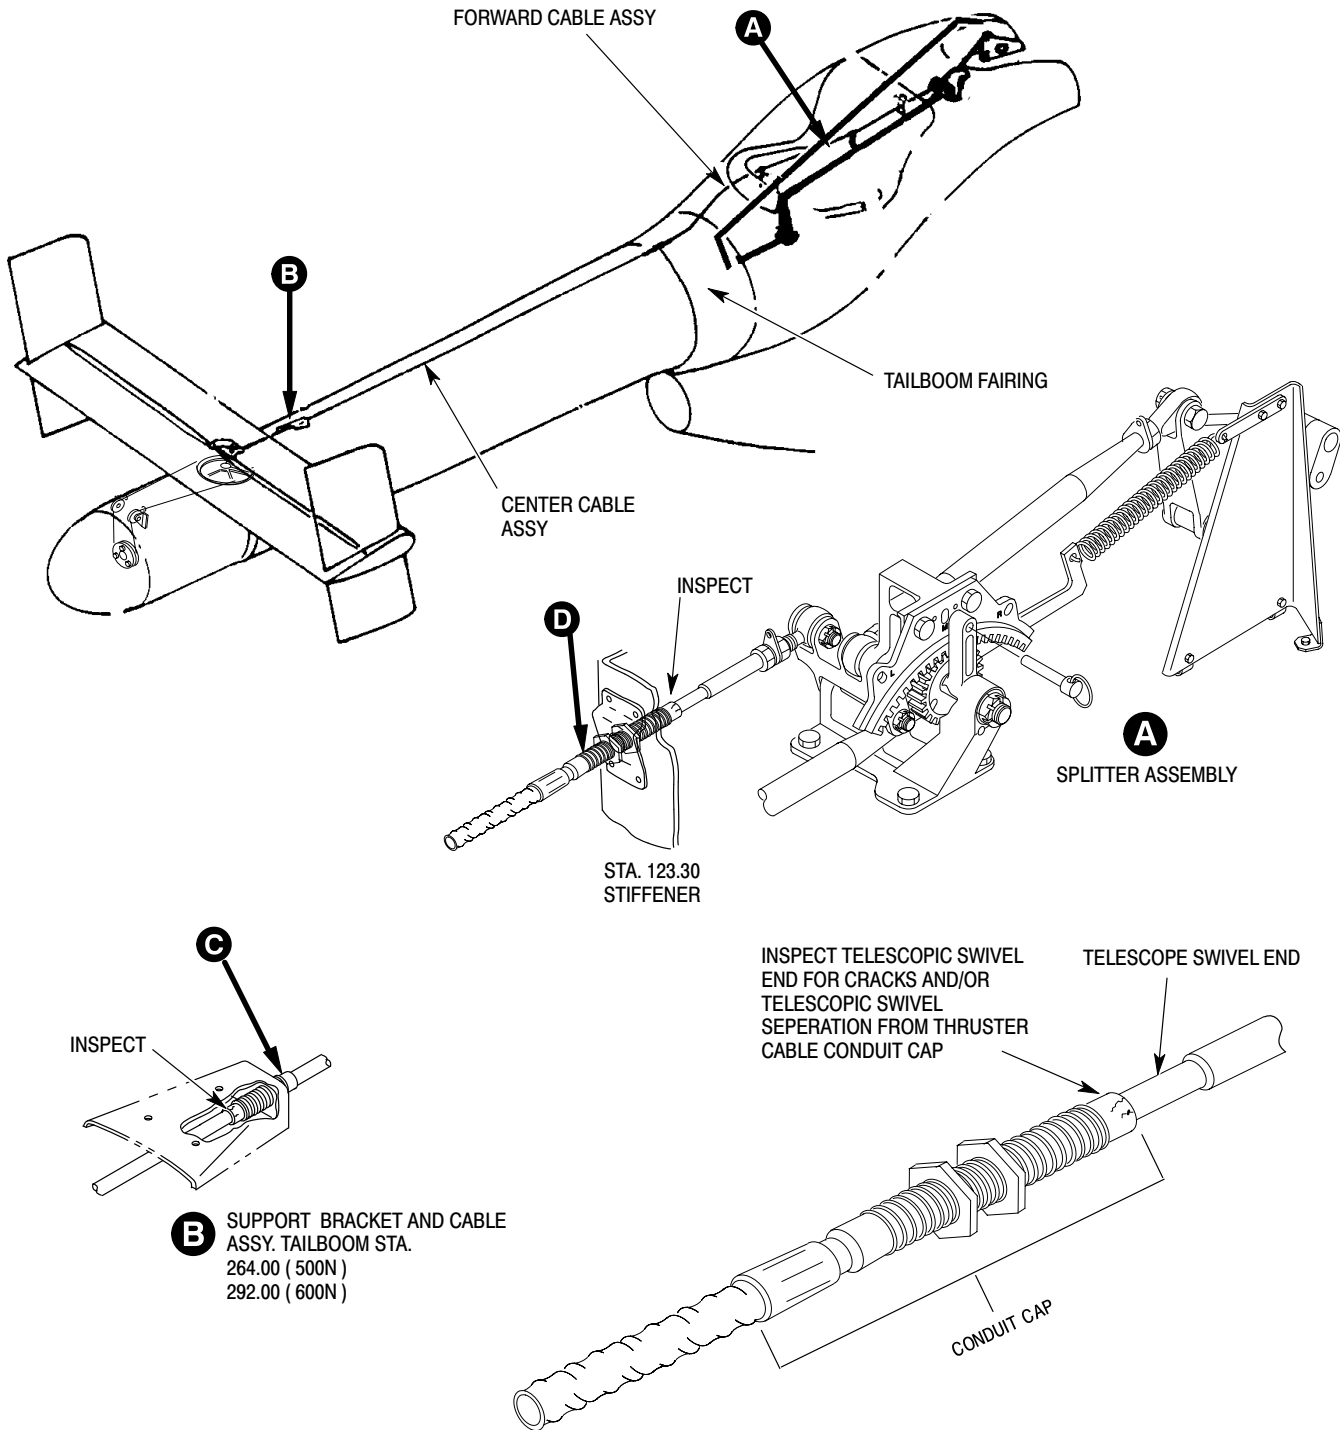
Figure 1. Forward and Center Cable Relief Area Inspection (Sheet 1 of 2)

Stress corrosion cracks have been discovered in the thruster control cable conduit cap at the telescopic swivel ends. Cracks have been found on the conduit cap of both the forward cable at Sta. 123.30 (500N/600N) and the center thruster cable at Sta. 264.00 (500N) or Sta. 292.00 (600N).

- (1). Remove left side engine inlet fairing to access splitter assembly area.
- (2). Locate forward thruster cable on left side of plenum area.
- (3). Inspect for any evidence of swivel ball separation from conduit cap.

- (4). Using a bright light and 10x magnifying glass, inspect the general area of the conduit cap and at the telescopic swivel end for cracks, corrosion and obvious damage.
- (5). Damage criteria requiring cable removal:
 - (a). Any missing piece in the end of the conduit cap at the telescopic end is not allowed.
 - (b). Any one crack larger than 0.15 inch is not allowed.
 - (c). The total length of all cracks can not exceed a combined total of 0.30 inch.

- (1). Remove stationary and rotating thruster cones (Ref. CSP-HMI-2).
- (2). Inspect for any evidence of swivel ball separation from conduit cap.
- (3). Using a bright light and 10x magnifying glass, inspect the general area of the conduit cap and at the telescopic swivel end for cracks, corrosion and obvious damage.

- (4). Damage criteria requiring cable removal:
 - (a). Any missing piece in the end of the conduit cap at the telescopic end is not allowed.
 - (b). Any one crack larger than 0.15 inch is not allowed.

- (c). The total length of all cracks can not exceed a combined total of 0.30 inch.
- (5). If an unacceptable crack is found, remove the cable and mark as scrap for return to MDHI. Replace with a serviceable cable which has been inspected per the requirements of this Bulletin.

- (6). If an unacceptable crack is found, remove the cable and mark as scrap for return to MDHI. Replace with a serviceable cable which has been inspected per the requirements of this Bulletin.
- (7). Install a secondary safety using 0.032 inch stainless steel safety wire as follows:
 - (a). Safety wire starts at the top of the jamnut, goes to the end of the conduit cap, is tightly wrapped around the shaft in front of the swivel ball joint a minimum of 3 times and a maximum of 5, and returns to the bottom side of the jamnut (Ref. Figure 1, Sheet 2)
- (8). Reinstall left side engine inlet fairing.
