SERVICE BULLETIN

DATE: 23 OCTOBER 2001

FAN PITCH CONTROL AFT TUBE ASSEMBLY ONE TIME INSPECTION

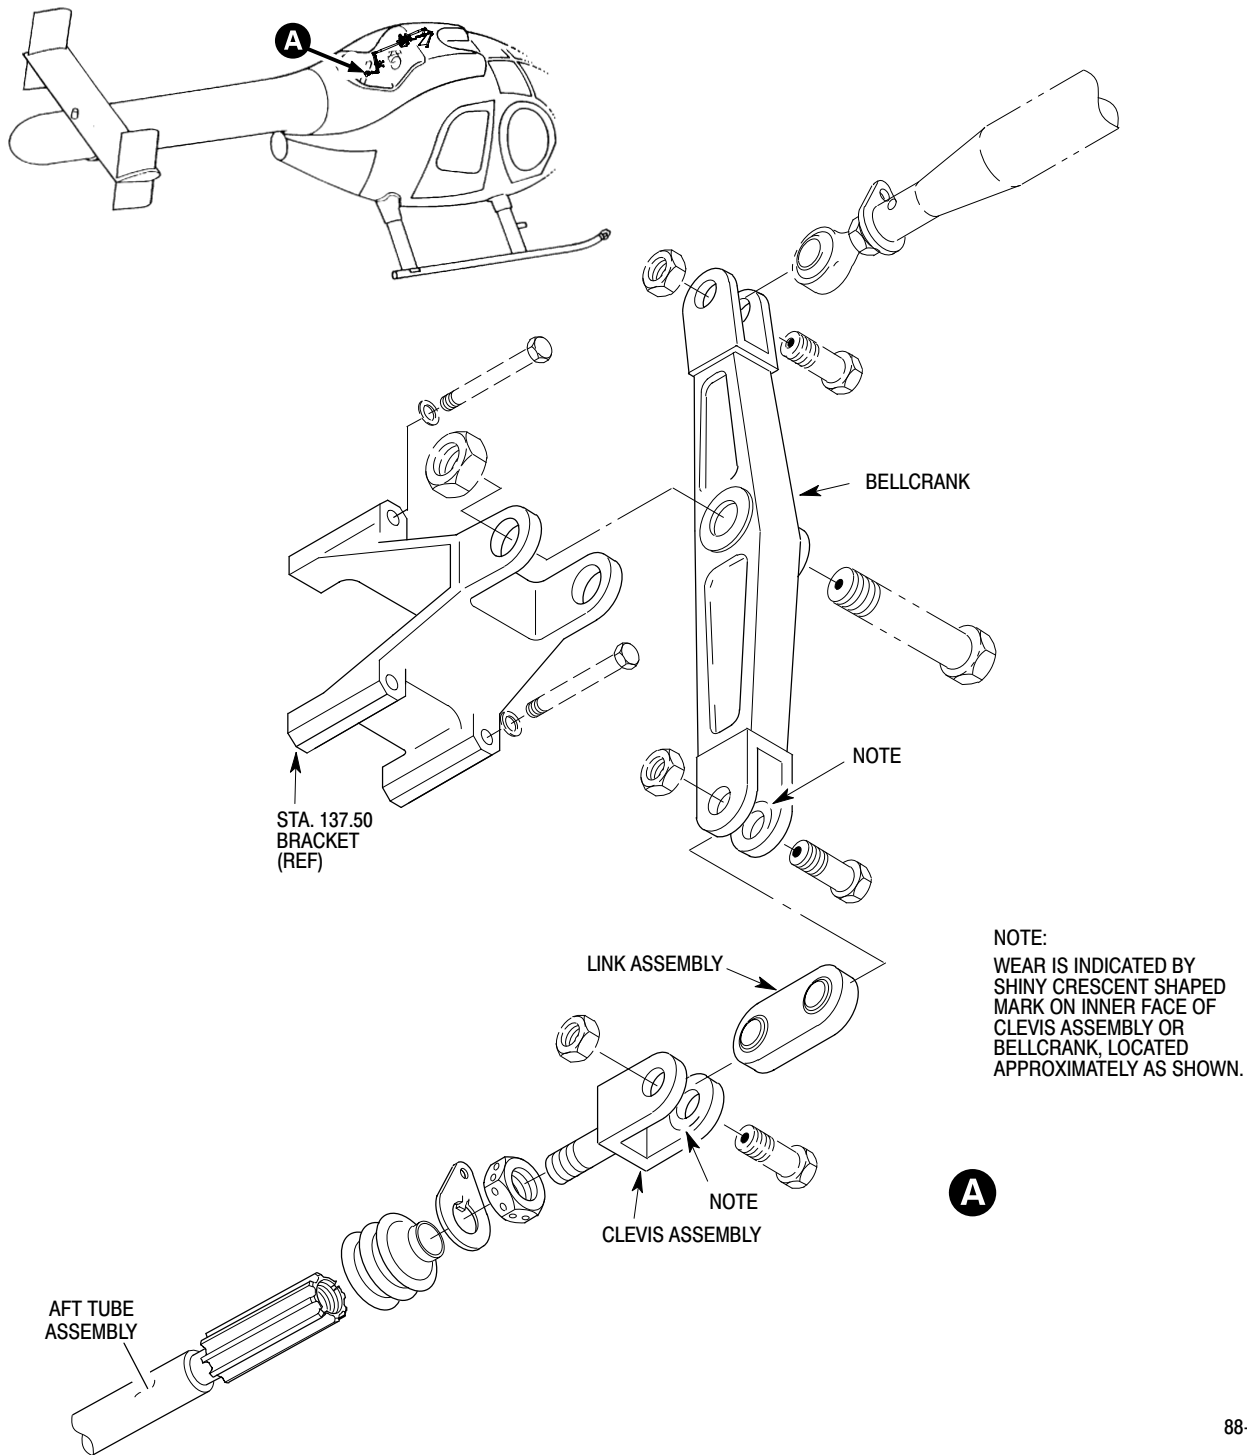
Figure 1. Fan Pitch Control Linkage

- (2). Inspect link assembly for contact with clevis assembly and bellcrank.
- (3). Inspect inside of clevis assembly and bellcrank for wear, indicated by shiny crescent shaped area near link assembly.

- (4). If link assembly is contacting either clevis assembly or bellcrank, replace aft tube assembly (Ref. CSP-HMI-2, Section 67-20-30, Fan Pitch Control Tube Replacement). Return removed aft tube assembly to MDHI.
- (5). If wear is observed on clevis assembly or bellcrank, replace aft tube assembly, clevis assembly and bellcrank (Ref. CSP-HMI-2, Section 67-20-30, Fan Pitch Control Tube Replacement and Station 135.50 Support Bracket and Bellcrank Replacement). Return removed aft tube assembly, clevis assembly and bellcrank to MDHI.
- (6). Install engine inlet screen (Ref. CSP-HMI-2, Section 71-10-00, Engine Air Inlet Screen Installation (600N) or install particle separator Ref. CSP-HMI-2, Section 71-10-60, Particle Separator Installation).

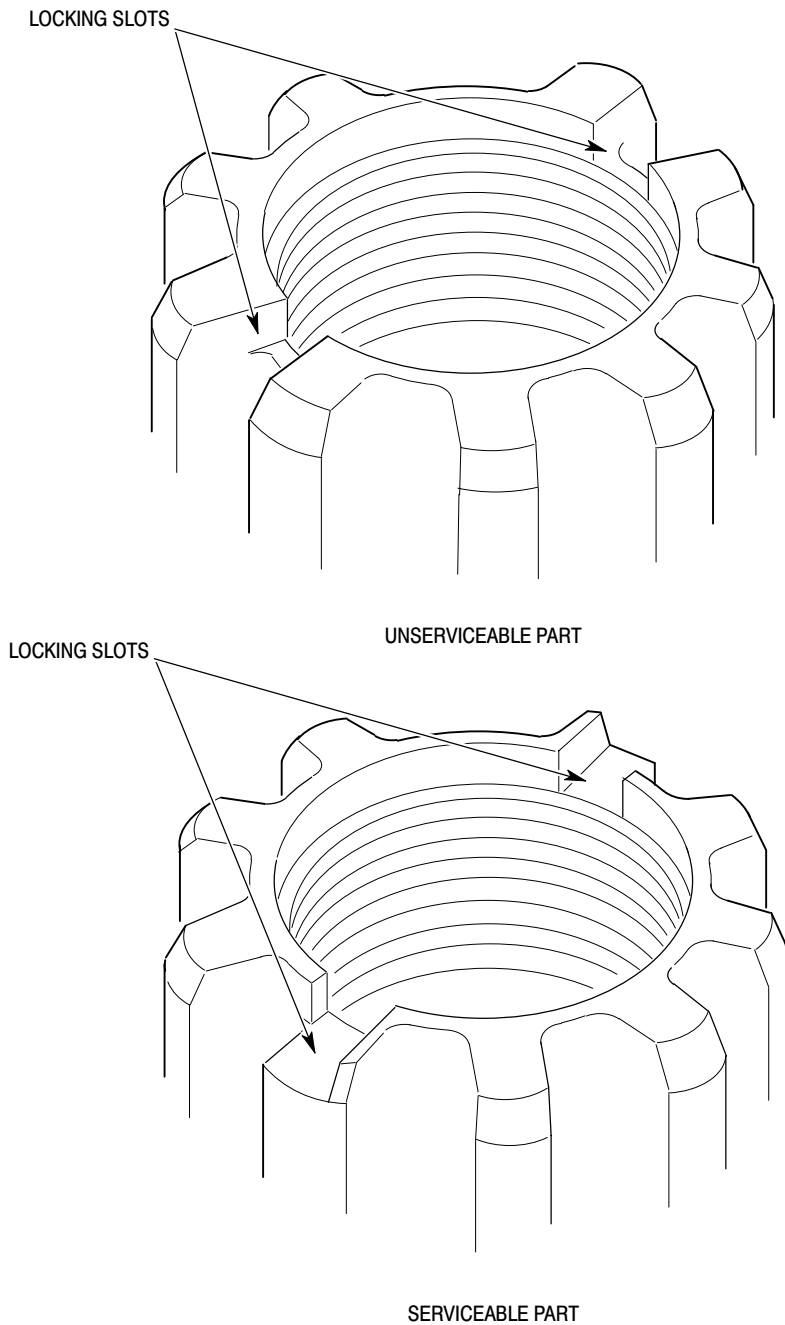
Figure 2. Splined End of Aft Tube Assembly

- (1). Inspect splined end of all aft tube assemblies in spares inventory that are marked "Jaco, 1/99".
 - (Ref. Figure 2)
 - (a). An unserviceable part is identified by the locating slot cut between the splines, as shown.
 - (b). A serviceable part is identified by the locating slot cut into part of the spline, as shown.
 - (2). Return unserviceable parts to MDHI.
