# TECHNICAL BULLETIN

## REPLACEMENT OF PLENUM WALL FITTINGS – TORQUE PRESSURE GAGE TUBING AND ENGINE OIL PRESSURE GAGE TUBING

500D Model 369D Helicopter Serial No. 0003D thru 0232D

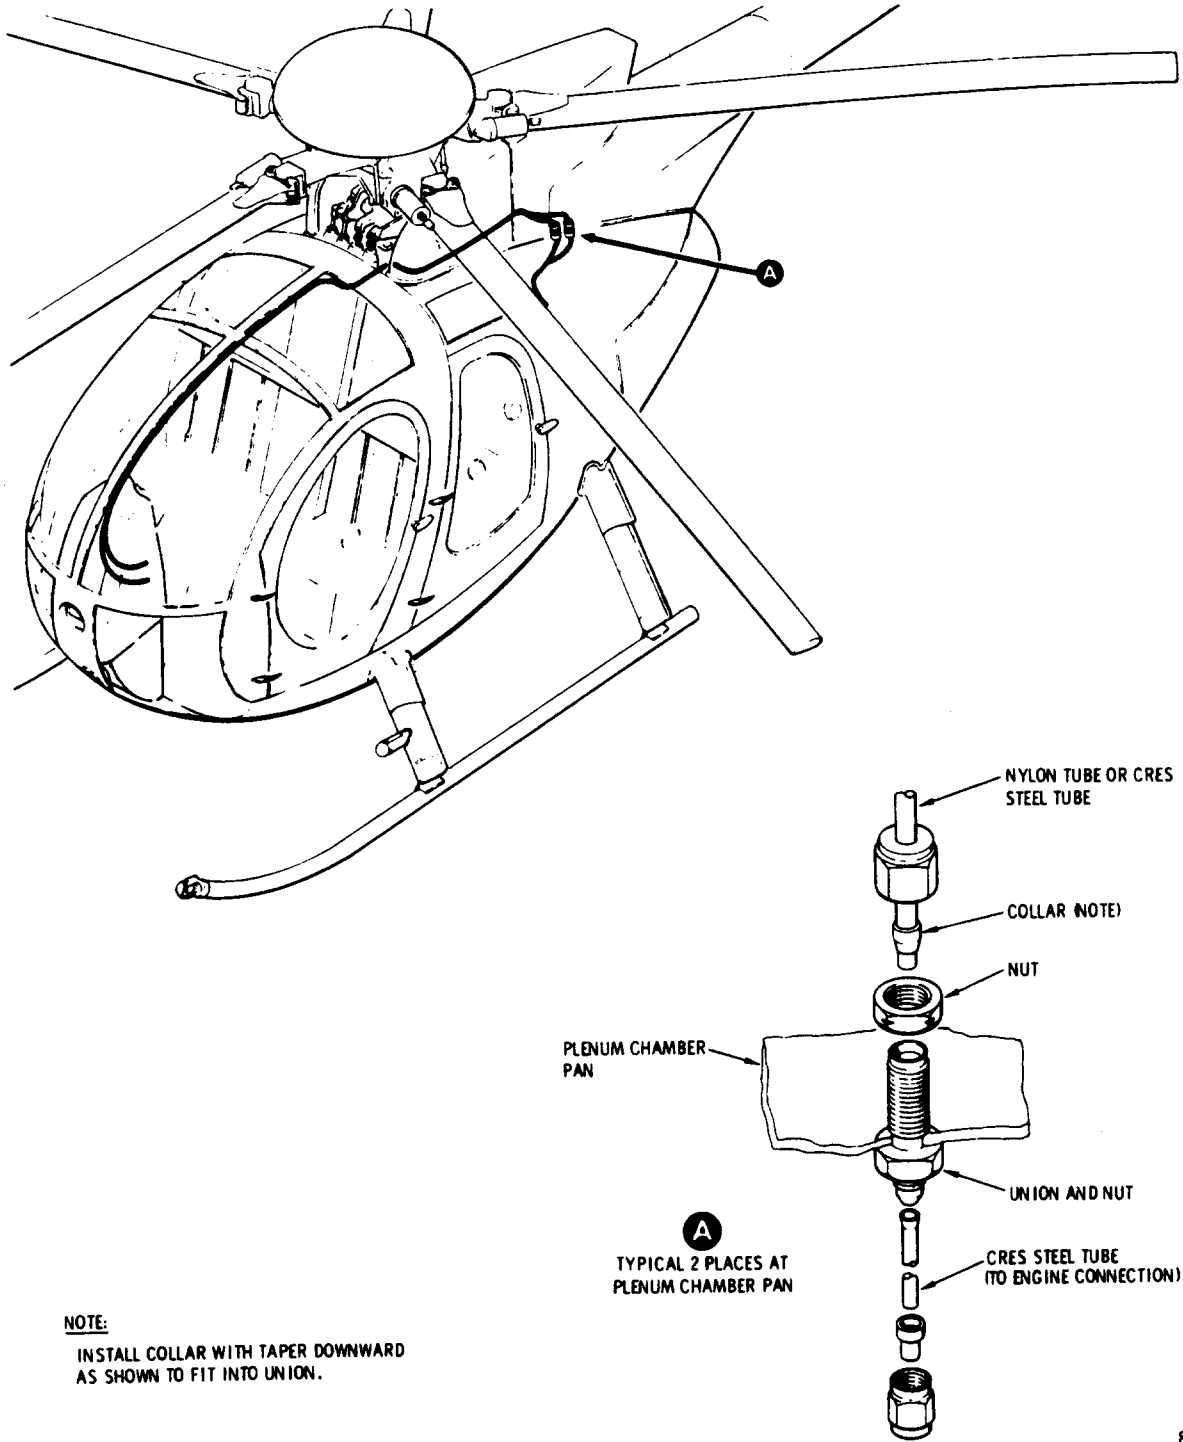
**Figure 1. Replacement of Plenum Wall Fittings - Torque Pressure Gage Tubing and Engine Oil Pressure Gage Tubing**

Field reports indicate that breakage and damage to the reducer installed on the plenum chamber pan firing has occurred during normal service or removal and installation of the engine oil pressure line. Installation of new type fittings is recommended for both the torque pressure gage and the engine oil pressure gage lines, to facilitate removal and installation of the tube assemblies and preclude possible breakage or failure of the fittings.

- (5). Remove existing fittings (reducers and unions) from plenum chamber pan.
- (6). Install new ASI 2-3XH2BZ-SS-T fittings at plenum chamber pan, as shown in Figure 1.
