DN-43

TECHNICAL BULLETIN

SUBJECT: FIELD REPAIR - TRIM TAB, MAIN ROTOR BLADE, PN 369D21100 SERIES

MODELS AFFECTED: All 500D Model 369D Series Helicopters equipped with subject Main Rotor Blades

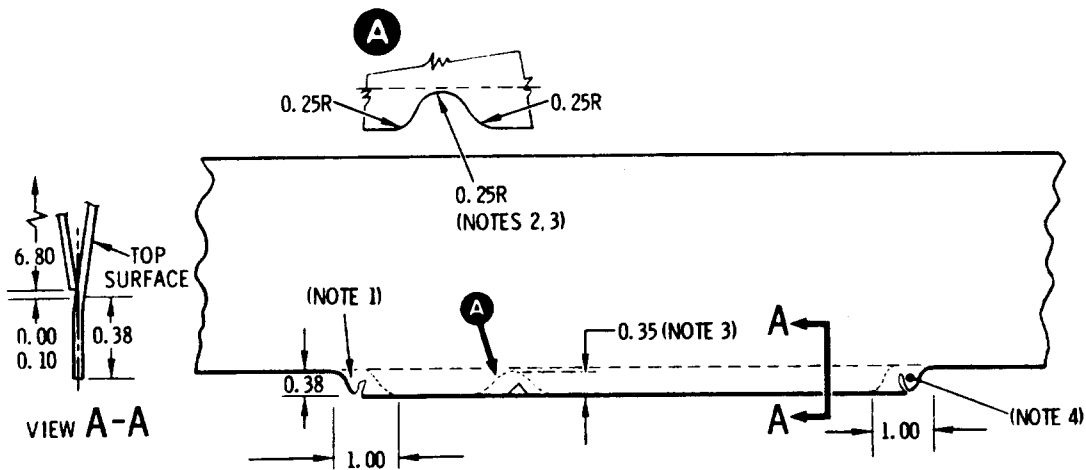
Figure 1. Repair and Removal of Trim Tab, Main Rotor Blade

It is to be noted that instructions in the Basic HMI specify that the blade must be rejected, if specified damage limitations for the tab area are exceeded. In the interest of safety and economy, the procedures given in this Notice provide a broader cleanup of the damaged trim tab area, which distributes stresses over a larger area to preclude cracking and permit continued use of the blade.

- e. Remove damaged area of trim tab by making V-type cut with 45° sides joined by a 0.25-inch radius at the bottom of the V, as shown in Figure I. Blend into trailing edge of the blade with a 0.25-inch radius as shown. Maximum V-cut depth is 0.35-inch; do not cut past trim tab area into main portion of blade.

- f. If damage occurs within 1 inch of either or both ends of trim tab, remove tab end(s) and restore contour as shown.
- g. If excessive damage requires full or partial removal of trim tab from blade, perform the following (no minimum length of trim tab is required):

- 2. Use metal cutting saw or equivalent to remove the 0.38-inch wide trim tab per dimensions shown in Figure 1, View A-A. Deburr edges in a SPANWISE direction only.
- h. Peel and remove tape from blade and inspect area around repair; clean repaired area with cloth dampened in solvent (aliphatic naphtha).
- i. Apply chemical film treatment (Iridite) to reworked area of blade trailing edge or trim tab; apply a thin film of primer and paint lightly.
- j. As applicable, reinstall main rotor blades, per Basic HMI - Vol I.

1. REMOVE DAMAGED END(S) IF THEY OCCUR WITHIN 1 INCH OF TAB ENDS.
2. 0.25 RADIUS CLEANUP. FINISH PER BASIC HMI.
3. MAXIMUM DEPTH OF REPAIR 0.35.
4. NO MINIMUM LENGTH OF TAB REQUIRED. IF DAMAGE OCCURS AT BOTH ENDS, IT IS PERMISSIBLE TO REMOVE AT BOTH ENDS.
5. ENTIRE TAB MAY BE REMOVED IF REQUIRED.
