# TECHNICAL BULLETIN

## FIELD FIX FOR MAIN ROTOR SWASHPLATE UNIBALL

All 500 Model 369H Series Helicopters

### 2. REWORK - MAIN ROTOR SWASHPLATE BEARING, PN 369A7003

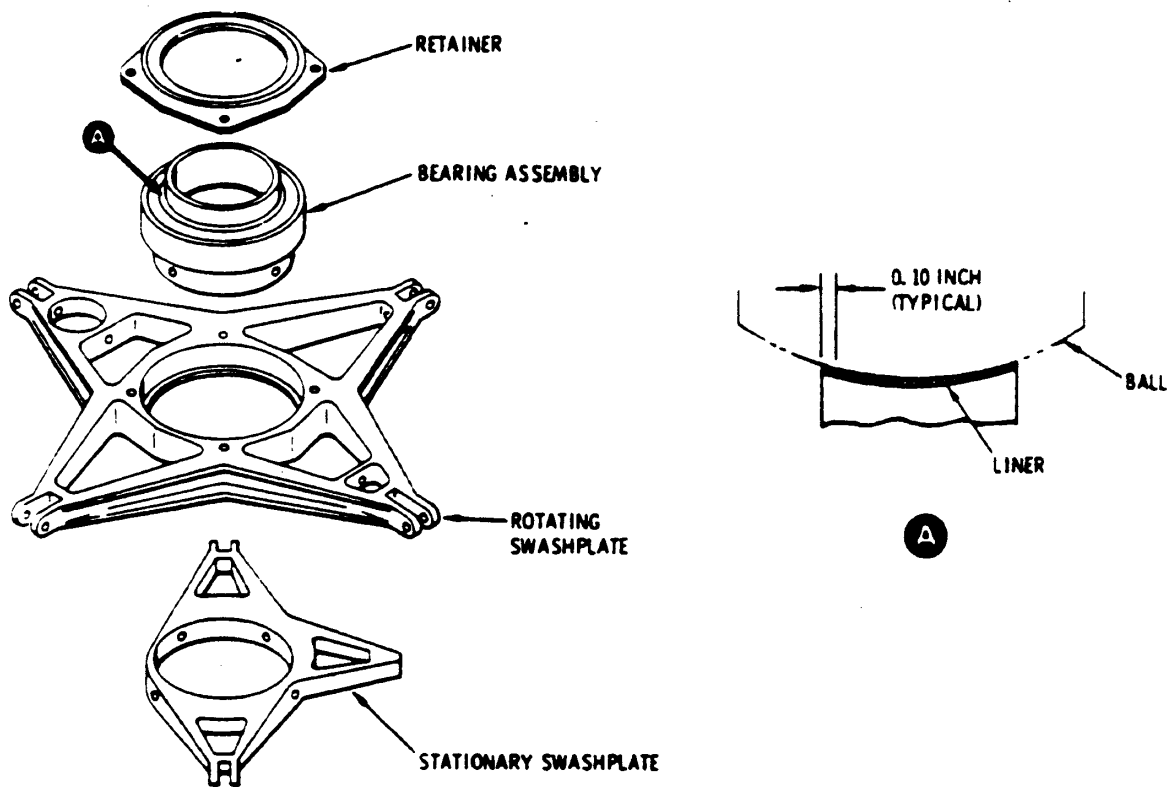
**Figure 1. Field Rework of Main Rotor Swashplate Bearing, PN 369A7003**

Field reports indicate that there have been isolated instances of pilots experiencing stiff main rotor controls caused by an excessive preload torque on the main rotor swashplate (Uniball) bearings. The high loading or "stiff ball" condition resulted from swelling of the bearing liner, particularly with bearings operating in a hot and extremely humid climate.

- (1). Remove and inspect main rotor swashplate assembly, per Basic HMI; do not disassemble swashplate assembly.
- (2). Place swashplate assembly in oven at temperature of 225° ±10° F for minimum of five hours. -Do not exceed oven temperature of 240° F.
- (3). Cool swashplate assembly to room temperature (approximately 70' F).
- (4). Using #400 wet and dry abrasive paper, sand both edges of bearing liner, as shown in Figure 1.

- (5). Clean entire liner with isopropyl alcohol after rework.
- (6). Reinstall main rotor swashplate assembly, per Basic
- (7). Perform operational check of main rotor controls. NOTE

**NOTE:** If stiff main rotor controls persist, replace swashplate bearing.
