TECHNICAL BULLETIN

DATE: 15 FEBRUARY 1979

FIELD REPAIR – TRIM TAB, MAIN ROTOR BLADE, PN 369A1100 SERIES

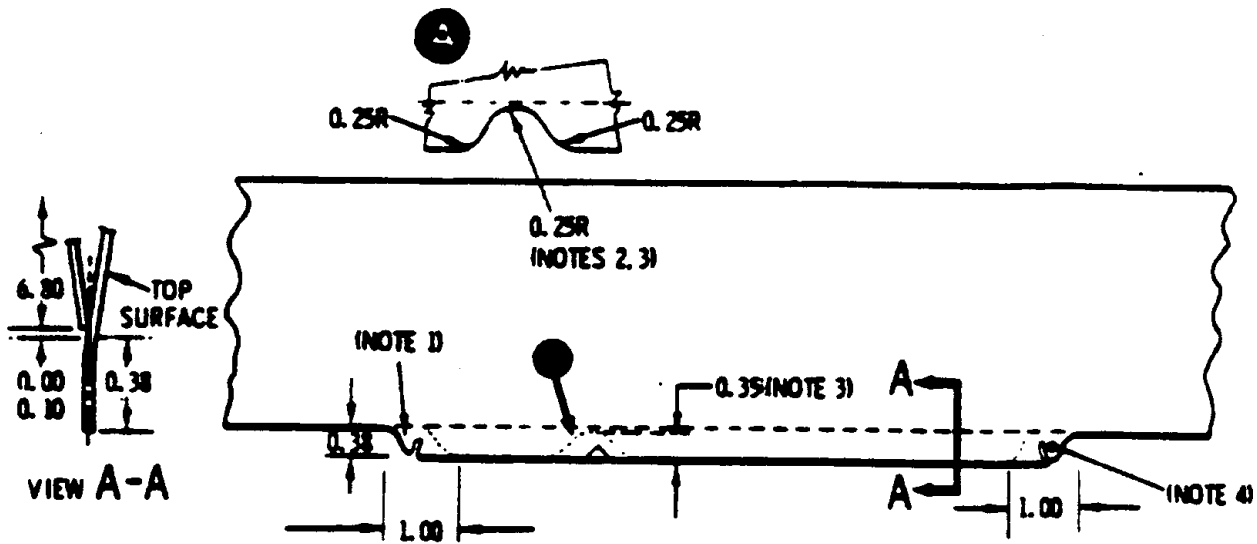
Figure 1. Repair and Removal of Trim Tab, Main Rotor Blade.

It is to be noted that instructions in the Basic HMI specify that the blade must be rejected, if specified damage limitations for the tab area are exceeded. In the interest of safety and economy, the procedures given in this Notice provide a broader cleanup of the damaged trim tab area, which distributes stresses over a larger area to preclude cracking and permit continued use of the blade.

- (3). Wipe away dirt on and around trim tab area with clean cloth dampened with dry cleaning solvent.
- (4). Mask edges of blade area around trim tab area with tape; do NOT cut tape after it has been applied to blade.
- (5). Remove damaged area of trim tab by making V-type cut with 45° sides joined by a 0.25-inch radius at the bottom of the V, as shown in Figure 1. Blend into trailing edge of the blade with a 0.25-inch radius as shown. Maximum V-cut depth is 0.35 inch; do not cut past trim tab area into main portion of blade.

- (6). If damage occurs within 1 inch of either or both ends of trim tab, remove tab end(s) and restore contour as shown.
- (7). If excessive damage requires full or partial removal of trim tab from blade, perform the following (no minimum length of trim tab is required):
 - (a). Position blade on workbench so that a firm straight edge is provided for cutting or filing off trim tab.

- Cutting, grinding or filing to remove trim tab, and deburring of reworked blade trailing edge, are to be performed in a SPANWISE direction only. Do NOT use shears or clippers to remove trim tab.
- (b). Use metal cutting saw or equivalent to remove the 0.38-inch wide trim tab per dimensions shown in Figure 1, View A-A. Deburr edges in a SPANWISE direction only.
 - (8). Peel and remove tape from blade and inspect area around repair; clean repaired area with cloth dampened in solvent (aliphatic naphtha).
 - (9). Apply chemical film treatment (Iridite) to reworked area of blade trailing edge or trim tab; apply a thin film of primer and paint lightly.
 - (10). As applicable, reinstall main rotor blades, per Basic HMI.

1. REMOVE DAMAGED END(S) IF THEY OCCUR WITHIN 1 INCH OF TAB ENDS.
2. 0.25 RADIUS CLEANUP. FINISH PER BASIC HMI.
3. MAXIMUM DEPTH OF REPAIR 0.35.
4. NO MINIMUM LENGTH OF TAB REQUIRED. IF DAMAGE OCCURS AT BOTH ENDS, IT IS PERMISSIBLE TO REMOVE AT BOTH ENDS.
5. ENTIRE TAB MAY BE REMOVED IF REQUIRED.
