TECHNICAL BULLETIN

DATE: 13 MARCH 2009

ENGINE AUTOMATIC RE-IGNITION MODIFICATION

All Model 369H/HE/HM/HS/D series helicopters with engine automatic re-ignition kit installed.

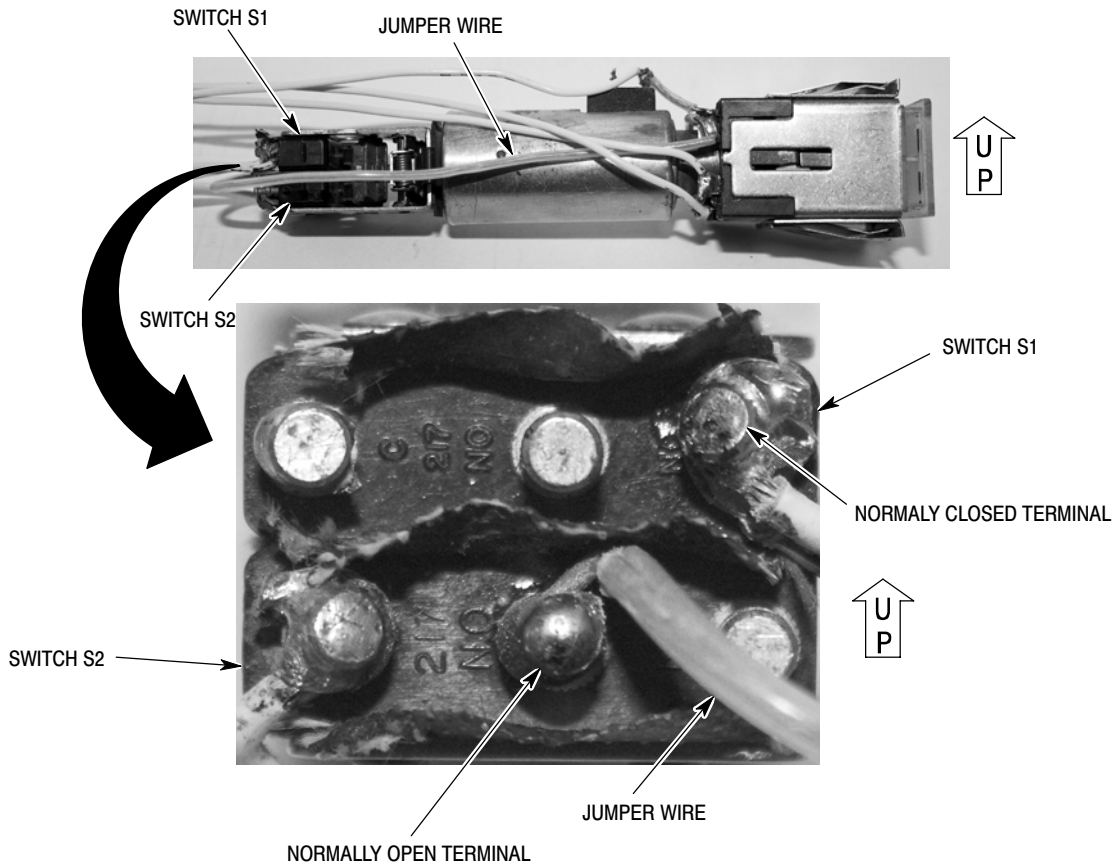
Figure 1. Engine Automatic Re-Ignition Indicator Light

To disconnect a defective switch in the XDS9 assembly from the system because replacement switches are not available. Also to change the manual reset function of the XDS9 engine automatic re-ignition (**RE-IGN**) indicator light to automatic reset after engine re-ignition.

- (1). 369H/HE/HM/HS helicopter, get access to the rear end of XDS9 light assembly (Ref. CSP-H-2 Basic Handbook of Maintenance Instructions and CSP-H-3 Optional Equipment Manual).

- (2). 369D helicopter, get access to the rear end of XDS9 light assembly (Ref. CSP-HMI-3 Handbook of Maintenance Instruction, Instruments - Electrical - Avionics).

- (8). Remove, or apply black paint to, the **PRESS TO RESET** decal on the engine automatic re-ignition switch panel.

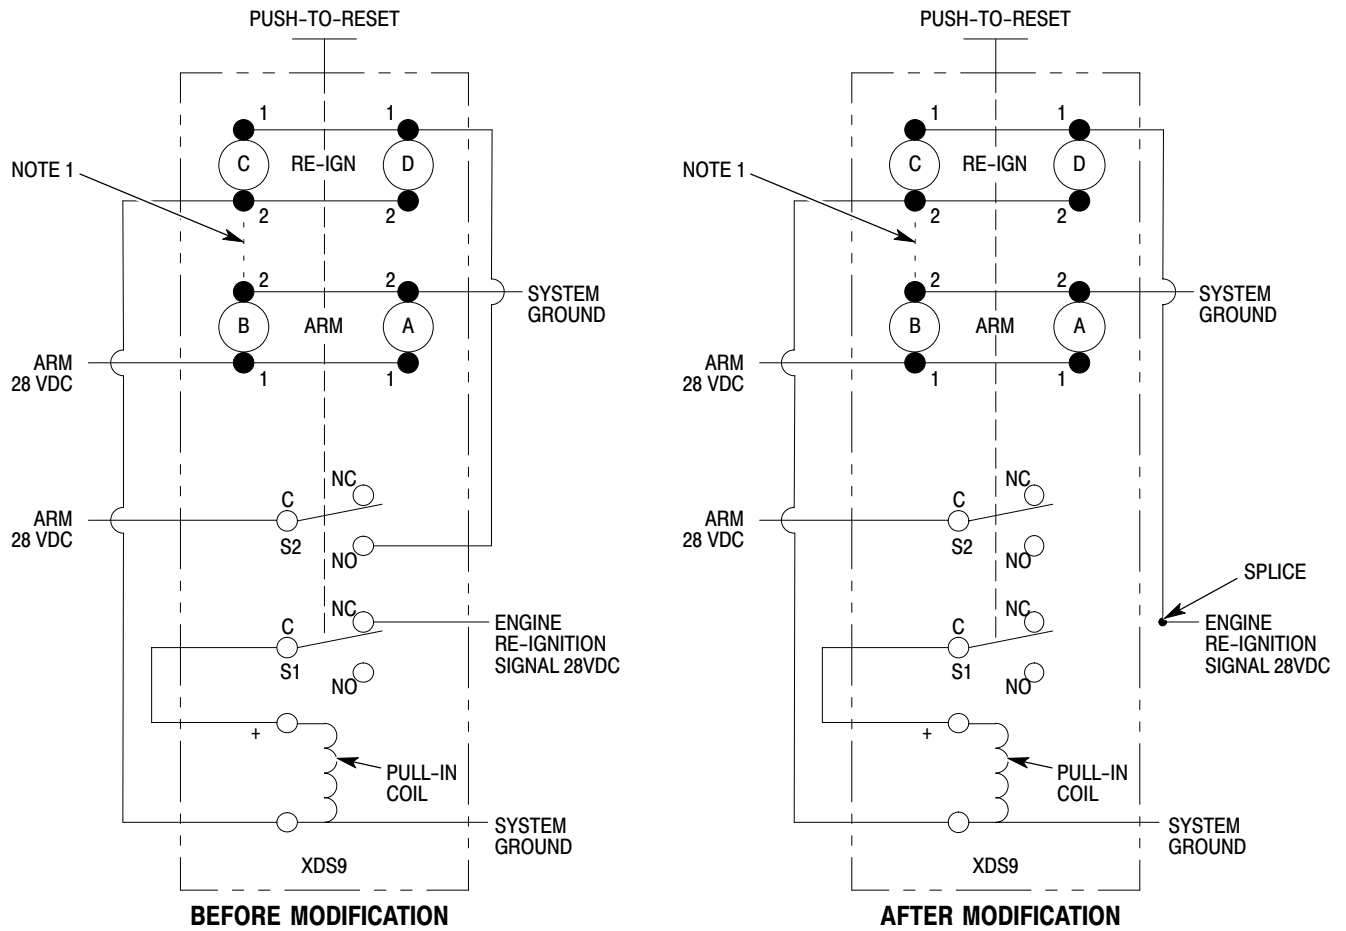
Figure 2. XDS9 Switch Assembly Connection Modification

This modification disconnects the wires from the switch in the XDS9 assembly from the system. The disconnected wires are then spliced together to make the XDS9 **RE-IGN** indicator light reset automatically after engine re-ignition.

- (3). Disconnect all wires from switch S2 Normally Open (NO) terminal.
- (4). Disconnect all wires from switch S1 Normally Closed (NC) terminal.
- (5). Splice the disconnected wires together, use a solder splice or solder and heat shrinkable sleeving.
