# SERVICE LETTER

## Hoist Inspection Hole Installation

**MODELS AFFECTED:** All McDonnell Douglas Helicopter Systems (MDHS) MD900 Series Helicopters having a hoist installed.

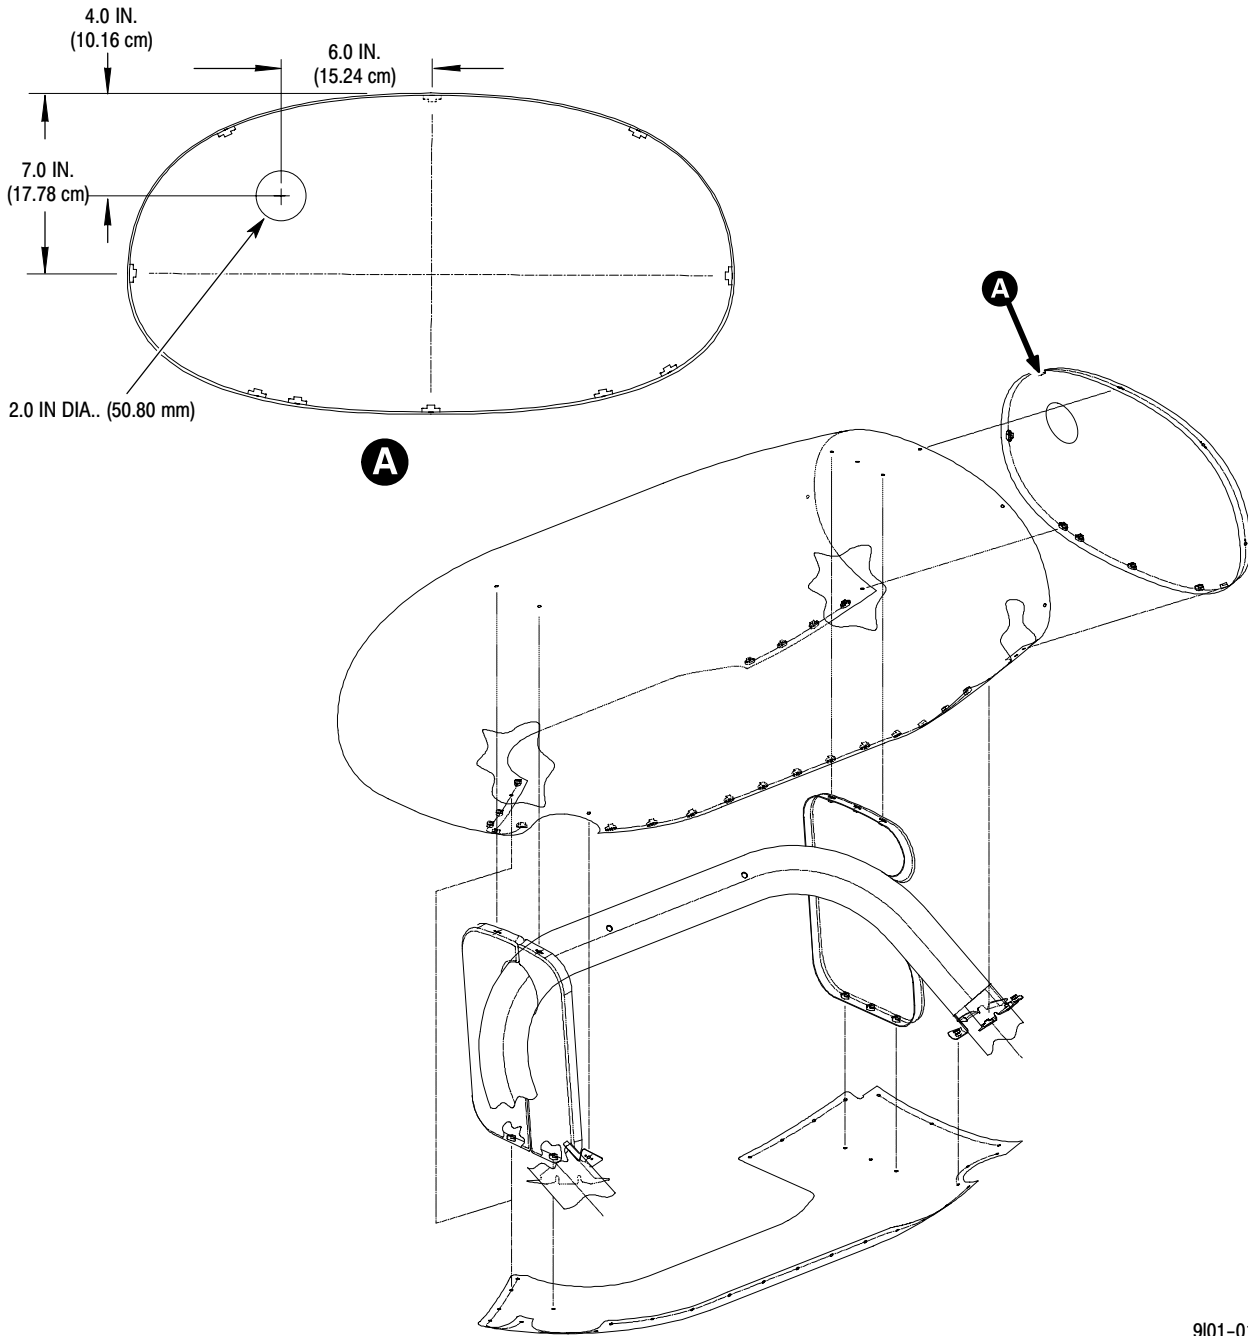
Figure 1. Inspection Hole location

1. **DESCRIPTION:** This Letter provides operators with instructions to modify their hoist fairing to provide access for inspection.

A. Locate hole as shown in Figure 1.

B. Cut hole in fairing bulkhead.

- 1). Pilot hole with a high speed drill to match hole saw pilot size.
- 2). Cut hole to size with a 2 inch diamond tipped hole saw.
- 3). Smooth edge with 280 grit sandpaper or finer.

4). Seal edge of hole with primer and topcoat.
