SERVICE LETTER

ANTI-TORQUE FAN INLET SCREEN

TO: ALL OWNERS AND OPERATORS OF MD-900 HELICOPTERS.

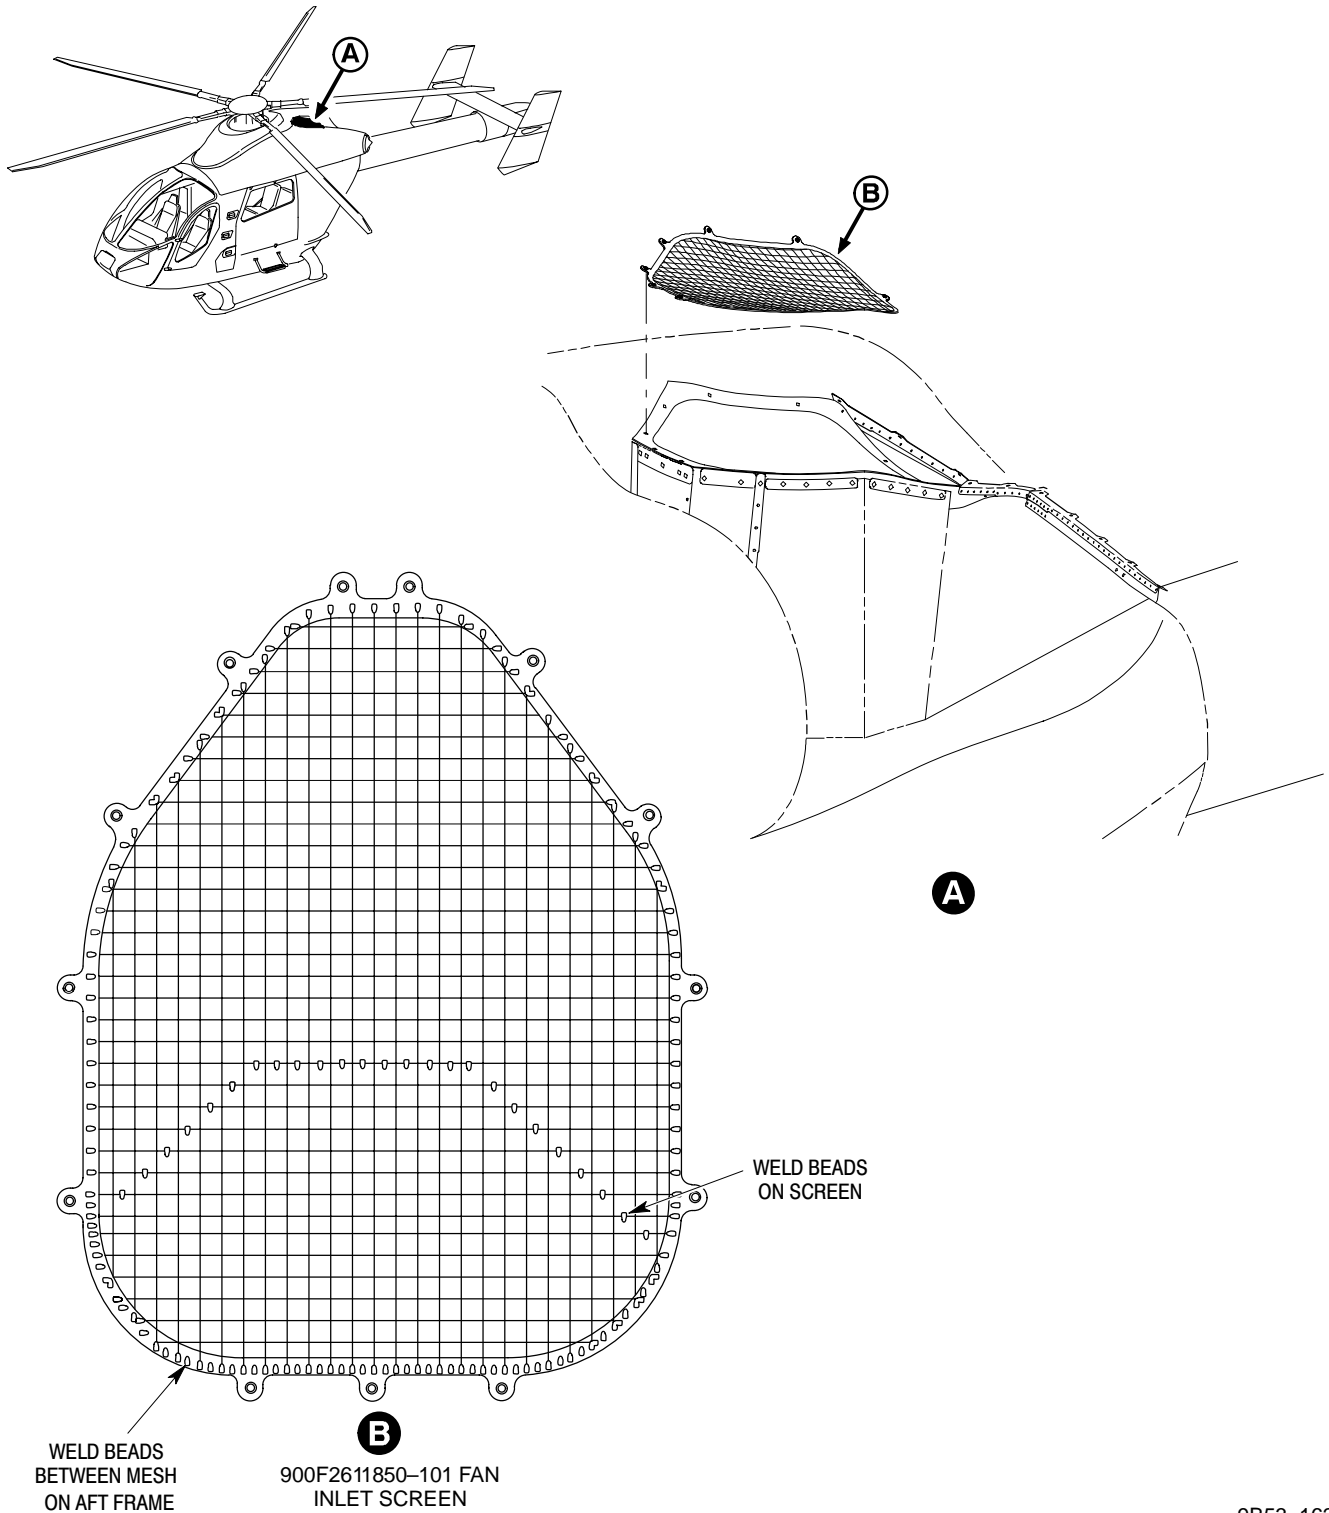
Figure 1. Anti-Torque Fan Inlet Screen

This Service Letter is issued to advise all owners and operators of possible cracks occurring in certain P/N 900F2611850-101 anti-torque fan inlet screens. These screens can be identified by weld beads between the mesh on the aft screen frame and weld beads on the screen itself (Ref. Figure 1).

If any of these screens are found or any broken strands are noted during the pilot's daily preflight check or any maintenance activity, contact the Field Service Department at MDHI, Mesa, Arizona by telephone at (800) 388-3378 or (480) 346-6387 for information on obtaining a replacement screen.
