SERVICE LETTER

DATE: 13 SEPTEMBER 2005
PAGE 1 OF 2

ANTI - TORQUE CONTROL PEDAL SEPARATION

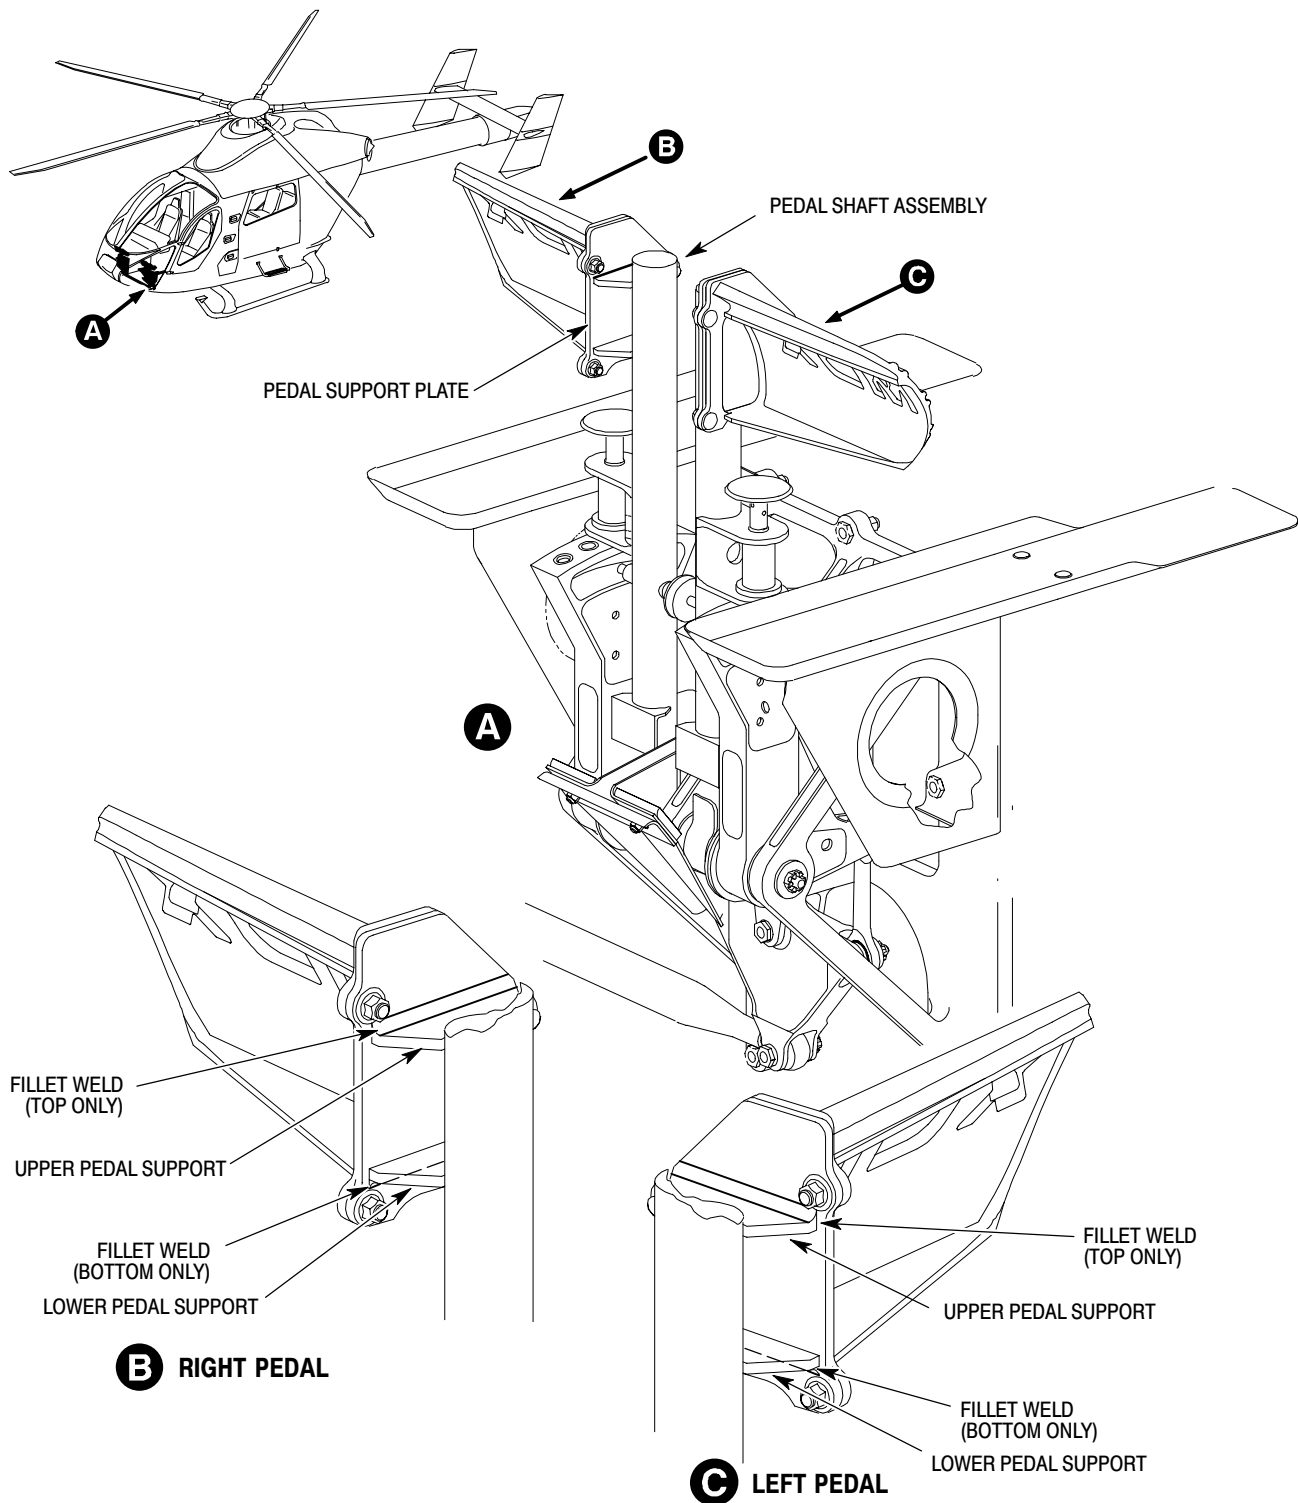
Figure 1. Anti-Torque Control Pedal Installation

This Service Information Letter is issued to inform owners and operators of MD900 helicopters of an accident where an anti-torque control pedal separated from the pedal shaft assembly. This incident is under investigation. A possible cause may be poor penetration on the fillet weld on the pedal support plate and fatigue (Ref. Figure 1).

If a pedal should separate from the shaft, anti-torque control can be maintained by the pilot placing his foot on the pedal shaft to maintain directional control. If this occurs in flight, perform a normal landing as soon as possible.
