SERVICE LETTER

DATE: 19 JUNE 2007

MAIN ROTOR BLADE RETENTION BOLT CHECK

MODELS AFFECTED: MD900 helicopters serial numbers 900-00008 and subsequent with 900R3100001-103 main rotor blade retention bolts installed.

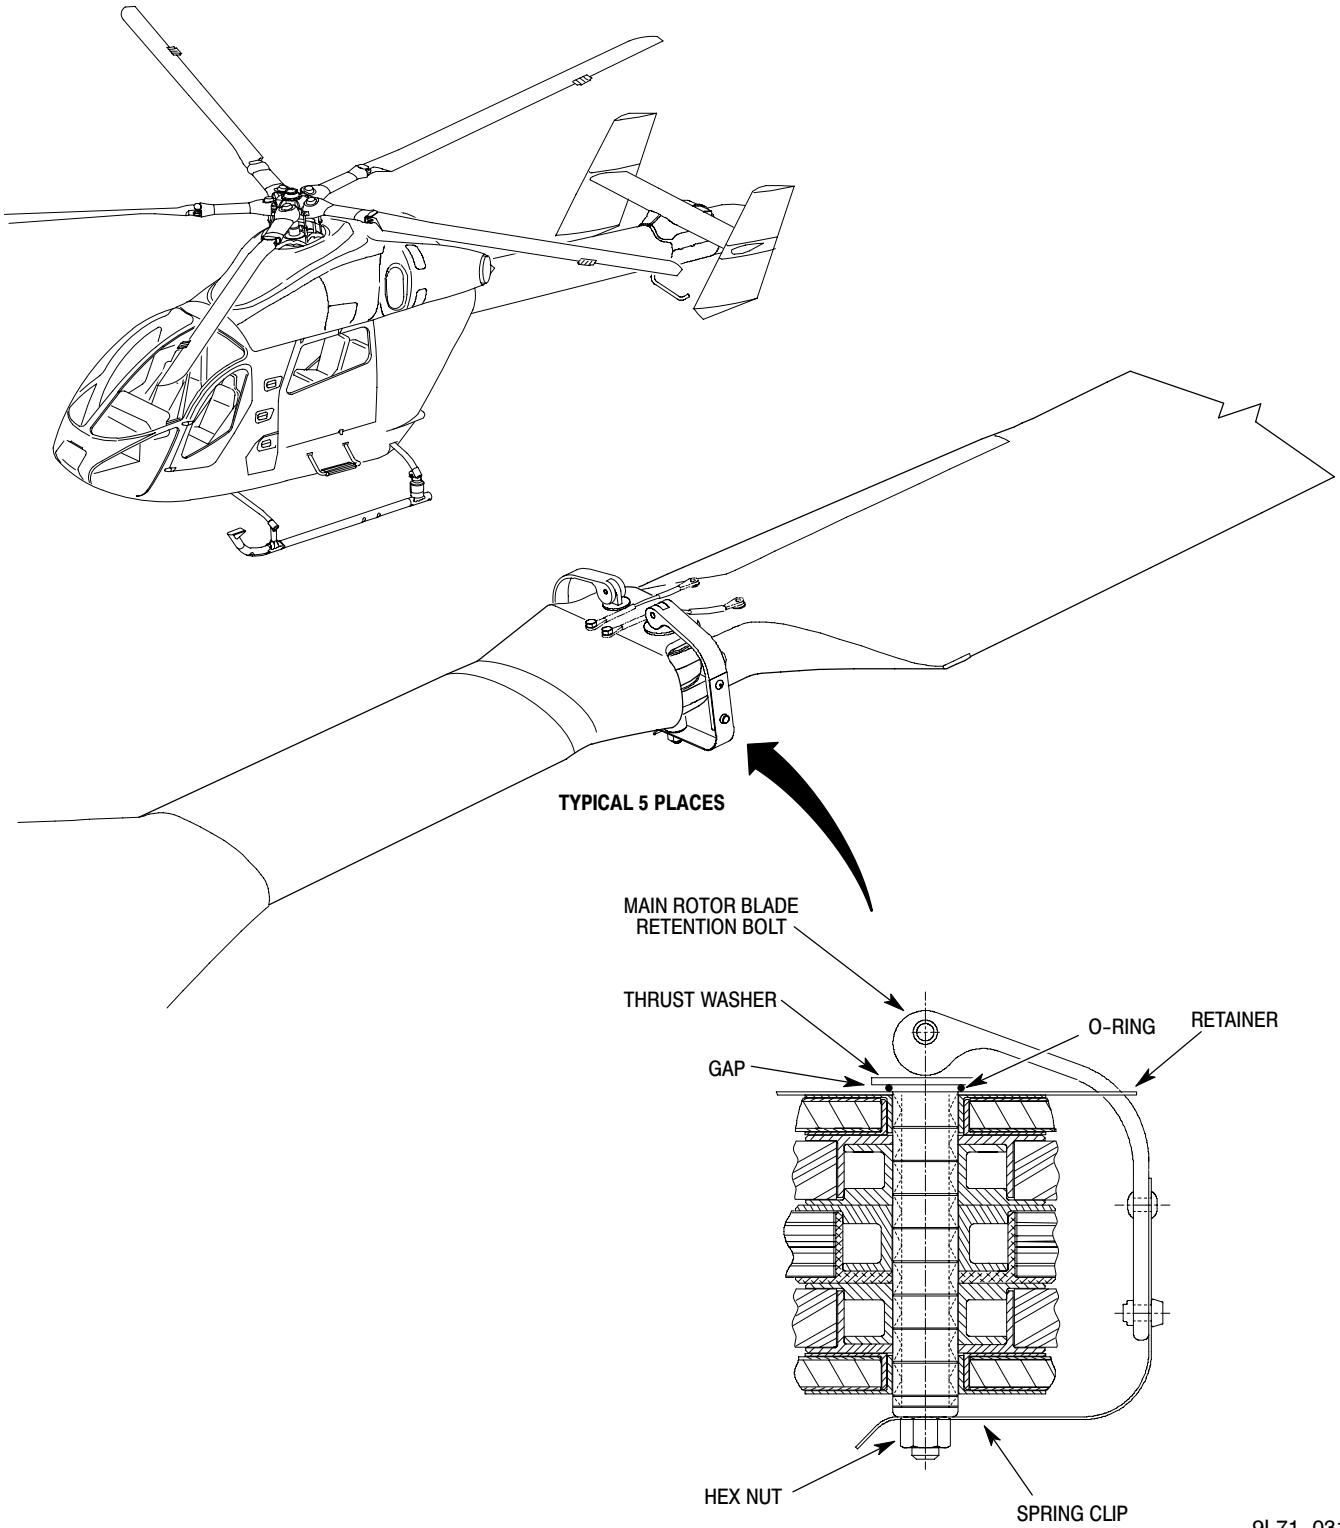
Figure 1. Main Rotor Blade Retention Bolt

Visually examine the area around the hex hole in the spring clip for cracks. Make sure spring clip hex hole is fully engaged on hex nut. Visually examine the position of each main rotor blade retention bolt to make sure it has not moved up in the pitchcase. Make sure there is a gap between the main rotor blade retention bolt thrust washer and the retainer. Compare the gap between the main rotor blade retention bolt thrust washer and retainer to the gap at the other nine bolts. Each of the ten gaps must be almost the same.

If you think a main rotor blade retention bolt has cracks around the spring clip hex hole, spring clip hex hole is not fully engaged on hex nut, has moved up, or there is no gap under the thrust washer, have a certificated maintenance technician remove bolt and do a detailed inspection of the bolt (Ref. CSP-900RMM-2, Section 62-10-00). If no defects are found, install bolt (Ref. CSP-900RMM-2, Section 62-10-00).
