SERVICE LETTER

DATE: 7 APRIL 2011

INSTALLATION OF ENGINE GROUND STUDS

MODELS AFFECTED: MD900 helicopter serial numbers 900-00008 thru 900-000143.

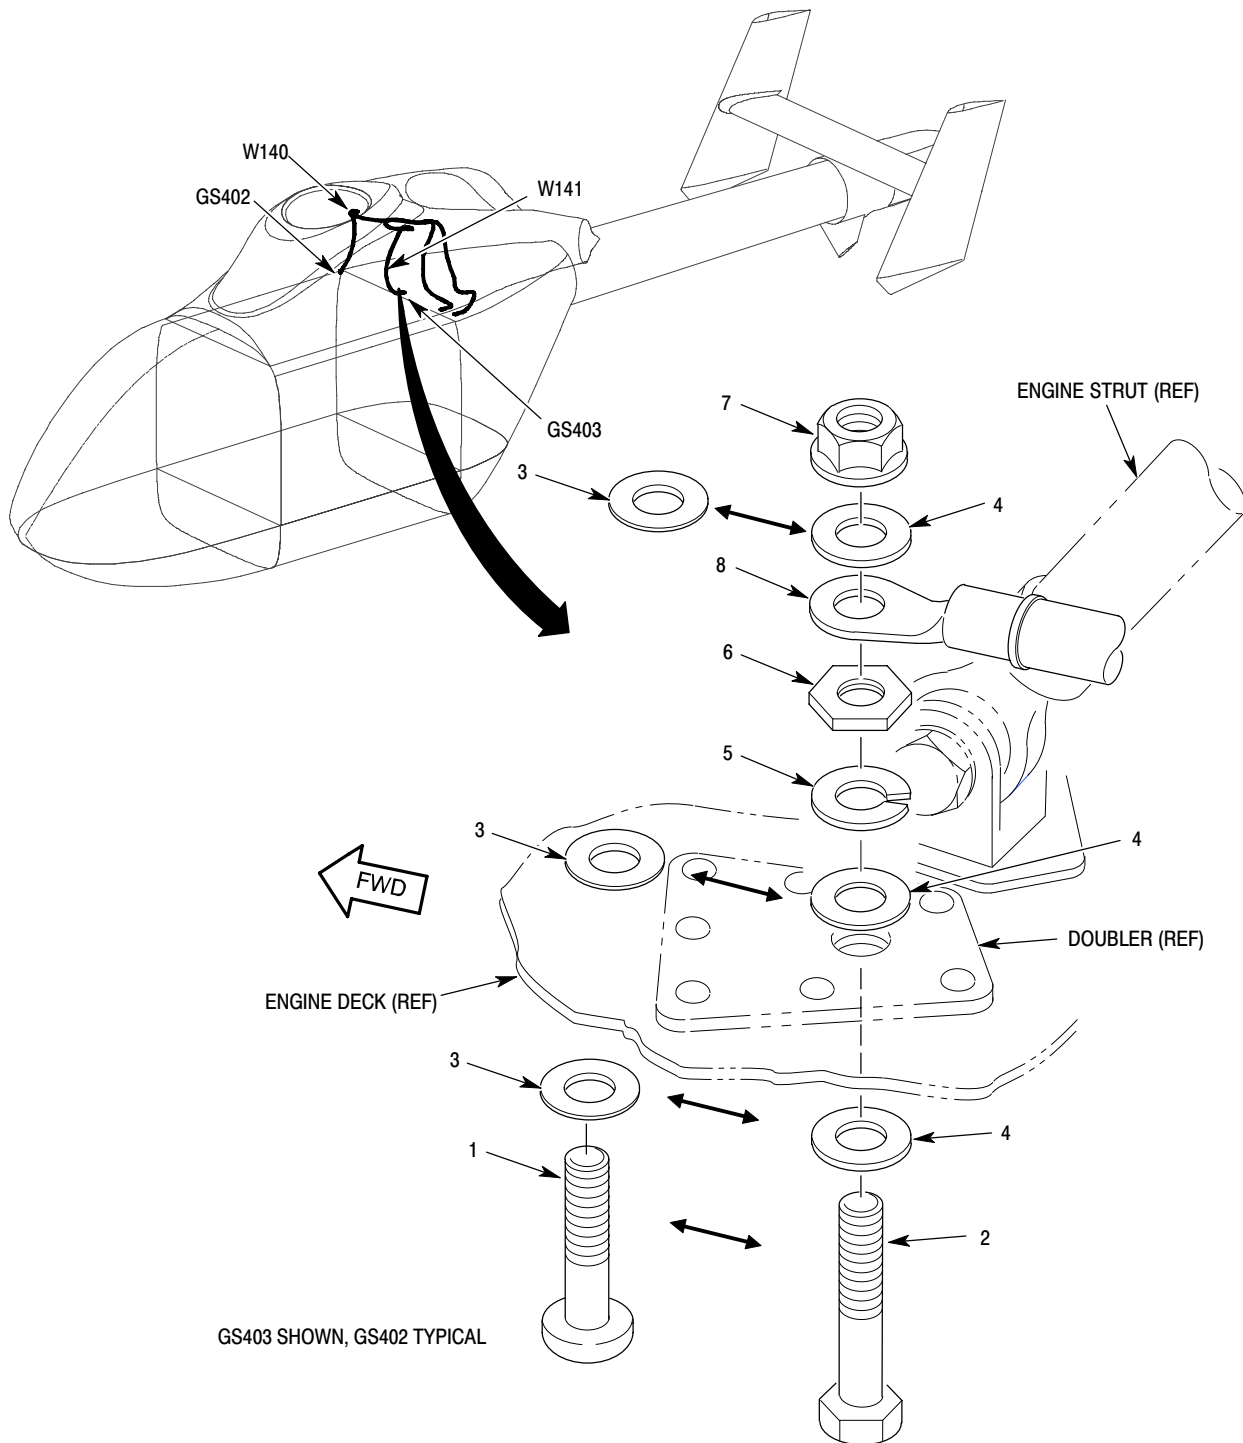
Figure 1. Stack-up of Ground Studs at GS402 and GS403

This Service Letter is issued to recommend that operators inspect starter/generator ground studs for arcing, corrosion, and looseness at the next annual inspection. This inspection is necessary to find loose ground studs, or corrosion or arcing that can cause a starter/generator problem. The ground studs are located on the engine deck: right-hand GS402 at STA 225.45 BL 23.12 and left-hand GS403 at STA 228.67 BL -5.15 (ref. Figure 1).

Corrosion cannot be more than **0.012 inch (0.30 mm) deep**. If corrosion on the doubler is more than this limit, contact the Field Service Department at MDHI, and remove and replace the doubler.

If arcing or corrosion is found, the wire lug and its interfaces must be cleaned.

If no corrosion is found, but the grounding stud is loose, torque the ground stud to **110 in-lb (12.4 Nm)**.

To decrease the possibility of incorrect torque, MDHI will no longer use NAS1635-6-16 Phillips-head screws with three AN960JD616L flat washers at each of the starter/generator grounds. AN6C7A hex-head bolts with three NAS1149D0663J flat washers will be used as alternative ground studs on Rotorcraft SN 900-000144 and subsequent. AN6C7A bolts and NAS1149D0663J washers can be purchased commercially by the operator and can be installed on all rotorcraft without modification.

NOTE: If the NAS1635-6-16 screws and AN960JD616L washers are replaced with AN6C7A bolts and NAS1149D0663J washers, you do not have to do the next or future annual inspections.

NOTE: If necessary add washer. (4).
