SERVICE LETTER

DATE: 14 JANUARY 2010

THRUSTER ASSEMBLY WASHER MODIFICATION

MODELS AFFECTED: All MD900 helicopters.

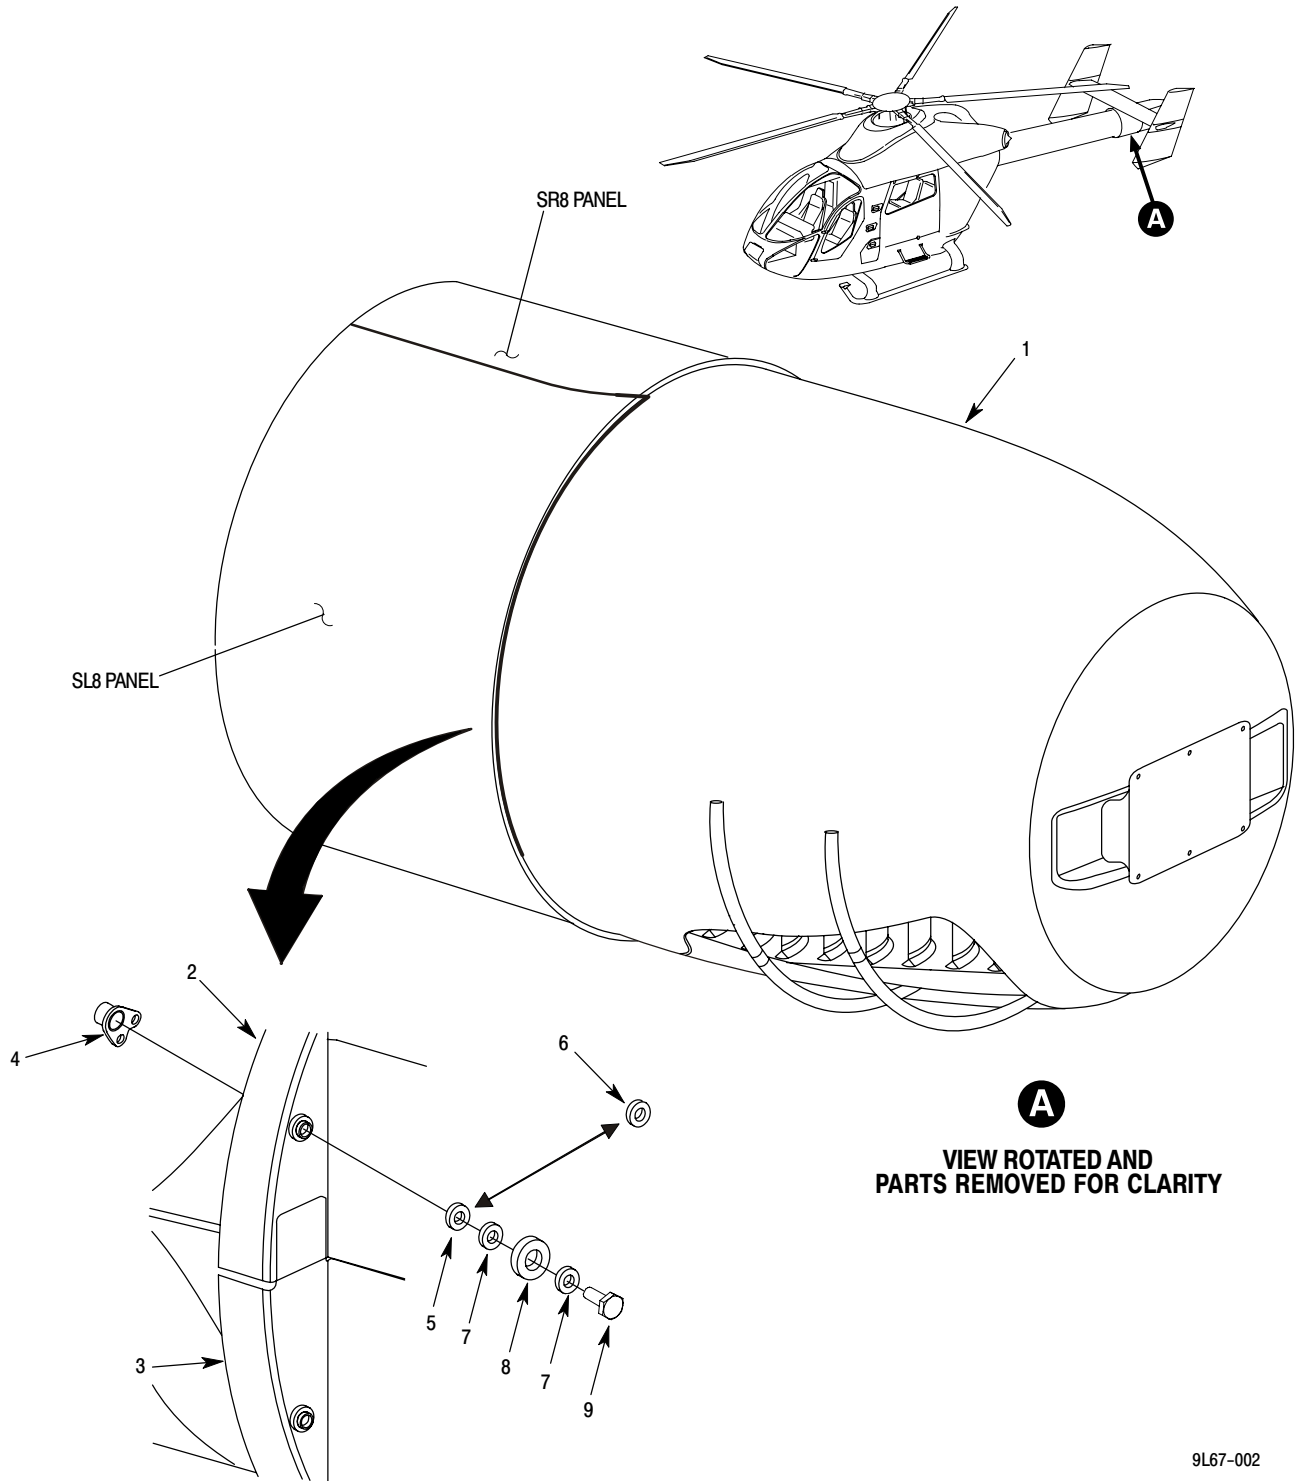
Figure 1. Location of Thruster Assembly Washer Modification

This service letter is issued to tell owners and operators that the control bearing (ref. Figure 1) for the rotating cone assembly may not move freely because the attaching bolts have been over-torqued during installation. Torque more than **30 in-lb (3.4 Nm)** can cause the nylon flat washers to extrude and cause an interference with bearing rotation. At the next bearing inspection/replacement interval, MDHI recommends the removal of flat nylon washers, PN NAS1515H3L (5), and their replacement with corrosion-resistant steel (CRES) flat washers, PN NAS1149C0363R (6). The CRES flat washers are thicker and provide increased clearance from the face of the thruster bulkhead.

At the next access to, or during scheduled maintenance to the control bearings, replace flat nylon washers with CRES flat washers. Install control bearings with new washer in the thruster assembly. Correctly torque bolts **15 to 20 in-lb (1.7 to 2.3 Nm)** plus run-on torque to get the correct locking torque on the nutplate. If it is necessary to remove remaining axial play of the stack-up, torque bolts to **24 in-lb (2.7 Nm)** maximum.
